Roads and Bridges

INTRODUCTION

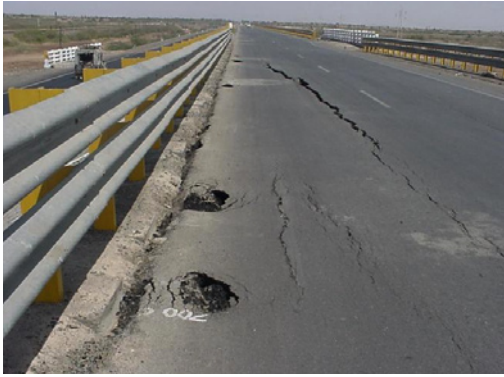
Figure 19-1. Roadway cracking between the towns of Gandhidham and Bhachau.

Newly finished roadways between the towns of Gandhidham and Bhachau suffered some damage. Longitudinal cracks 50 to 100 mm wide and approximately 300 mm deep cracks developed along the shoulder and edge of the traffic lanes on the embankment (Figure 19-1). Settlement of the shoulder edge and holes about 600 mm in diameter and 450 mm deep are also visible in the photo. A longitudinal crack separated the entire guardrail system from the roadway shoulder. While rock blocks were laid and mortared in place on the face of the slope, earthquake caused settlement and down slope movement of the underlying soil.

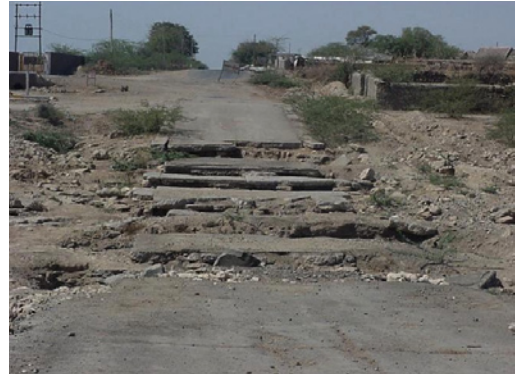
Figure 19-2. Collapse of roadway drainage structure between towns of Anjar and Bhuj.

Lack of structural adequacy resulted in the collapse of several traffic-bearing roadway drainage structures, as shown in Figure 19-2. Such roadway drainage structures were, in most cases, concrete box culverts, concrete pipes and unreinforced masonry box culverts. To accommodate postearthquake traffic, temporary detours were provided across adjacent dry-season riverbeds. Damaged drainage structures are not repairable, and need to be rebuilt with adequate attention to quality in design and construction.

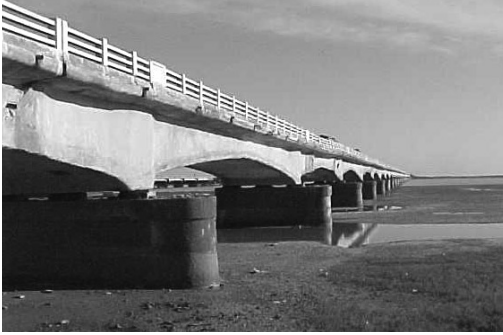
Figure 19-3. Old Surajbadi Highway Bridge.

This 1205 m bridge (Figure 19-3) has cast-in-place reinforced concrete balanced cantilever box-type superstructure (35 interior spans of 32.93 m each, two end spans 26 m each). The superstructures rest on steel rocker and roller bearings placed on top of reinforced concrete wall piers. The wall piers are supported on well foundations of different diameters (ranging from 7-10 m). The depth of the well foundations ranges from 13-18 m. Given the age of the bridge, seismic analysis and detailing may not have been considered in its design.

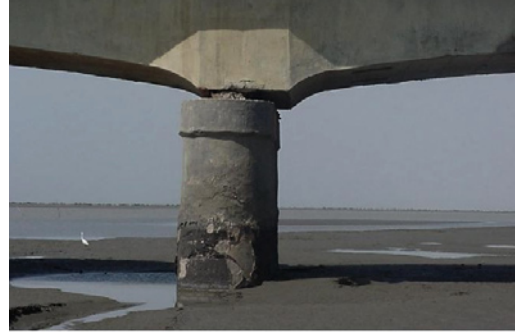
Figure 19-4. Relative longitudinal movement between the piers and the superstructure spans in the Old Surajbadi Highway Bridge.

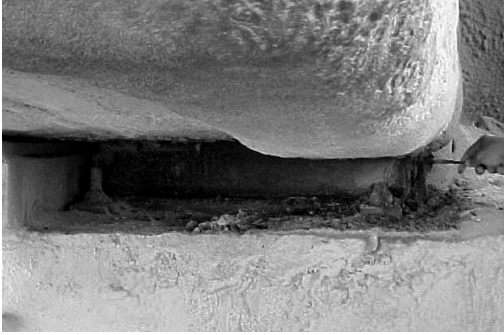
Figure 19-5. Roller bearing on the north side abutment of the Old Surajbadi Highway Bridge.

During the earthquake, all bearings under the superstructure of this bridge have been damaged (Figures 19-5 and 19-6). Due to liquefaction and ground movement, some piers moved and associated spans shifted on bearing supports. The bearings broke due to excessive lateral load at the inclined surface of the in-span hinge of the suspended span, which also sustained shear failure (Figure 19-7). This damage allowed the superstructure to slide off the bearings at several intermediate piers.

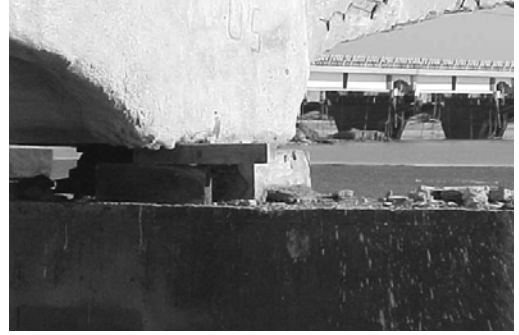
Figure 19-6. Damaged bearing on Old Surajbadi Highway Bridge. The New Surajbadi Highway Bridge (under construction) can be seen in the background.

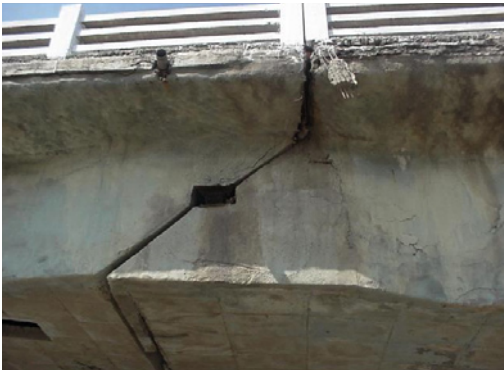
Figure 19-7. Failure of in-span hinge and traffic railings at Old Surajbadi Highway Bridge.

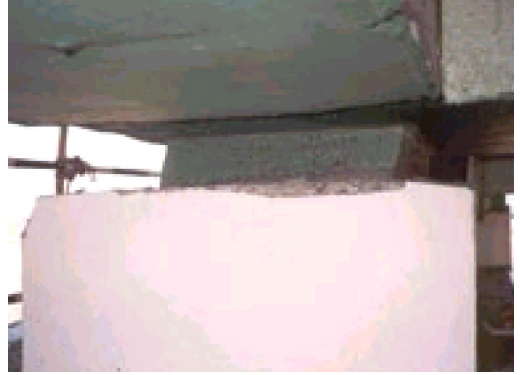
Figure 19-9. Severely strained elastomeric bearings of the New Surajbadi Highway Bridge.

Elastomeric bearings displaced from their original locations by as much as 0.25 m and were severely stressed (Figure 19-9). This suggests that the shaking intensity may have caused either the uplifting of the girder or the sliding of the girders over the concrete pedestal along with the bearings. The use of plain elastomeric bearings is not suitable for high seismic regions and a shear pin is required to prevent sliding during earthquakes. Indian codes do not prevent plain elastomeric bearings from being used in high seismic regions. Damages were also observed to the concrete pedestals (Figure 19-10) and to the soffit of the girder at the ends (Figure 19-11).

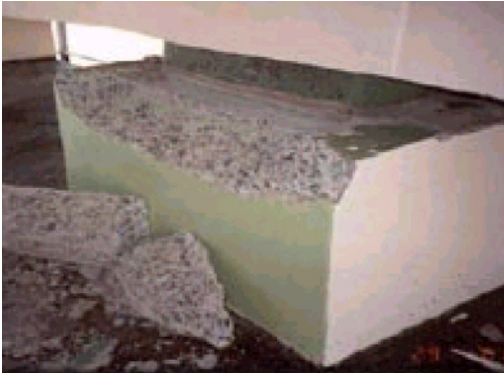
Figure 19-10. Damaged concrete pedestals of the elastomeric bearing of the New Surajbadi Highway Bridge.

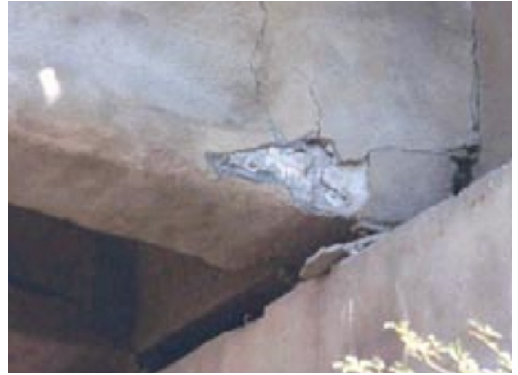
Figure 19-11. Damaged soffit of the girder at the span ends of the New Surajbadi Highway Bridge.

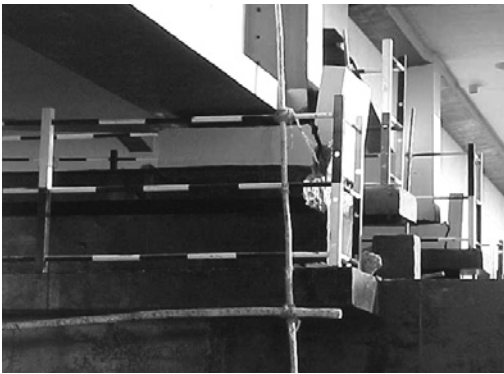
Figure 19-12. Cracked stoppers with separation as wide as 5 inches, New Surajbadi Highway Bridge.

Reinforced concrete stoppers were provided on the pier supports to limit the lateral seismic displacement of the girders. The gap on either side between the girders and the stoppers was about 115 mm. Almost all stoppers were damaged in the earthquake due to pounding by the girders, indicating a significant lateral motion of the girders during the earthquake. These stoppers definitely came into use during the January 26 earthquake. Although they have been damaged in their service, they also seem to have stopped the bridge deck from coming off its support. Figure 19-12 shows two damaged stoppers, one of them with a large 127 mm wide crack. The fusion-bonded epoxy-coated rebar showed poor bond characteristics (Figure 19-13).

The girders were jacked up and repositioned, the alignment of the bridge was restored, the last two spans were completed, and the damaged reinforced concrete stoppers were reconstructed.

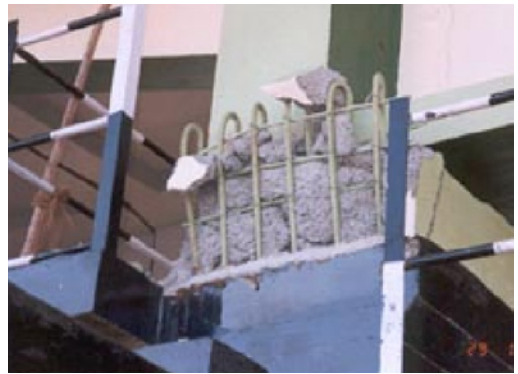
Figure 19-13. Damaged reinforced concrete stoppers showing poor bond between the epoxy-coated rebar and the adjoining concrete at the New Surajbadi Highway Bridge.

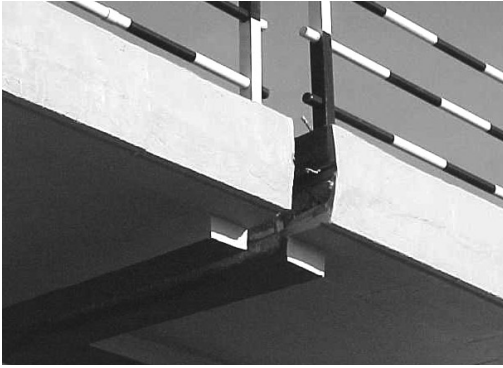
Figure 19-14. Transverse displacement of the superstructure decks of the New Surajbadi Highway Bridge.

There was no apparent or reported damage to the piers and foundations. But, large lateral (204 mm) and vertical (64 mm) relative displacements of the decks at some deck joints were observed (Figure 19-14). These vertical displacements indicate a possible settlement of the foundation. Damage to the deck joints due to mutual pounding of the two spans was observed (Figure 19-15).

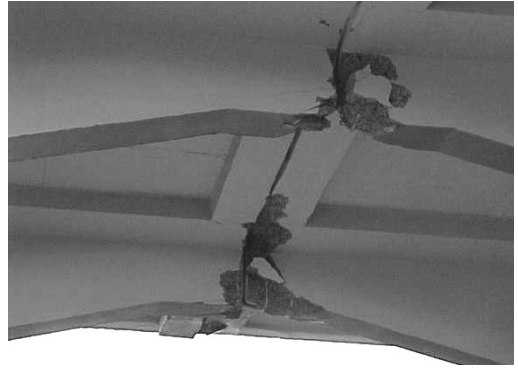
Figure 19-15. Pounding between two adjacent bridge spans, New Surajbadi Highway Bridge.

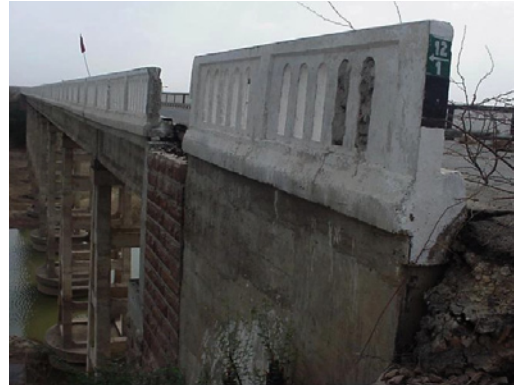
Due to the seismic excitation, lateral spreading and ground cracking at the north abutment resulted in settlement of the bridge approach (Figure 19-18). Also, cracks developed at the north abutment parallel to the stream bank (Figure 19-19). These cracks were 150 to 300 mm wide and up to 1.2 m deep. These are attributed to lateral spreading of the soil in the riverbed and extended on both the upstream and downstream sides of the bridge for a distance of about 450 m. However, there was no apparent damage to the south abutment due to this lateral spreading. There was no noticeable displacement of the abutments or intermediate piers due to ground movement. But, gapping or separation between the pier caissons and the surrounding ground of up to 300 mm occurred due to movement of the surface soil.

Figure 19-18. Collapse of the north end approach earthwork and of the parapet walls at Rudramata Bridge.

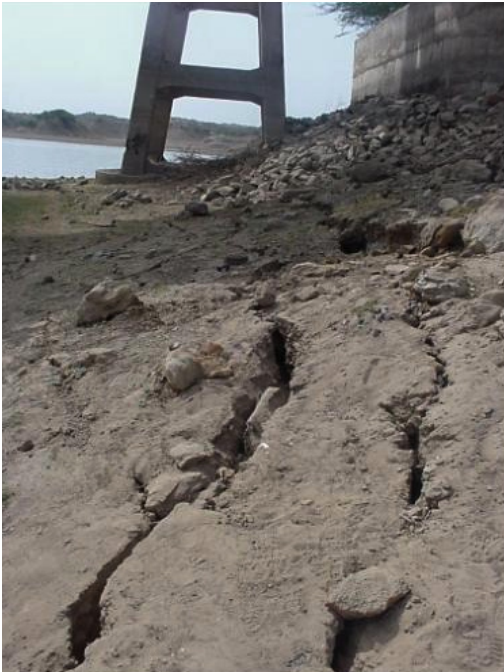
Figure 19-19. Ground cracks at intermediate and end piers. The ground around the Rudramata Bridge experienced extensive lateral spreading in the riverbed parallel to the south side riverbank on both the upstream and downstream sides of the bridge.

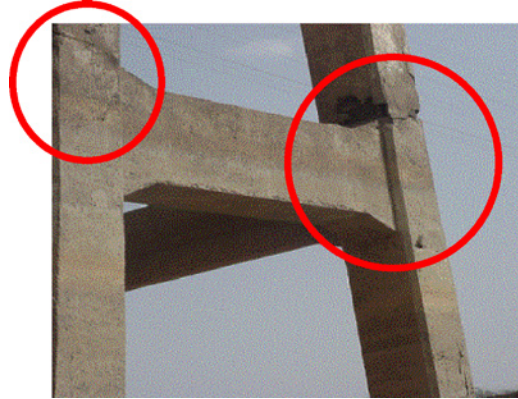
The A-frame tower at Pier 2 experienced horizontal flexural cracks along the exterior face of the column members and primarily shear cracks in the beam-to-column joint (Figure 19-20). These cracks are primarily due to the bending of the tower under seismic loads. The maximum crack width is approximately 6 to 12 mm. Some of the cracks have since been patched, though proper procedure for crack repair requires removal of spalled concrete, sandblasting and provision of adequate cover, which apparently was not done. Smaller cracks can be repaired by epoxy injection.

Figure 19-20. Flexural cracks in the columns and shear cracks in the beam-to-column joints occurred at the RC frame member junctions in the A-frame Pier No.2 of the Rudramata Bridge. The girders are deeper than columns, and use of flared beam-ends are noticeable. Spalling of cover concrete and corrosion of reinforcement bars is also evident at these locations.

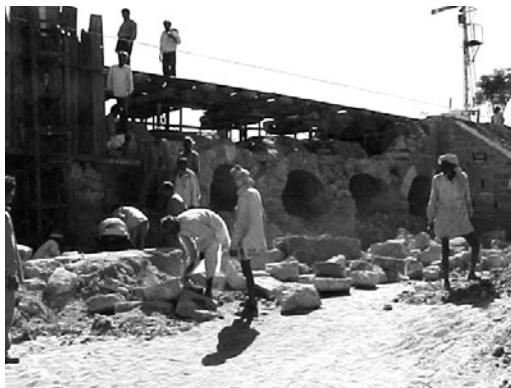
Figure 19-21. A damaged stone-masonry arch bridge, built in 1912. Temporary side supports (at left) are being erected to retain the ballast and open the traffic.

There are several small railway bridges in the area that were damaged. Like the stone masonry houses, the bridges that suffered the most damage were the ones with unreinforced masonry supports. A few of them were constructed in the early 20th century; the mortar between the stone masonry may have deteriorated over the years to provide only insignificant bonding. The masonry arch bridges shown in Figures 19-21 and 19-22 were of this type.

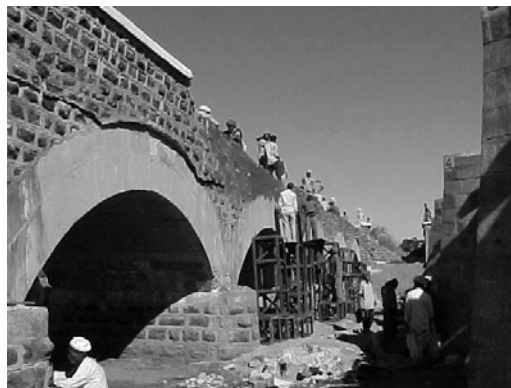
Figure 19-22. Damage to a railway masonry arch bridge. The sidewalls on the arches have fallen off. One of the stone blocks was loosened and partially dislodged from the center of one of the arches. These bridges were also built in 1912 under the meter-gauge rail line.

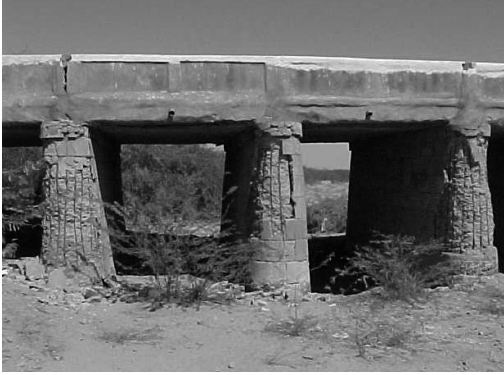
Figure 19-23. Weathered and poorly concreted piers further damaged by the earthquake. The concrete cover simply spalled off the piers.

These bridges are all in poor condition, with spalled concrete and exposed rusted rebar (Figure 19-23). Past attempts at repair using a shotcrete layer did not protect the structures from deterioration. In spite of such poor structural condition, none of the bridges collapsed during the earthquake. This is in part due to over-design, given the use of the short spans and large wall piers.

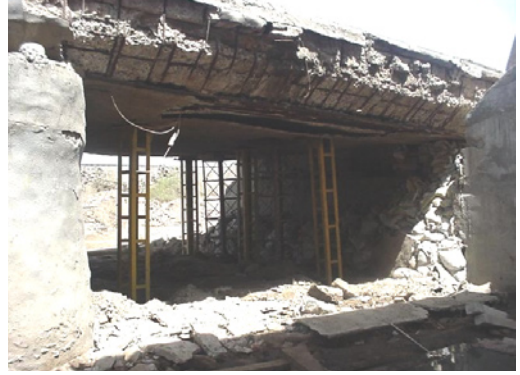
Figure 19-24. Failure of super and substructure of a bridge; rural area between the towns of Gandhidham and Bhachau.

Some older bridges suffered more damage than the others. The bridge shown in Figure 19-24 did not collapse during the earthquake, but suffered serious damage to end diaphragms, end pier walls, backwall, bearings and traffic barriers. The traffic barriers are in most cases post-and-beam type and their connection to the balusters and slab had completely deteriorated prior to the earthquake. Given the need to maintain traffic flow on NH8, temporary supports allow for its continued use, though the damage incurred dictates that it be replaced.

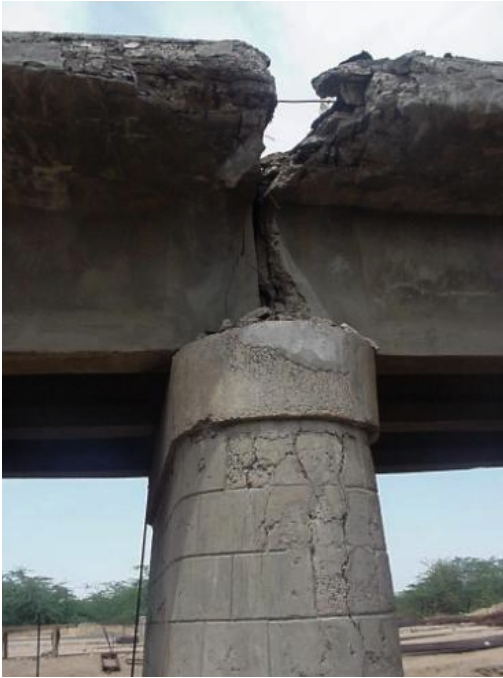
Figure 19-25. Failure of the girder end and expansion joint of a bridge between the towns of Gandhidham and Bhachau.

slab at the expansion joint grew to include the cantilever slab. Concrete at the end of the girder sheared off and the bearing area was significantly reduced (Figure 19-25). Vertical cracks due to shear friction appeared at the end of the girder. The substructure experienced diagonal cracking in the pier cap and vertical cracking in the wall pier. Cracks are 12 to 25 mm wide and will require immediate repair.

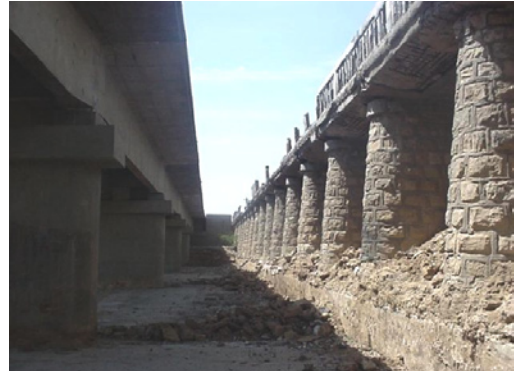
Figure 19-26. Failure of masonry wall pier of a bridge between the towns of Gandhidham and Bhachau.

The masonry wall piers are supported on a continuous raft footing approximately 900 mm deep (Figure 19-26). The superstructure is supported on bearings, which over the years have completely deteriorated such that their existence is hard to discern. The concrete arches are supported on the mat footing on pedestals. Due to the longitudinal movement of the bridge, the fixed connection failed and the end diaphragm cracked vertically. The end span sagged by about 50 mm resulting in cracking and spalling of the concrete at the bottom of the slab.

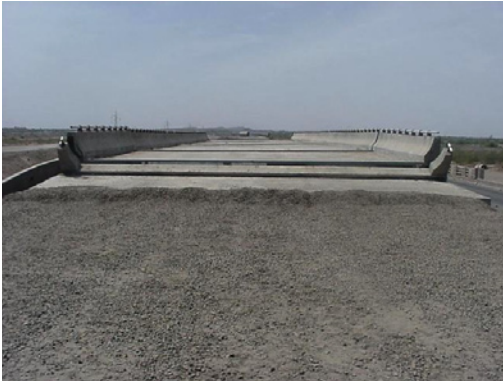
Figure 19-27. Failure of approach slab of a bridge at the village Vondh.

These bridges under construction were designed and detailed with the same structural concepts as the older bridges. They have short simply supported spans approximately 15 m long with expansion joints at each pier, but no provisions for ductility. They have cast-in-place super- and substructures with L-abutments as end piers. There was no indication of seismic design and detailing in spite of the high potential for liquefaction in this Seismic Zone V. Shallow, rather than deep, foundations were employed. The failure of abutments, piers, expansion joints, and settlement of approach slabs (Figure 19-27), was typical among the bridges under construction.

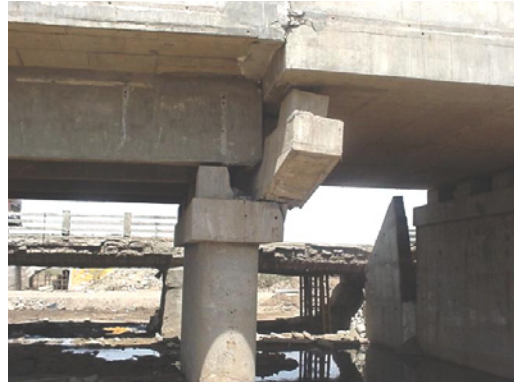
Figure 19-28. Failure of crossbeam of a bridge at the village Vondh.

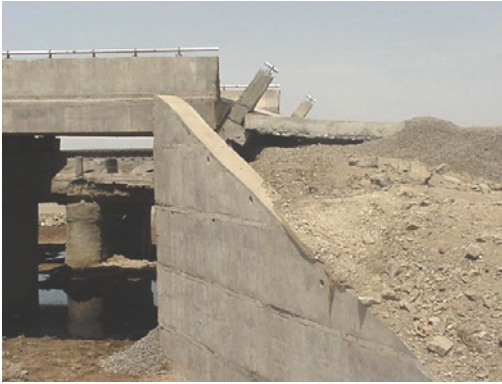
Further, due to the relative longitudinal movement of the bridge superstructure and the abutment, the superstructure pounded on the abutment backwall and caused cracking and spalling of the concrete at the base of the backwall. In turn, the backwall of the abutment also pushed into the approach slab. The approach backfill settled and spread out toward the wing walls on the side. Consequently, the connection between wingwall and abutment wall failed (Figure 19-29).

Figure 19-29. Failure of abutment of the bridge at the village Vondh.

Settlement of the approach backfill of between 300 and 450 mm was noticed in this short-span bridge. The repair of this bridge will require extensive work, including rebuilding of the abutment wall, expansion joint, backwall, wingwalls, backfill and approach slab.
