# Impact of Great December 26, 2004 Sumatra Earthquake and Tsunami on Structures in Port Blair

Hemant B. Kaushik<sup>1</sup> and Sudhir K. Jain, M.ASCE<sup>2</sup>

**Abstract:** This paper reports on the effects of the great Sumatra earthquake and tsunami of December 26, 2004, in and around Port Blair, the capital city of the Andaman and Nicobar Islands, India. The earthquake shaking and subsequent tsunami caused substantial damage to structures that include buildings, harbors, overhead water tanks, seaport control towers, and so on. Other important structures, for example, dams, bridges, hangars, and so on, also suffered minor damage without disrupting their functioning. Reinforced concrete structures on the islands were the worst performers, while traditionally constructed timber and masonry structures performed well in response to ground shaking. The mandatory Indian Standards were not complied within the design of many recent structures on the islands located in the most severe seismic zone in India.

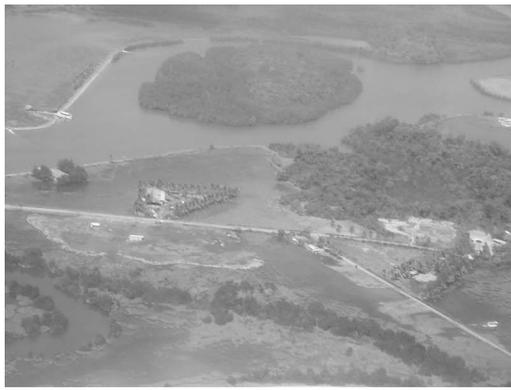
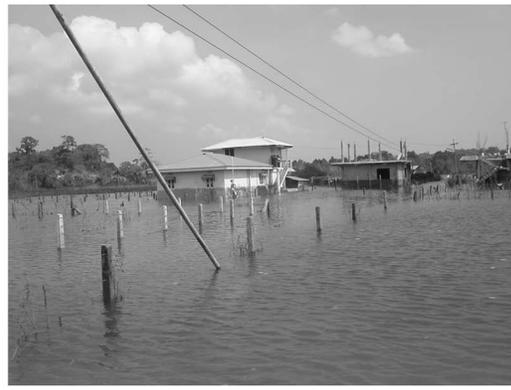
**Fig. 1.** Inundation of low-lying areas in and around Port Blair indicating subsidence of islands: (a) aerial view; (b) inundated houses at Nayashahar near Port Blair

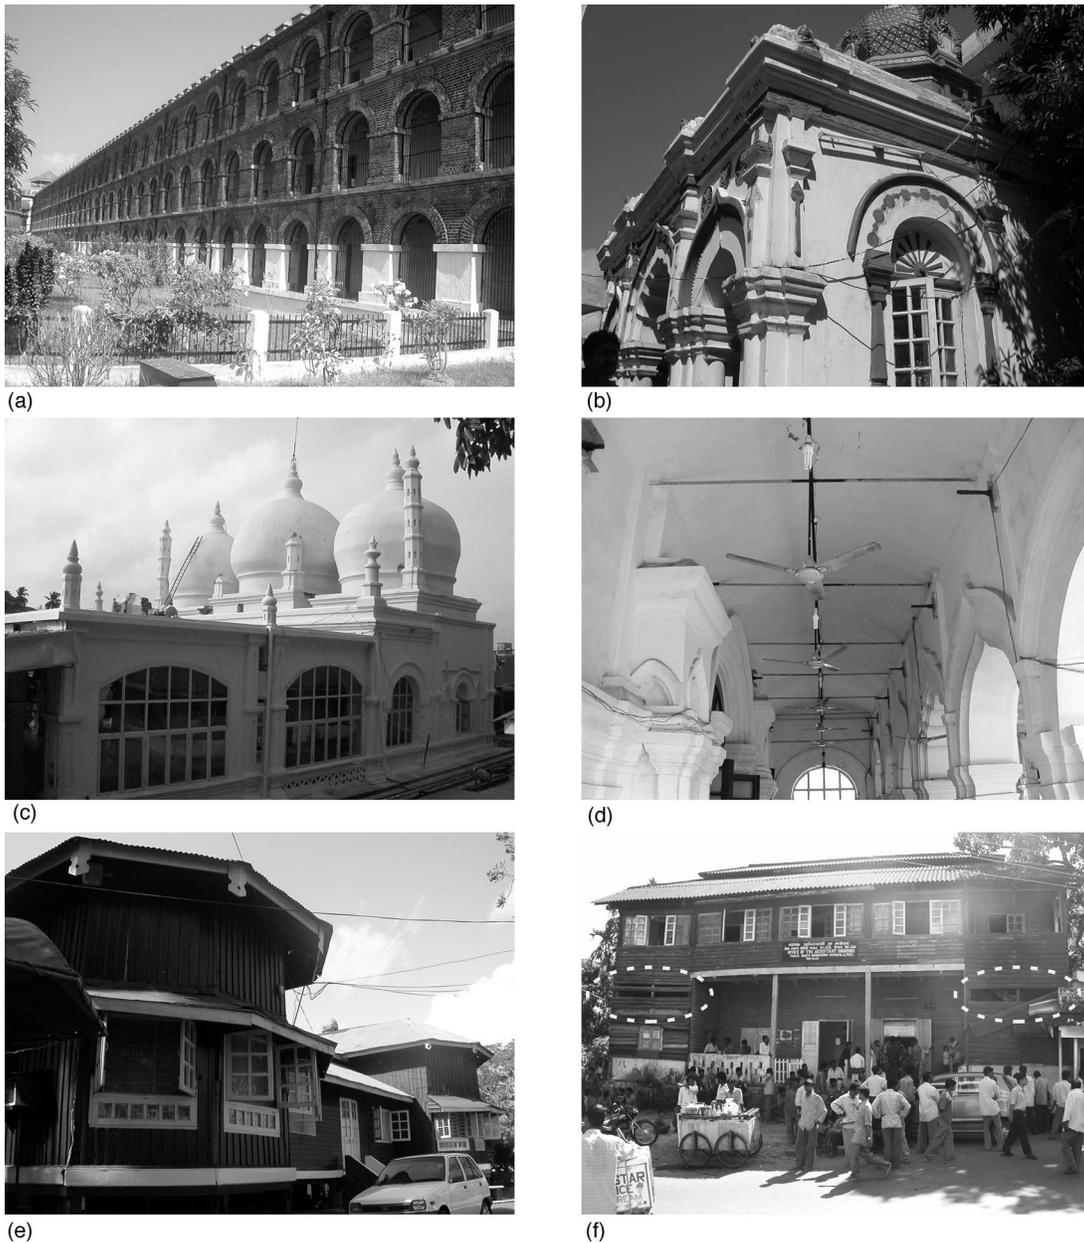
Presently, only a few masonry structures are left in Port Blair, and these performed well during the shaking caused by the 2004 event. A temple (*Police Mandir*) at Aberdeen market in Port Blair is a single-story brick masonry structure constructed in the 1930s [Fig. 2(b)] that did not suffer any damage during the 2004 shaking. The mosque at Aberdeen in Port Blair (*Jama Masjid*) is a single-story masonry structure (20 m high and  $22 \times 32$  m in plan) constructed in 1913 with hemispherical domes and minarets.

The mosque was damaged in the June 26, 1941 earthquake (magnitude 7.7), after which it was retrofitted using tie rods across the halls, which tied the walls together. In 2001–2002, while the mosque was being renovated, the tie rods that had corroded over the years were replaced. During the 2004 shaking, the building performed very well, the only damage being the collapse of a few slender minarets [Figs. 2(c and d)]. This mosque provides a good example of how simple retrofitting interventions in time can be critically beneficial to the building in the event of an earthquake.

Traditional timber buildings in Port Blair performed extremely well during the shaking, and several properly maintained timber buildings did not suffer any structural damage [Fig. 2(e)]. A few timber buildings with improper maintenance suffered minor damage in the form of detachment of timber planks from the timber frame [Fig. 2(f)].

**Fig. 2.** Undamaged historical and traditional construction in Port Blair: (a) masonry structure of cellular jail; (b) *Police Mandir* at Aberdeen Market; (c) collapsed minarets mark only damage to *Jama Masjid* at Aberdeen; (d) seismic retrofit of mosque using tie rods; (e) timber house at Marine Hill; and (f) timber building used as office of assistant engineers, Public Health Engineering Division, Andaman Public Works Department

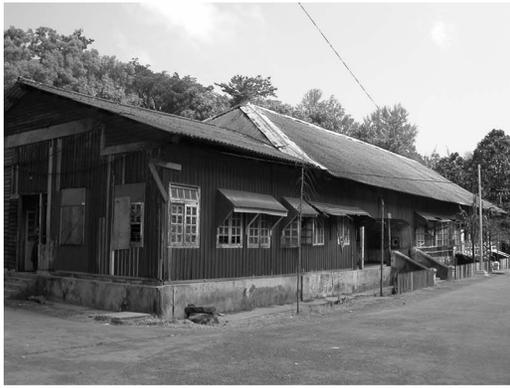
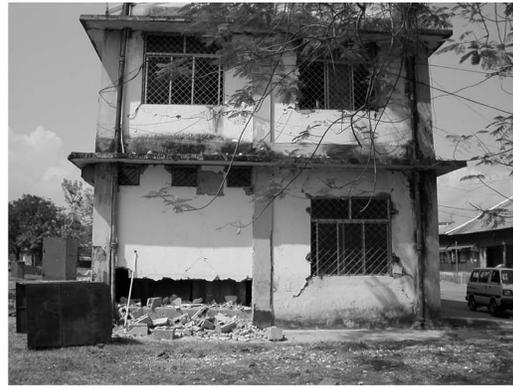
Presently, RC buildings are preferred over the traditional timber and masonry construction. At several places, older timber structures are being abandoned for newly constructed and supposedly “strong” RC buildings. An interesting example is of a 50-year-old timber office building in the Marine jetty dry dock campus, which was considered dilapidated and was being vacated at the time of the earthquake shaking [Fig. 3(a)]. The office complex was being shifted to a newly constructed 3-story RC building (*Siddhartha*) situated right across the road [Fig. 3(b)]. The timber building performed well during the shaking, even though the *Siddhartha* building was significantly damaged. Damages were observed in the RC frame and masonry infills in the *Siddhartha* building and severe corrosion was observed in the building due to poor quality of construction. As a result, the *Siddhartha* building had been

**Fig. 3.** (a) Undamaged 50-year-old timber building at Marine jetty dry dock; (b) damaged *Siddhartha* building in dry dock complex

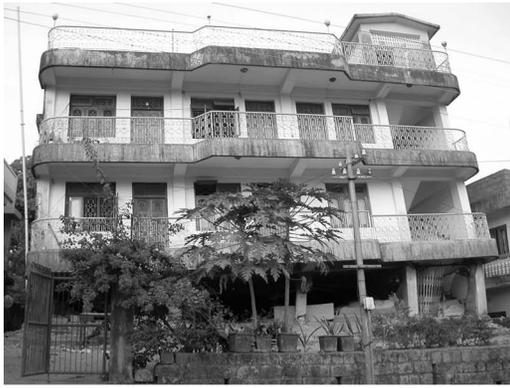
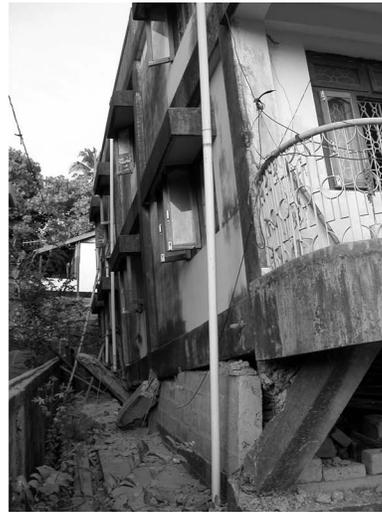
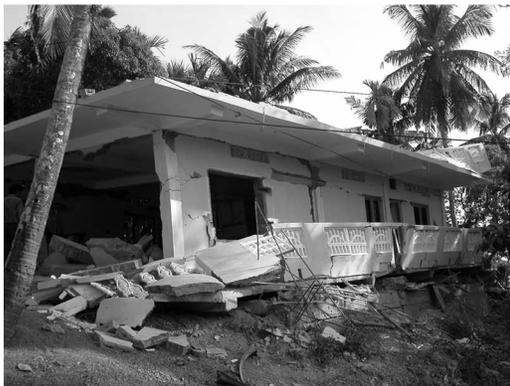
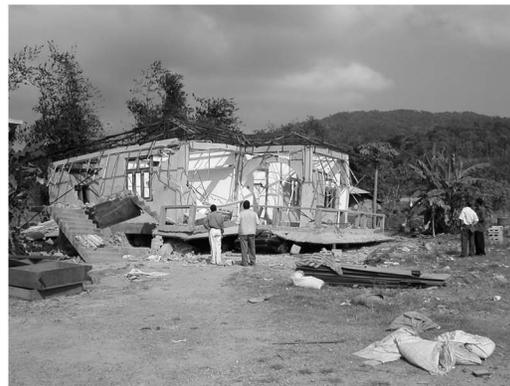
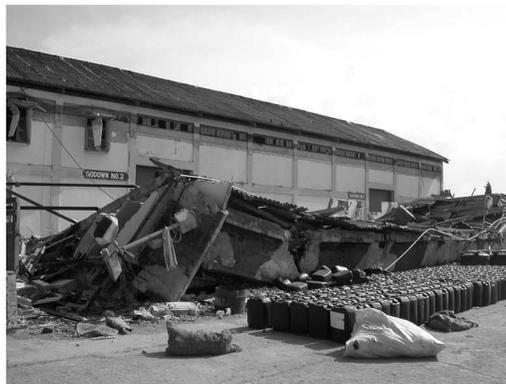
In recent years, common construction practice in Port Blair (and in most of urban India, for that matter) is to generate parking space in the first story of multistoried RC buildings by not providing masonry infill walls in that story. This makes the open first story much softer and weaker than the adjacent stories, in which masonry infills are provided. Several such buildings suffered severe damage or complete collapse due to ground shaking (Fig. 4). Most of these buildings were constructed without engineering supervision and lacked proper seismic design and ductile detailing. The provisions in Indian seismic code (IS:1893 2002) require such buildings to be designed for enhanced forces, which were definitely not followed in design of these buildings. The collapsed 3-story building at Naya Gaon [Figs. 4(a and b)] and two recently constructed collapsed buildings at Bamboo Flat [Figs. 4(c and d)] were privately owned. A 2-story Police Barrack building with an open first story collapsed at Haddo wharf [Fig. 4(e)], whereas adjacent buildings with infills in the first story survived the shaking.

**Fig. 4.** Collapse of RC buildings on stilts at (a), (b) Naya Gaon; (c), (d) Bamboo Flat; and (e) Haddo wharf

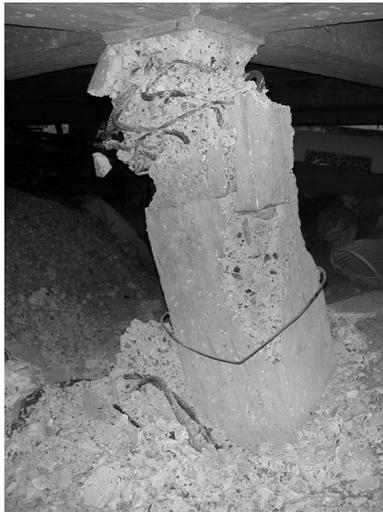
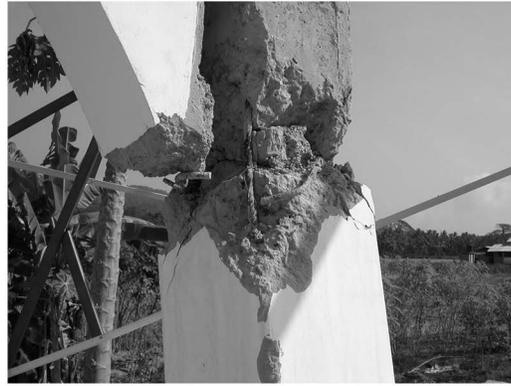
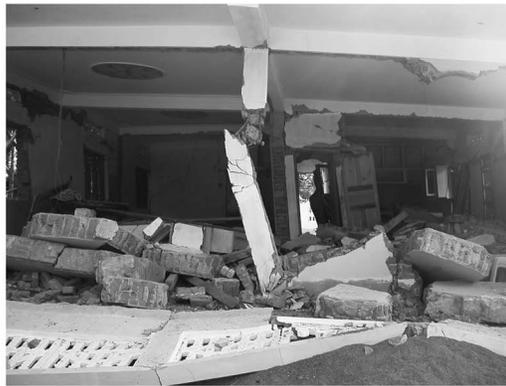
In Port Blair, generally very light lateral shear reinforcement is provided in columns in the form of 6–8 mm diameter bars with  $90^\circ$  hooks at about 200–250 mm spacing. Therefore, open first-story columns and beam-column joints of several buildings suffered extensive damage in brittle shear mode, resulting in complete collapse of some buildings (Fig. 4). In several columns of these buildings, the  $90^\circ$  hooks of the shear reinforcement opened up, leading to buckling of longitudinal bars and subsequent crushing of concrete (Fig. 5). The partially collapsed Passenger Terminal Building at Haddo wharf was recently constructed (around 1999) and formally designed by a structural engineering firm in Chennai and constructed by a contractor with engineering supervision. The building was partly supported on RC piles and partly

The Indian seismic code for ductile detailing (IS:13920) (BIS 1993) has clear specifications for the design of shear reinforcement in columns and beam-column joints for better confinement of concrete. Noncompliance with these provisions in design resulted in extensive damages to several buildings.

**Fig. 5.** Poor shear design attributed to several column failures in RC buildings at (a) Naya Gaon; (b), (c) Bamboo Flat

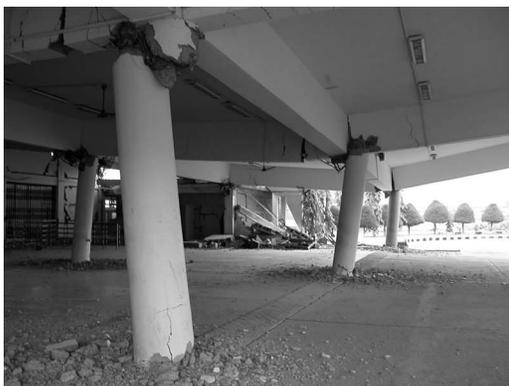
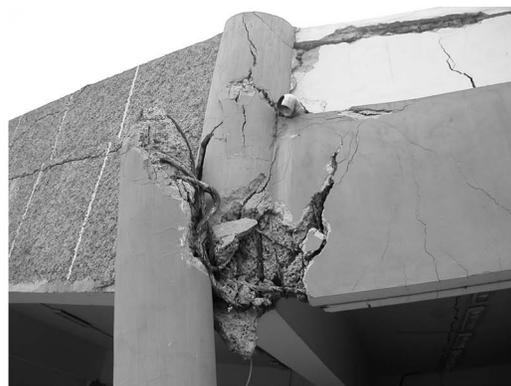
on spread footing on relatively soft soil, which aggravated the damage to the building. Ductile reinforcement detailing was not found in RC members of the building, resulting in extensive damage to columns, beams, and beam-column joints in shear and flexural modes (Fig. 6).

**Fig. 6.** Recently constructed passenger terminal building at Haddo wharf suffered extensive damage due to earthquake shaking: (a) partial collapse of part constructed on reclaimed land on spread footing; (b) shear failure of column at beam-column joint

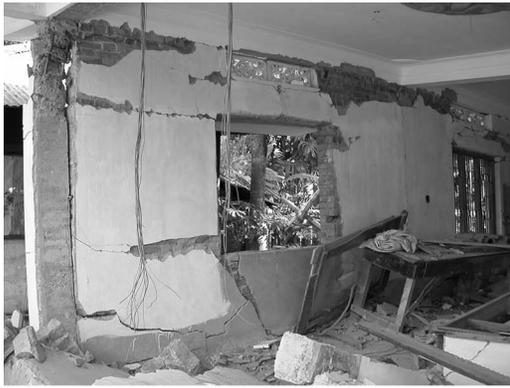
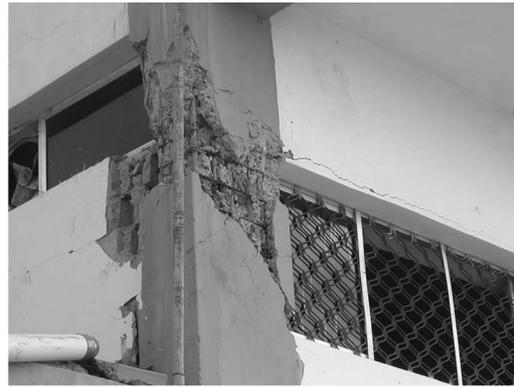
RC frames only up to partial heights, which creates short columns in the building and significantly increases shear demands in the columns. Several short columns in buildings at Bamboo Flat [Fig. 7(a)] and in the Passenger Terminal Building at Haddo wharf [Fig. 7(b)] suffered damage at the locations where partial height infills were provided. The ductile detailing code (IS:13920) (BIS 1993) requires that such columns be provided with special confining reinforcement throughout their height, which was not followed in the design of these buildings.

**Fig. 7.** Damage associated with short column effect in buildings at (a) Bamboo Flat; (b) Passenger Terminal Building at Haddo wharf

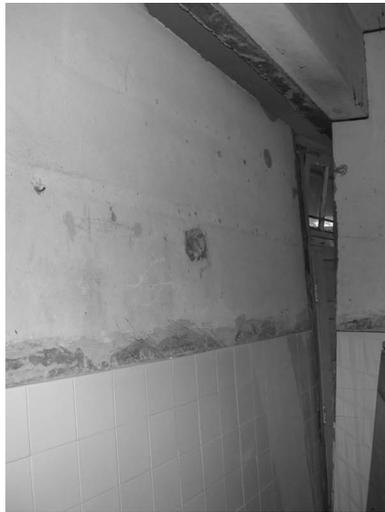
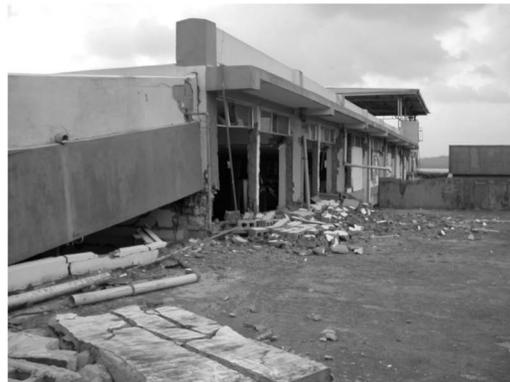
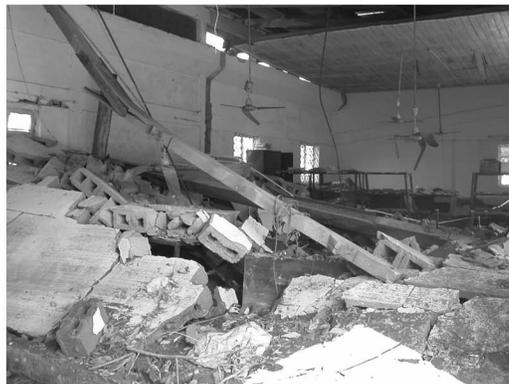
plane failure of infills was observed in several RC buildings in Port Blair, primarily due to poor quality of masonry and inadequate and loose joints between RC frame and masonry walls. In the 3-story school building at Mohunpura in Port Blair, long infill walls tilted out of plane [Fig. 8(a)]. Similar damage was observed in the Passenger Terminal Building [Fig. 8(b)] in the second-story infills. In the single-story RC building with flexible timber roof at the office complex of Andaman Lakshadweep Harbour Works (ALHW) at Mohunpura, several masonry partition walls collapsed out of plane [Fig. 8(c)].

**Fig. 8.** Out-of-plane failure of masonry infills in buildings at (a) Mohanpura (school building); (b) Passenger Terminal Building at Haddo wharf; and (c) ALHW office complex

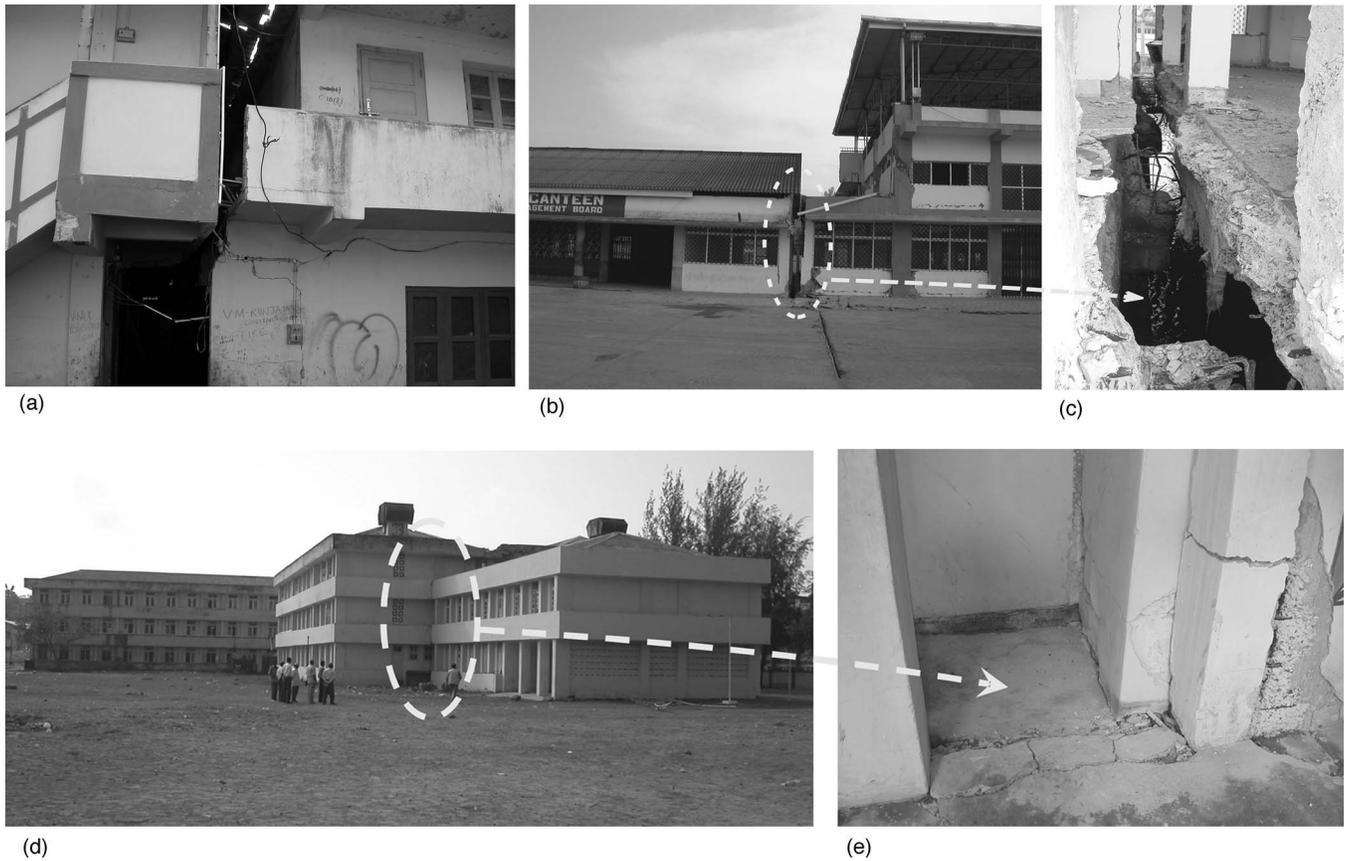
Buildings are required to be constructed with a sufficient gap between them such that lateral displacement of buildings occurring due to ground shaking during earthquakes can be safely accommodated. Several buildings constructed very close to each other in the Bamboo Flat shopping complex and Passenger Terminal Building at Haddo wharf suffered substantial damages in slabs, columns, and masonry infills because of pounding [Figs. 9(a–c)]. The L-shaped 3-story RC school building at Mohunpura constructed in stages between 1986 and 1989 was damaged at the expansion joints provided between different blocks [Figs. 9(d and e)].

**Fig. 9.** Pounding damage in buildings at (a) Bamboo Flat shopping complex; (b), (c) Passenger Terminal Building at Haddo wharf; and (d), (e) school building at Mohanpura

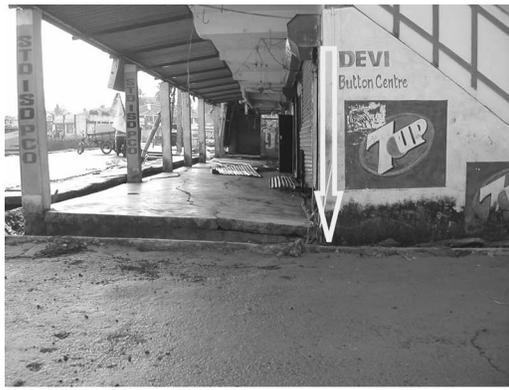
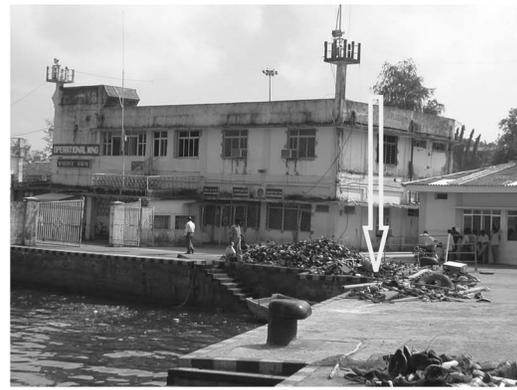
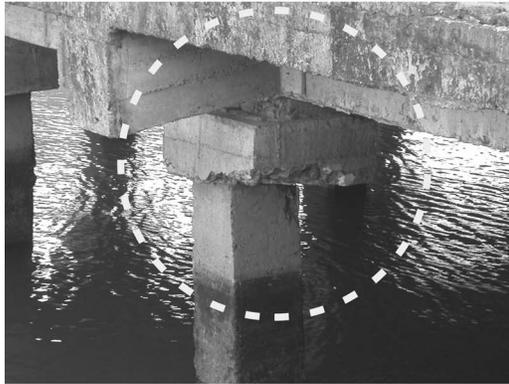
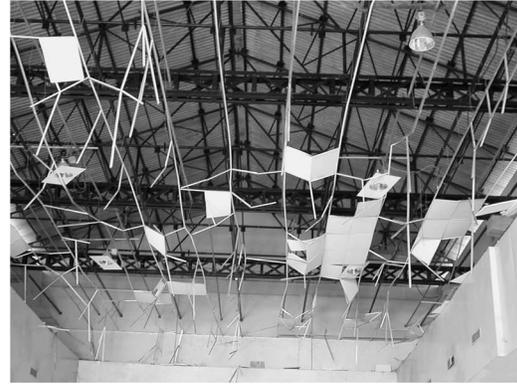
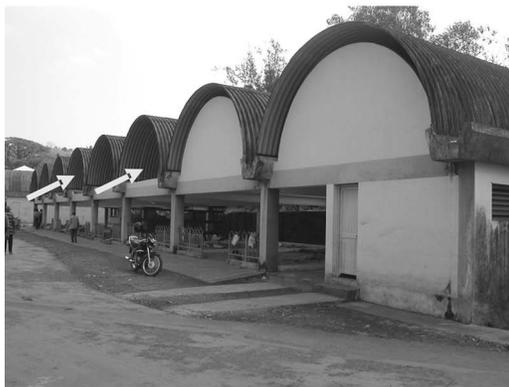
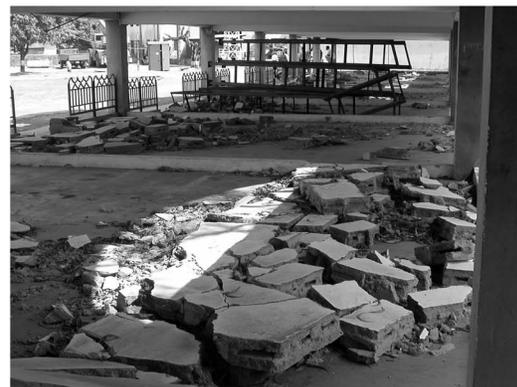
In addition, several other types of damages were observed in RC buildings in Port Blair, which disrupted the occupancy of these buildings. Several buildings at Bamboo Flat settled down, possibly due to liquefaction and erosion or settlement of underlying soil due to inundation by tsunami [Fig. 10(a)]. Several buildings at the Marine jetty complex and Haddo wharf also settled due to failure/settlement of foundation piles [Figs. 10(b and c)]. Damage to nonstructural elements in buildings due to earthquake shaking were observed in several buildings; for example, the false ceiling of a fiberglass boatshed in the Marine jetty dry dock complex collapsed completely [Fig. 10(d)]. Laterally unsupported masonry walls in the shell structures used as a storage area in the dry dock complex collapsed due to absence of any confining elements [Figs. 10(e and f)].

**Fig. 10.** (a) Settlement of buildings at Bamboo Flat shopping complex; (b) settlement of Operation Wing building by about 200 mm at one end along its length at Marine jetty complex; (c) failure of RC pile supporting godown building at Haddo wharf; (d) collapse of false ceiling of fiberglass boat shed at marine jetty dry dock; and (e), (f) out-of-plane collapse of nonstructural masonry walls in storage structure at marine jetty dry dock

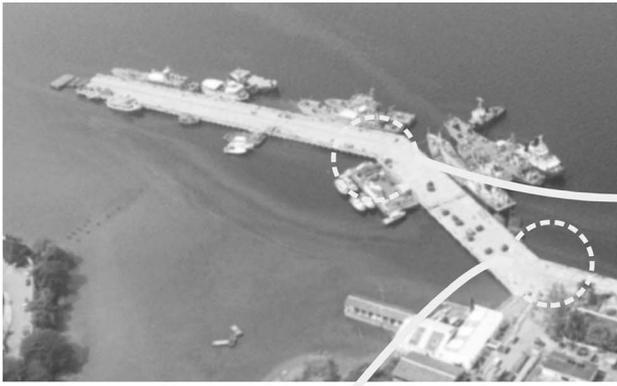
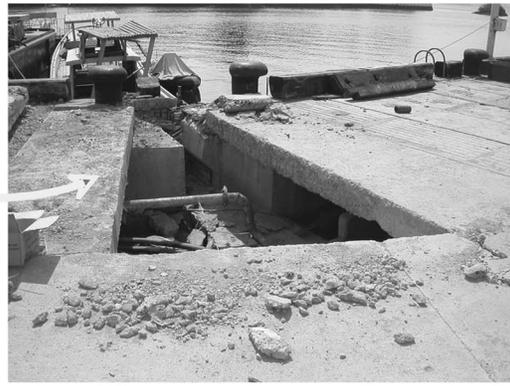
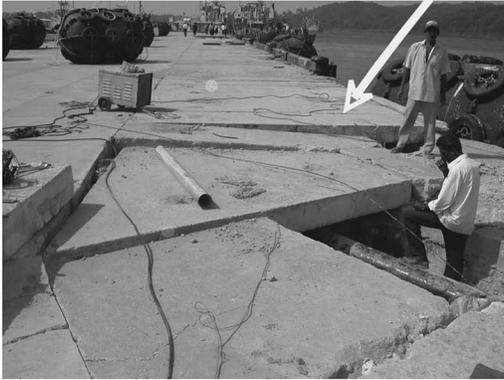
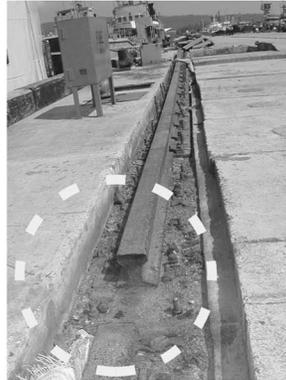
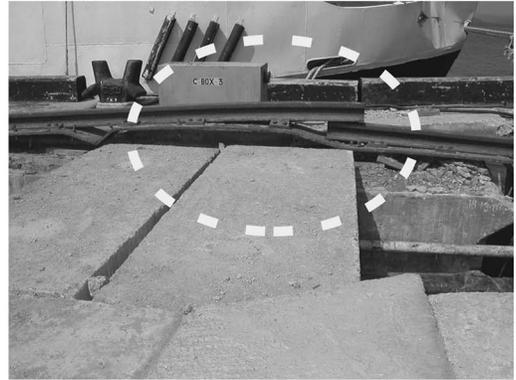
The Haddo naval jetty has a reentrant plan shape due to the extension of the jetty in 2003. The extension joint between the old and new constructions suffered some damage. An aerial photo of the jetty shows the location of damage concentrated at the reentrant junctions [Fig. 11(a)]. Significant displacement and damage were observed in heavy RC slabs on the jetty near these reentrant junctions [Figs. 11(b and c)], and the crane track was displaced by about 400 mm in the longitudinal direction [Figs. 11(d and e)].

**Fig. 11.** (a) Aerial photo showing irregular configuration of Haddo jetty (used with permission of Javed N. Malik); (b), (c) concentration of damage at the location of joint between old and new construction, which are reentrant corners; and (d), (e) damage in steel rails over jetty (which disrupted functioning of jetty—400 mm gap was observed at joints of rails)

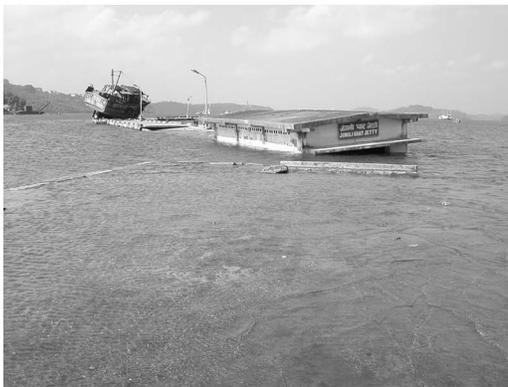
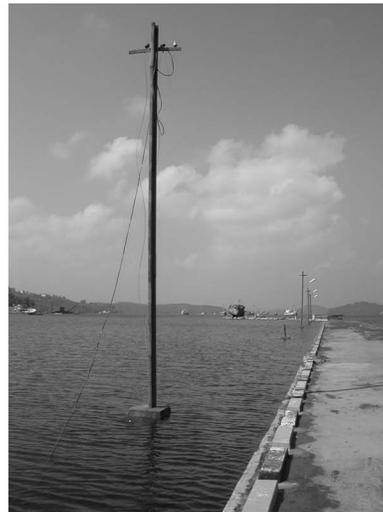
The Jungli Ghat jetty in Port Blair, used primarily as a passenger jetty, was severely damaged and the entire working and operation were closed. Part of the jetty and RC passenger waiting room constructed over the jetty collapsed into the sea because of failure of the piles underneath [Fig. 12(a)]. The electricity supply to the jetty was hampered due to severe damages to electric poles and cables by the high pressure tsunami waves [Fig. 12(b)].

**Fig. 12.** Severely damaged Jungli Ghat jetty: (a) part of jetty collapsed because of failure of RC piles over which it was constructed; (b) electricity supply on jetty was severely affected because poles were broken and cables washed away by tsunami

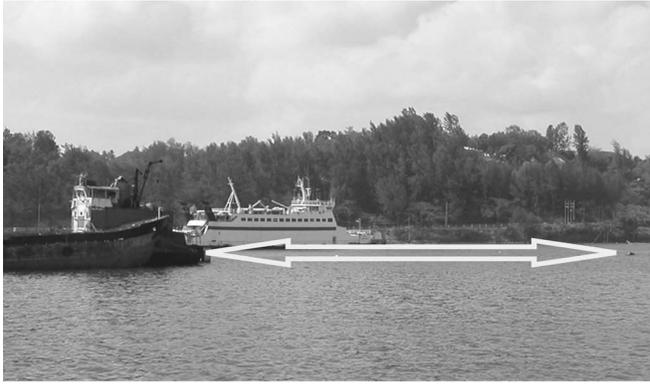
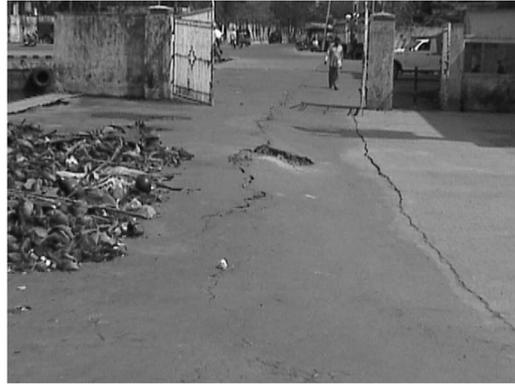
About a 20-m stretch of a jetty in the Marine jetty complex in the Phoenix Bay collapsed because of failure of piles when the tsunami struck [Fig. 13(a)]. Extensive settlement of roads [Fig. 13(b)] took place in the jetty complex, primarily because of failure/settlement of a large number of piles, which disrupted the operation of the jetty. Settlement of an approach road to an RC bridge in the complex forced the authorities to close the bridge to vehicles. The marine jetty dry dock, which is required to remain dry for maintenance work on ships, submerges in water during high tides since the earthquake because of subsidence of land in

**Fig. 13.** (a) Collapse of about 20-m length of jetty at Marine jetty complex; (b) settlement of roads in complex because of settlement/failure of piles underneath

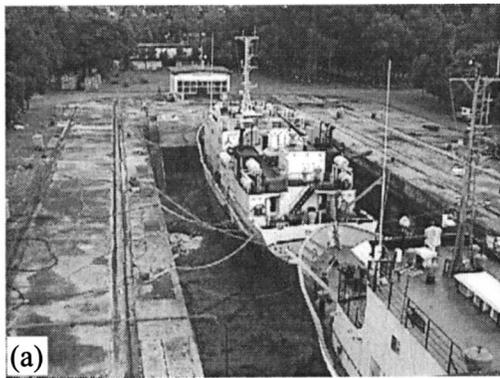
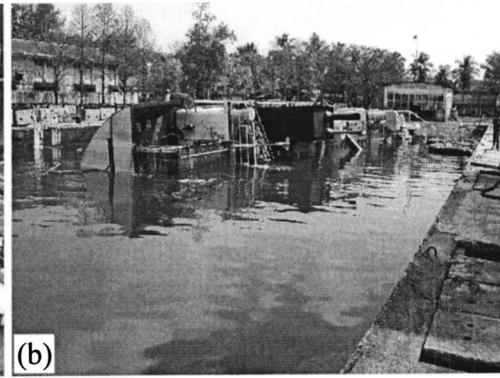
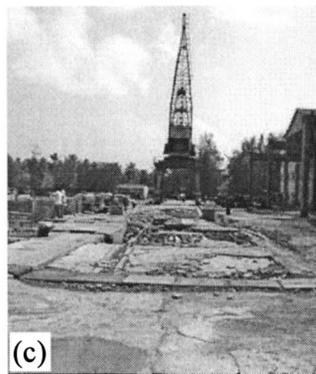
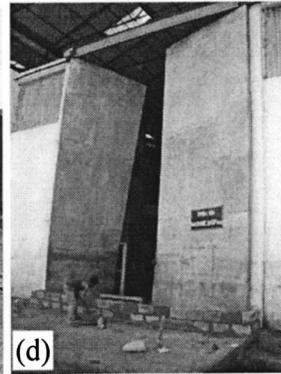
the area. It was reported that the water level in the area has risen by about 1 m. All the structures on the dry dock suffered extensive damage because of shaking and the tsunami. An undated photo obtained from the ALHW shows the maintenance work being done on several ships in the dry dock [Fig. 14(a)], whereas several ships were lying under water after the event [Fig. 14(b)]. A large portion of the RC slab with crane tracks suffered extensive damage due to shaking [Fig. 14(c)], and several steel gates of the machine shops were bent and damaged after the tsunami struck the dock. Temporary masonry walls of about 300 mm height were quickly constructed in front of all the machine shops to prevent seawater from entering them [Fig. 14(d)].

**Fig. 14.** (a) Drydock in working condition before tsunami (used with permission of Andaman Lakshadweep Harbour works); (b) damaged ships in inundated drydock after tsunami; (c) damaged RC track below crane; and (d) damaged steel gates of machine shops due to tsunami

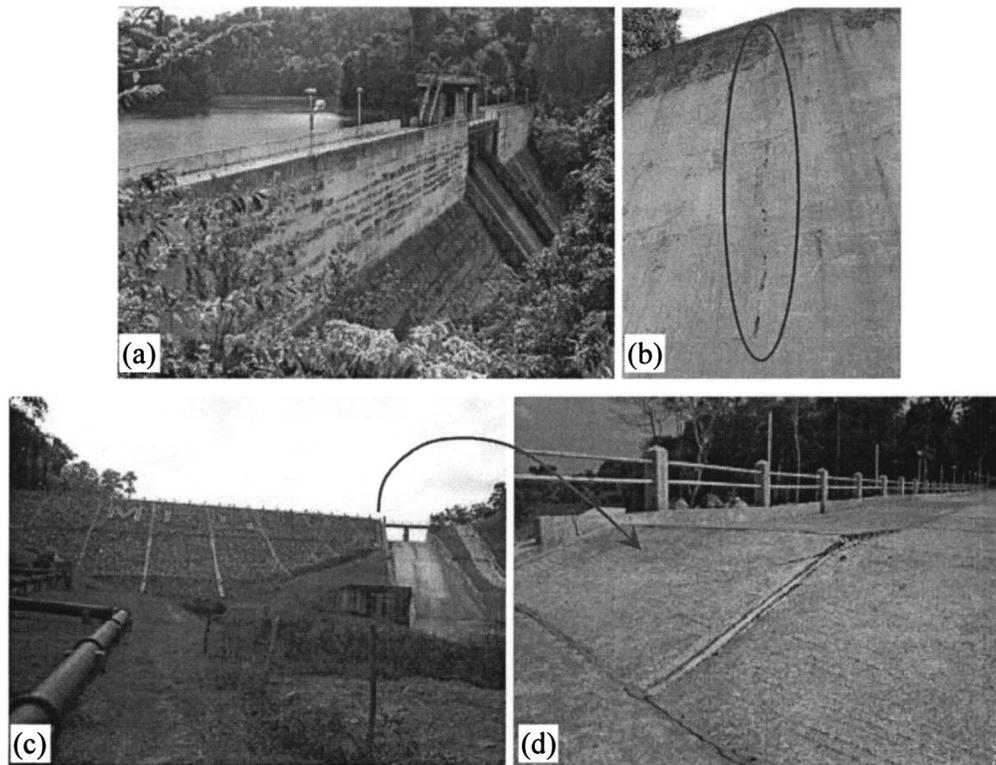
Dhanikari dam is 132 m long and 32.25 m high [Fig. 15(a)], and the ground shaking induced vertical cracks at the spillway section along the full height of the dam on the downstream face [Fig. 15(b)]. Seepage through the dam body collected in the inspection gallery before the earthquake was 25–30 L/min, which

increased to 110–120 L/min after the earthquake because of formation of the crack. However, it was reported that the increased seepage was still within the alarming limit of 160 L/min. Chouldari dam is 95 m long and 19 m high [Fig. 15(c)] and did not suffer any significant structural damage during the earthquake. The unreinforced concrete apron on top of the dam buckled upwards by about 8 cm due to pounding from the adjoining

relatively stiff RC bridge deck over the spillway section of the dam [Fig. 15(d)].

**Fig. 15.** (a) Dhanikari concrete gravity dam at Nayashahar; (b) vertical cracks formed in body of Dhanikari dam due to earthquake shaking; (c) Chouldari earthen dam at Chouldari; and (d) buckling of unreinforced concrete slab over top width of Chouldari dam

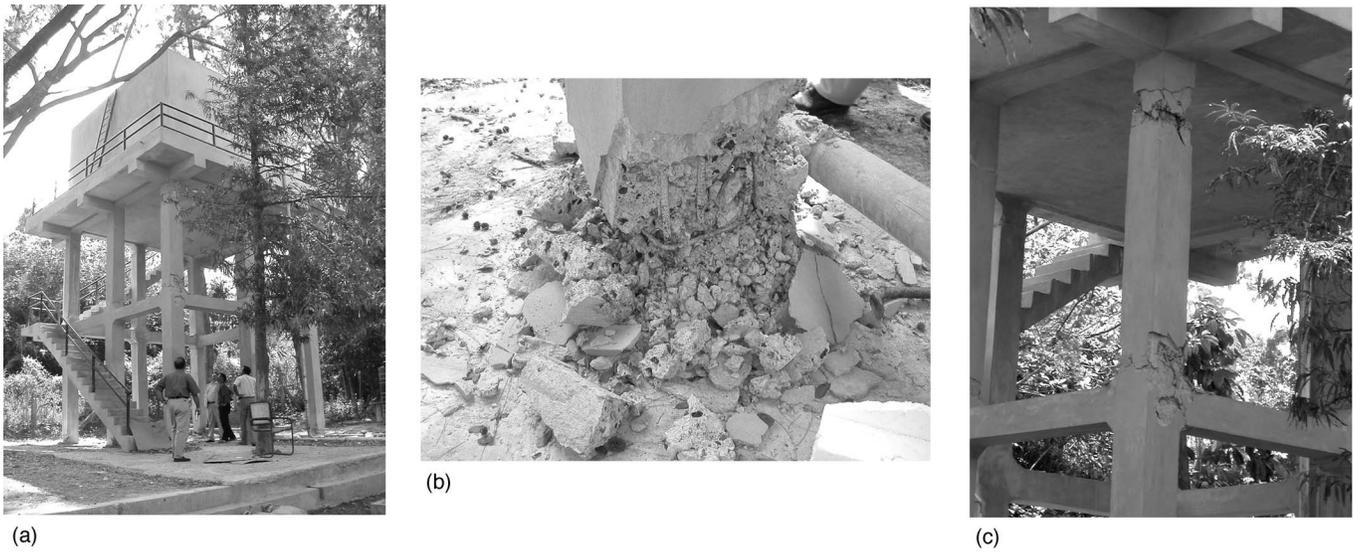
During the shaking, some of these tanks suffered substantial damages in the RC staging. A 50,000 L capacity water tank in the converter room of Haddo naval jetty is supported on 6-m high staging consisting of eight 300-mm square RC columns with intermediate RC beam braces at 3 m height [Fig. 16(a)]. Plastic hinges developed at the bottom of all the columns and at the top of a few columns [Figs. 16(b and c)], while the container sustained no damage. An RC staircase was provided in the tank

going around the staging, which seems to have made the tank geometry unsymmetrical, and the tank sustained a torsional response. An overhead water tank at MES headquarters, Birchgunj Military Station in Port Blair, was damaged by severe corrosion of reinforcement in the RC-framed staging and tank, but structural damage was not observed in the tank and it was still under use.

**Fig. 16.** (a) Water tank at Converter Room of Haddo naval jetty; (b) formation of plastic hinge at bottom of all RC columns in tank staging; and (c) formation of plastic hinges at top of a few columns in tank staging

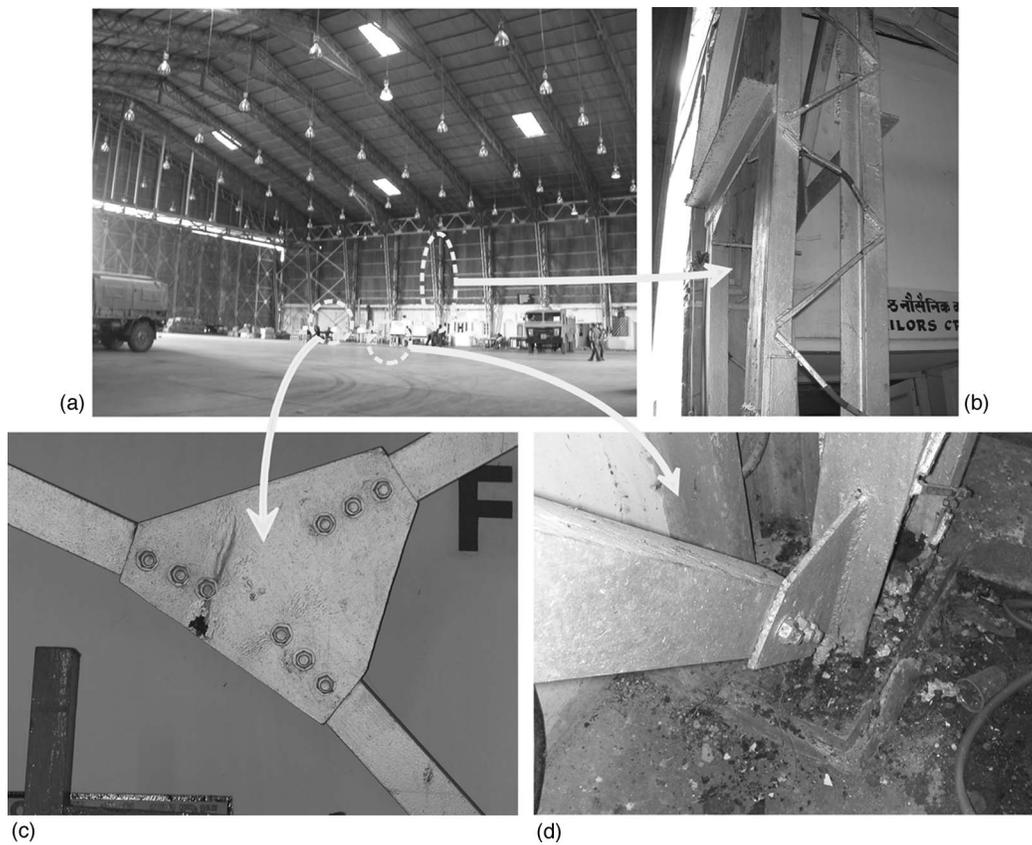
The hangar (*INS Utkarsh Complex*) at the Port Blair airport was constructed in 1986 and suffered slight damage due to the ground shaking, but was fully operational. The steel frame structure is  $50 \times 50$  m in plan with roof truss 10 m tall at eave level and 14 m tall at the crown [Fig. 17(a)]. Several braces in the steel columns, which were made of 15 mm square bars, were found to be buckled [Fig. 17(b)]. Several gusset plates connecting inclined brace members between adjacent columns buckled because of nonconcurrent members meeting at the plate [Fig. 17(c)]. Severe corrosion was observed at the junction of several base plates with columns at ground level [Fig. 17(d)].

**Fig. 17.** INS hangar at Port Blair Airport: (a) overview of hangar structure; (b) buckling of braces in steel columns; (c) buckling of gusset plates connecting nonconcurrent braces between adjacent columns; and (d) severe corrosion at junction of base plate and column at ground level

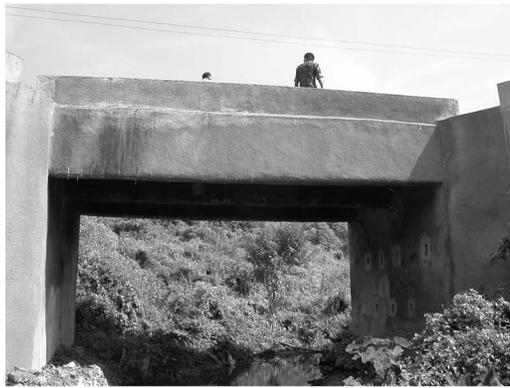
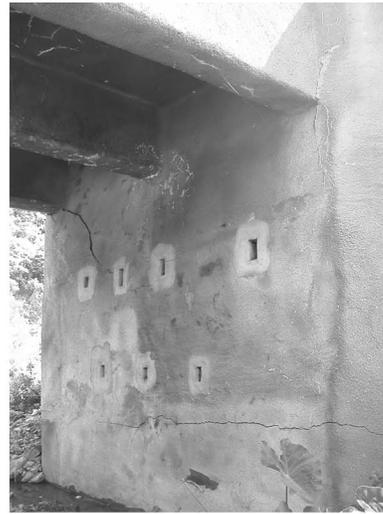
The 6-m-long RC culvert [Fig. 18(a)] in the Haddo navy area in Port Blair sustained cracks due to shaking at the junctions of the

abutment and girder-slab system at both ends [Fig. 18(b)], but the culvert remained open for traffic because the deck of the RC culvert sustained no damage.

**Fig. 18.** (a) Slightly damaged 6-m long RC culvert at Hadoo navy area in Port Blair; (b) cracks developed in both abutments of culvert

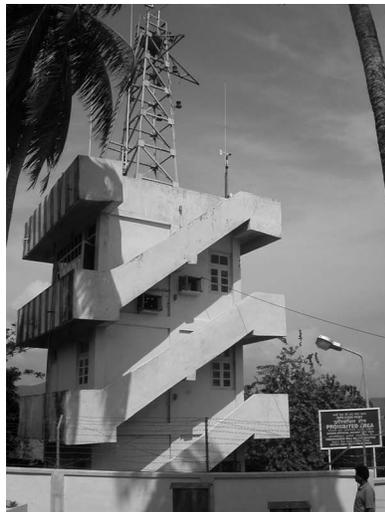
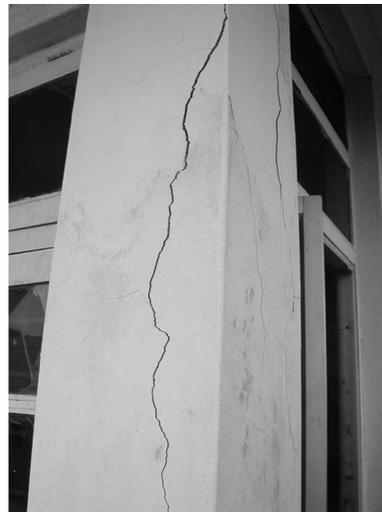
The 3-story RC structure of the Atlanta Control Tower at Atlanta Point in Port Blair was constructed in 1997 and used as a port communication center for long range [Fig. 19(a)]. The structure suffered slight damage to its columns, and corrosion cracks, which were in existence in several columns before the earthquake, widened after the shaking [Fig. 19(b)]. The control tower was fully functional after the shaking.

**Fig. 19.** (a) Atlanta Control Tower of Port Management Board did not suffer any substantial damage due to earthquake shaking; (b) corrosion cracks in a few columns, which reportedly existed before shaking, widened after shaking

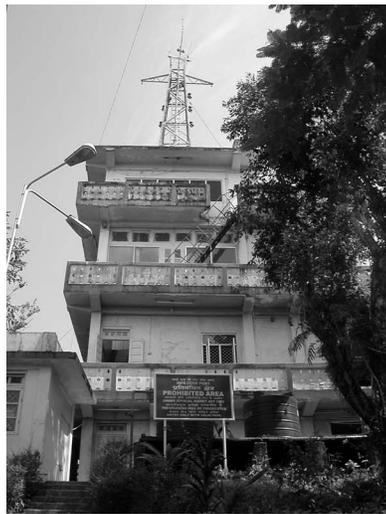
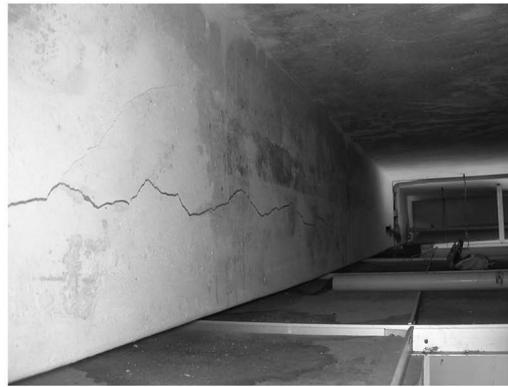
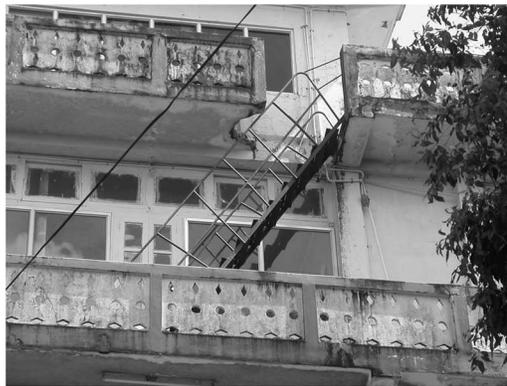
The Chatham Port Control Tower at Chatham in Port Blair is a 4-story RC building [Fig. 20(a)] and suffered severe damage because of ground shaking. Originally the building had 3 stories constructed in 1970–1971. Eventually one story was added in 1984 to enable better communication, and the tower was shifted at the top of the 4th story. After the earthquake, most of the damage was found to be concentrated in the additional 4th story. All the RC beams of the 4th story below the tower were damaged by the shaking [Fig. 20(b)]. The columns in the top story did not suffer any substantial damage, but corrosion cracks developed in two RC columns in the 3rd story, which widened after the earthquake.

In the first and second stories, RC shear walls were provided, whereas very limited masonry walls were provided on the top two stories because of the requirement of big window openings for

inspection. The upper two stories did not perform well during the earthquake shaking because of their higher flexibility compared to the lower two stories. During the construction of the additional floor, the RC staircase from the bottom stories was not continued in the upper stories. Instead, a narrow and steep steel staircase was provided between the third and fourth stories by cutting a portion of the third story RC slab [Fig. 20(c)]. A similar staircase was provided between the fourth story and the terrace to reach the tower. After the earthquake, workers were reluctant to work in the upper stories because of such staircases.

**Fig. 20.** (a) Damaged Chatham Port Control Tower; (b) longitudinal cracks formed in all beams of fourth story; and (c) narrow and steep staircases were provided in upper additional stories by cutting portion of RC slab
