DAMAGES OF SMALL TO MEDIUM SIZE EARTH DAMS DURING BHUJ EARTHQUAKE OF 26 JANUARY 2001

Umesh Dayal¹ and Sudhir K. Jain²

ABSTRACT

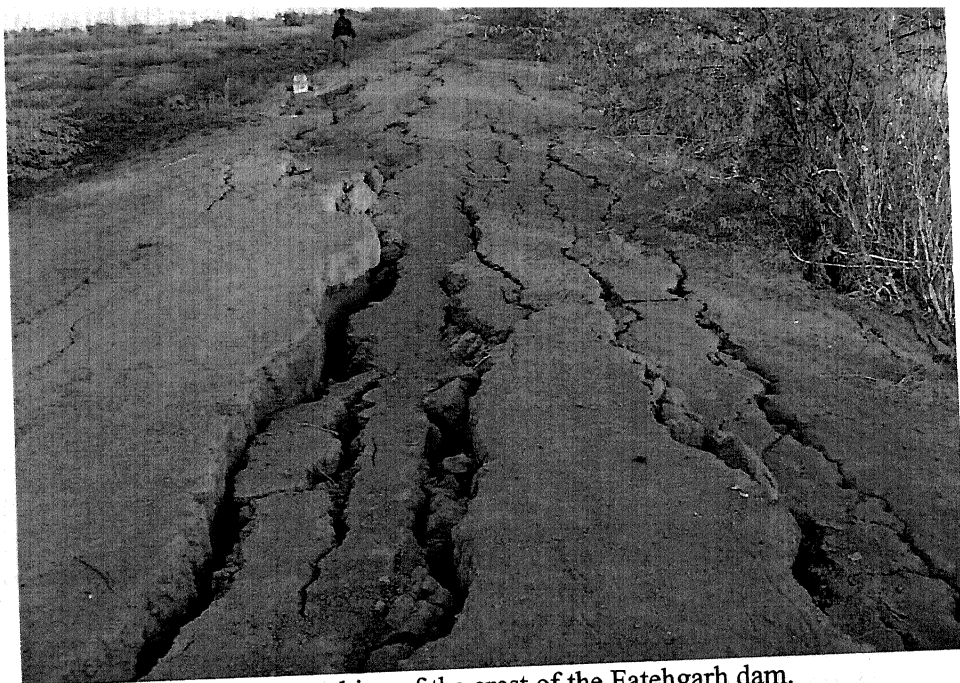
Longitudinal cracks ranging from several centimeters wide to two meters are visible all along the crest of the dam (Figure 3). The entire crest dropped; the maximum crest settlement of about 30cm is noticed at location near to spillway (Figure 4). Transverse cracks with openings up to about 5cm are also observed near both the abutments. This could have been developed due to differential settlement of dam crest along the longitudinal direction. At two locations, a major deep-seated circular sliding of the slope, extending from the middle of crest to several meters beyond the toe of the dam has occurred. These slides seem to have occurred due to development of very high pore pressure and liquefaction of the foundation soil (Figure 5), which appears to be fully saturated due to lake water, which is almost at the toe of upstream slope. At several locations, ground spreading resulted in lateral displacement of the upstream toe. Typically, cracks up to 2m wide, over 2m deep extending over a stretch of 30-40m have been created at a few meters upslope from the toe (Figure 6). The compression toe bulging was also visible at or near the downstream toe of the dam.

Figure 3 : Severe longitudinal cracking of the crest of the Fatehgarh dam.

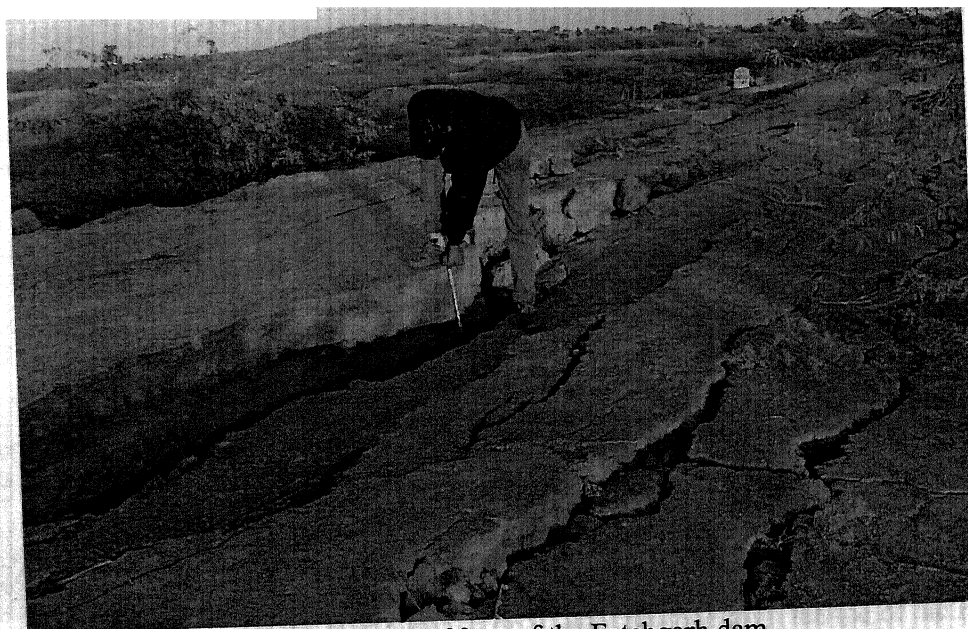
Figure 4 : Settlement of the crest by about 30cm of the Fatehgarh dam.

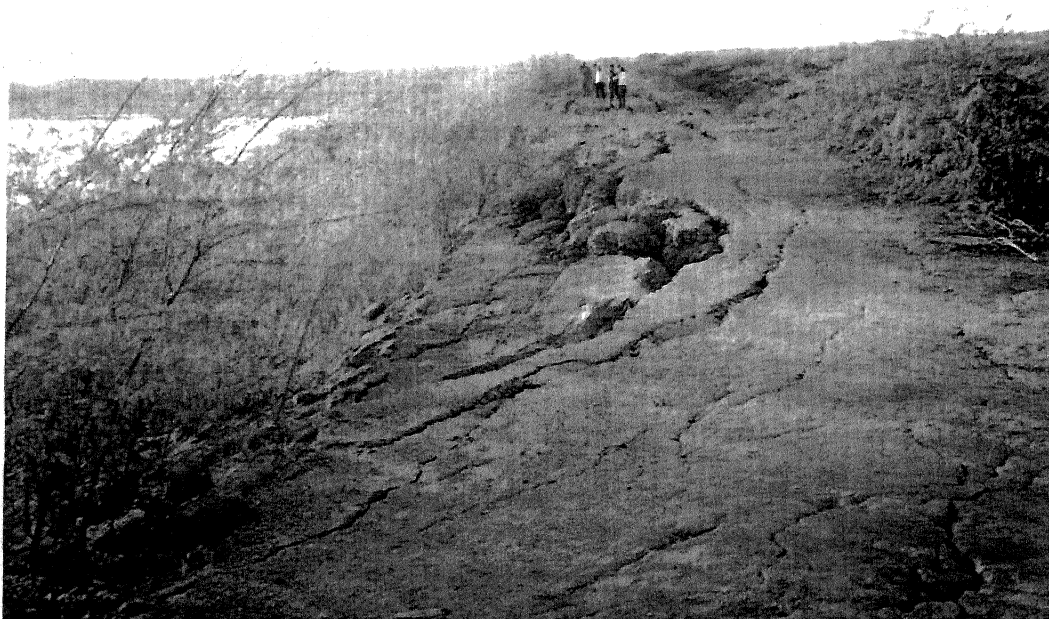
Figure 5: Liquefaction induced failure of the Fatehgarh dam.

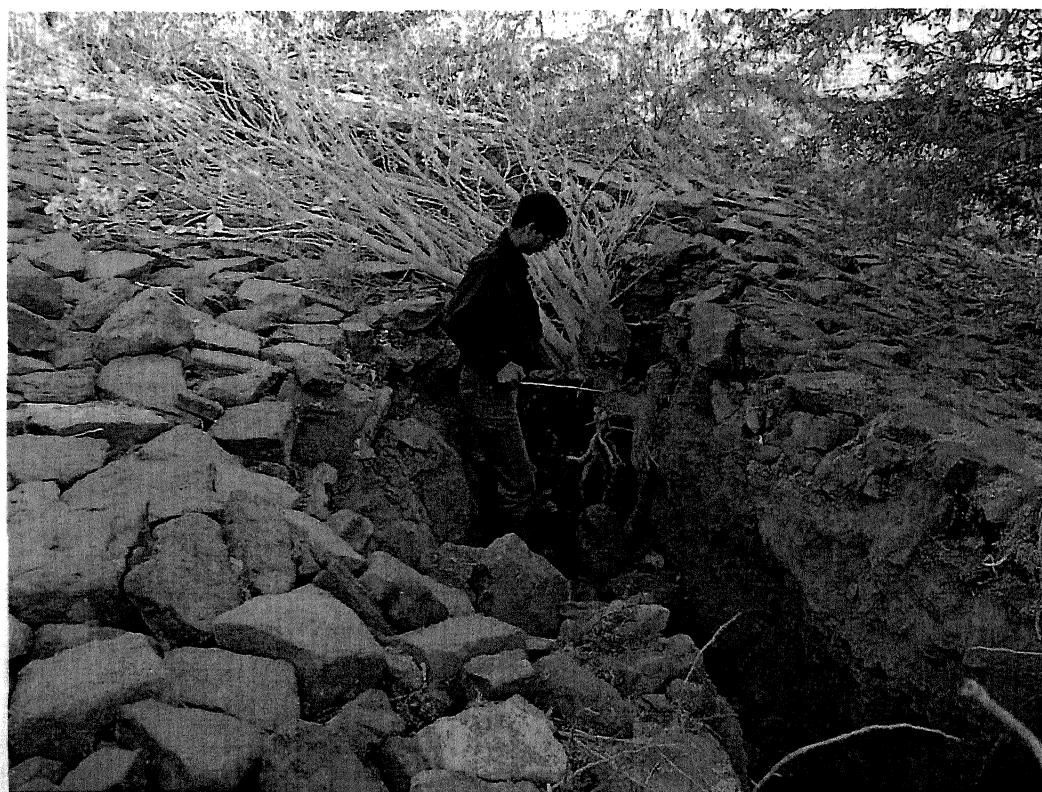
Figure 6: Deep and wide cracks over a stretch of 30-40m upslope from the toe of the Fatehgarh dam.

The failure is extended beyond the toe of the dam into the upstream ground resulting in the toe bulging, undulations and cracks. Scraps up to 1.5m high were seen with some evidence of rotational failure. A pillar located in the lake water about 2-3m from the upstream toe, was tilted inward, indicating the deep-seated failure condition. The subsoil at the site consists of sandy material. The liquefaction of the foundation soil was evident as sand boils and ground cracking were observed at the upstream toe location where major deep-seated failure of the dam has occurred.

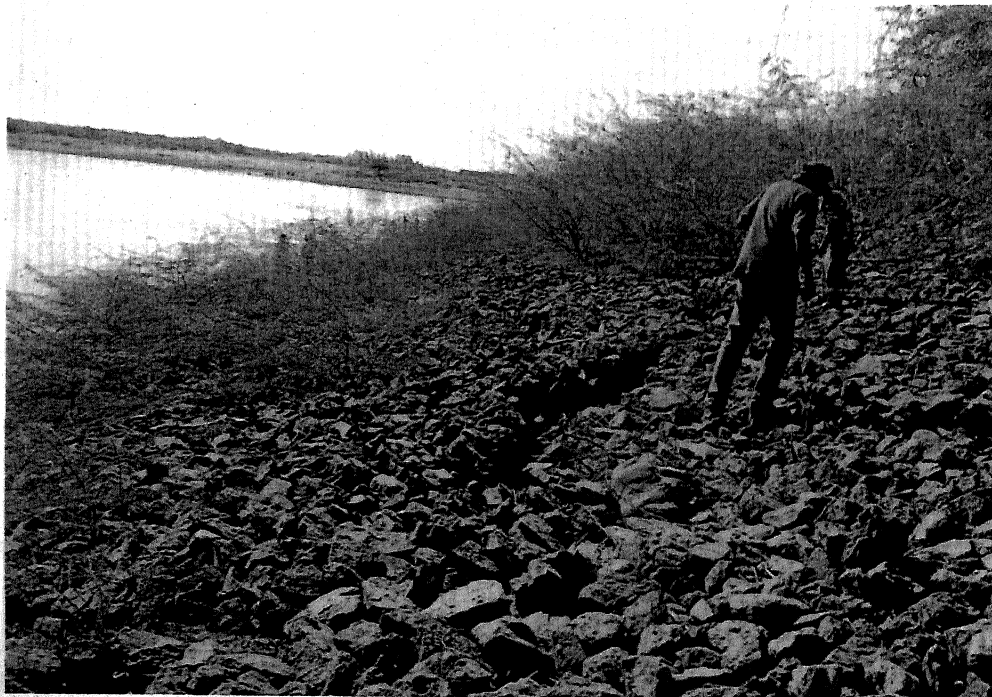
More than half the length of the parapet wall was collapsed. The main cause of the failure of this dam appears to be liquefaction of foundation soil, which has resulted in a subsidence up to a maximum of 60cm at the deepest section of the dam. The liquefaction of the foundation soil also caused lateral spreading near the upstream toe of the dam (Figure 7). A crack of about 100m long, 1m wide and 1.5m deep is visible at the toe of the dam.

Figure 7: Lateral spreading owing to liquefaction of the upstream toe of the Suvi dam.

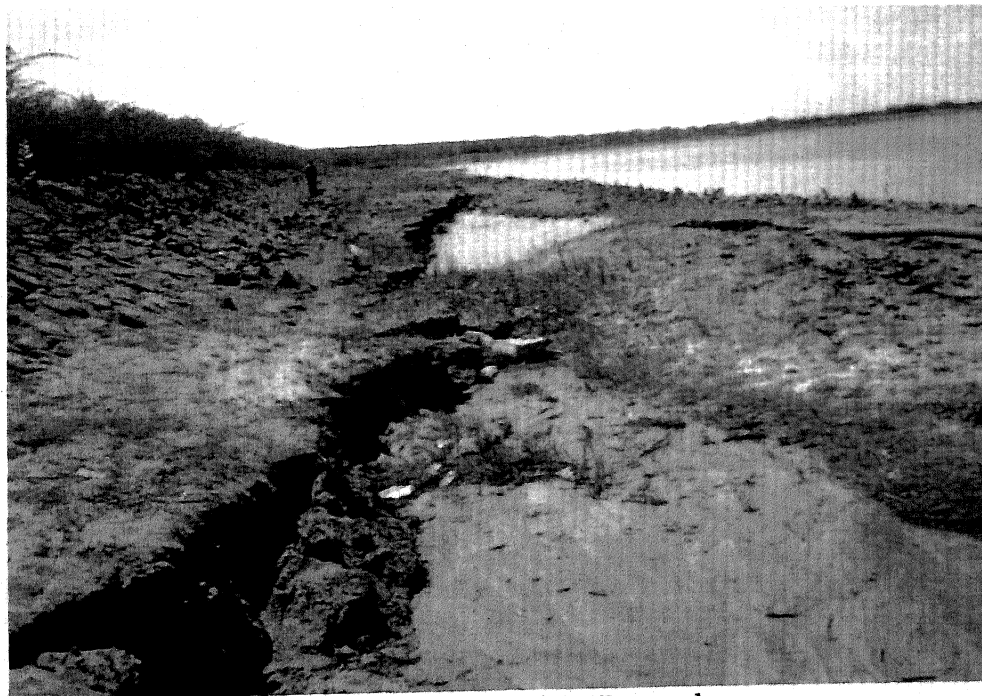
This dam experienced major upstream and downstream slope failures, and longitudinal cracks extending over a kilometer stretch of the crest. The cracks up to about 300m long, 1m wide and over 60cm deep were measured. The upstream berm has settled by over 8cm. The lateral spreading at the upstream toe caused several meter wide and over 2m deep lateral cracking, and the down drop of over 50m stretch of the upstream section (Figure 8). At several locations, the upstream section of the slope failed and scrap of the order of 75cm is seen. The water intake structure and the connecting pipelines are completely damaged. However, the newly constructed concrete spillway experienced only minor damage.

Figure 8: Lateral spreading near the upstream toe of the Tappar dam.

The major cause of the failure of the dam is due to extensive liquefaction of the foundation soil. Ejecta consisting of silty sandy soil at upstream toe and sand boils near the downstream toe of the dam were evident.

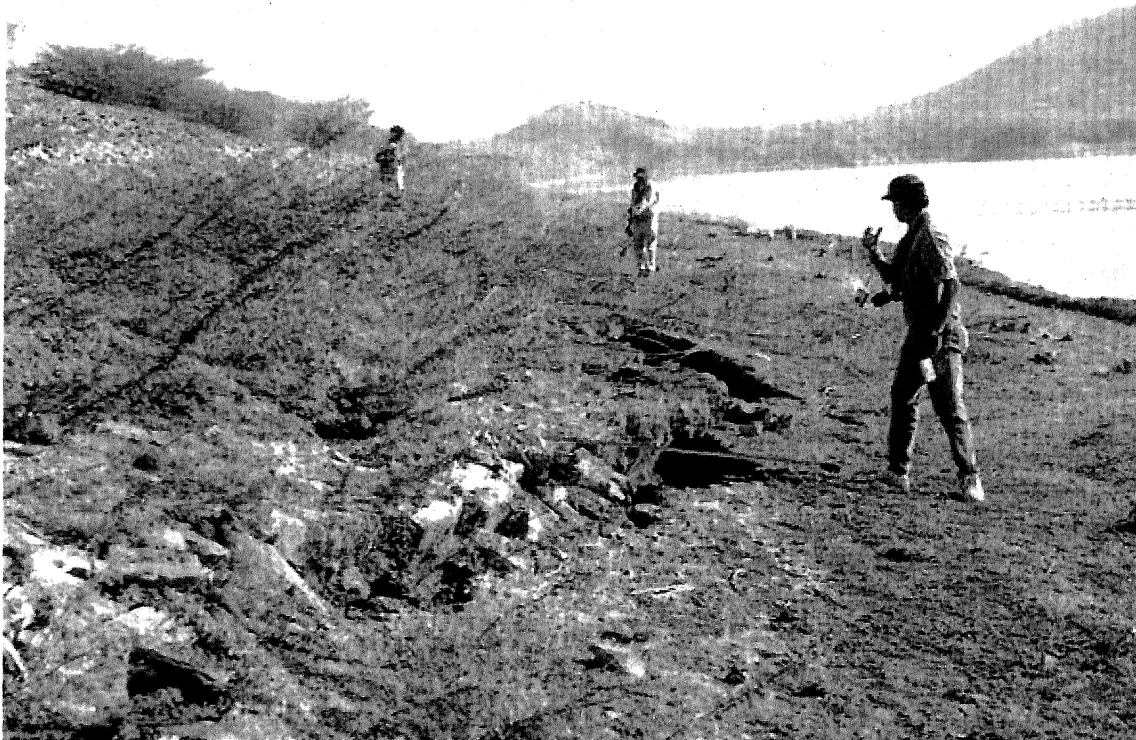
This dam is severely damaged. A 10cm wide lateral crack extending for almost half a kilometer is visible at the crest. Massive upstream and downstream slope failures occurred at this dam site. Cracks up to 70cm wide and about 1m deep were observed on the upstream face of dam (Figure 9). Lateral spreading of about 1m wide and 1m deep is visible near the upstream toe. Also, toe bulging is evident. Liquefaction of the foundation soil appears to be the major cause of the dam failure.

Figure 9: Massive crack near the upstream toe of the Kashwati dam.
