Geotechnical Damage Due to Bihar Earthquake of August 1988

SYNOPSIS: The Bihar-Nepal earthquake of August 21, 1988 (magnitude 6.6) caused significant loss of life and property. Besides the epicentral area, two distant places (Munger in India and Bhaktapur in Nepal) suffered significantly. This was also the case in the 1934 earthquake (magnitude 8.4) and is due to peculiar geology of the area. Geotechnical damage in the affected area includes liquefaction, cracking and subsidence of embankments, and cracks in bridge abutments and wing walls. Besides, in the hilly regions of Sikkim, landslides and rockfalls disrupted road network significantly. Extensive damage took place in the eastern Nepal also. This paper describes the geotechnical damage to the Indian areas only.

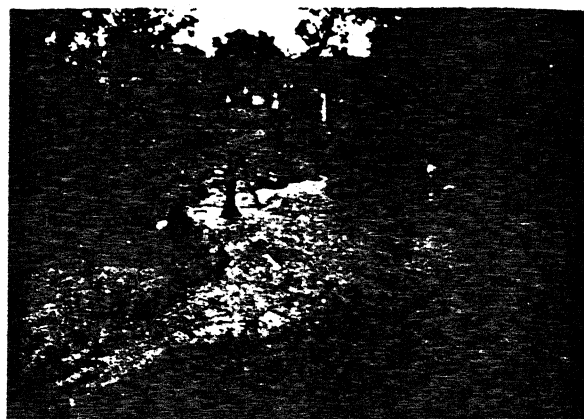
Darbhanga, was found choked with sand. A hand pump was mounted on the top cover slab of the well. The upward thrust on the pump punctured the top brick slab and a big heap of sand brought by the springing water was lying all around the well (Fig. 3). A typical sand dune due to liquefaction inside the premises of the Bihar Public Works Department rest house is seen in Fig. 4.

FIG. 3 Sand Boil, Around Hand Pump Inside the Residence of the Superintendent of Police, Darbhanga.

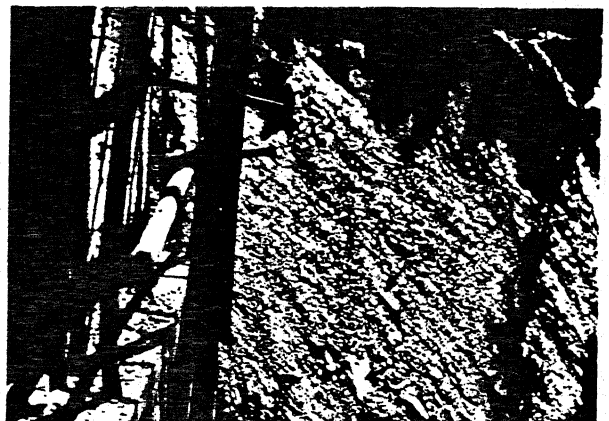
This bridge site is also located on river Kalej Khola at about two miles upstream from the Legship Bazar and is on Legship-Tashiding road. Bridge was under construction and its towers and cable anchors were complete at the time earthquake occurred. Proposed bridge is of suspension type with a span of about 450 feet. Legship end abutment cum suspension tower of reinforced concrete was situated just by the side of a high hill-cliff. During the quake, a huge soil cum boulder mass from the cliff came down and washed away the whole construction on Legship end (Fig. 13). The other end was however intact. An old suspension bridge with wooden

FIG. 13 The Landslide that Damaged the Tashiding Bridge (arrows show pieces of the suspension tower).

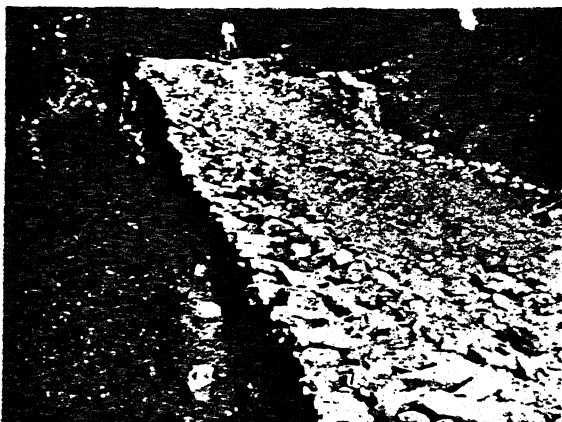
Damaged site is located about half a mile short of the Legship Bazar township on Gangtok-Legship state highway in the state of Sikkim. At a few places significant subsidence of road, one foot to 10 feet, was observed (Fig. 15).

FIG. 15 Subsided Stretch of Gangtok-Legship State Highway (partly repaired).
