Garhwal Earthquake of Oct. 20, 1991

A four-member team from Civil Engineering Department of the Indian Institute of Technology, Kanpur conducted a survey of the significantly affected areas during October 27 to November 4. The team members were Dr. Sudhir K. Jain, Dr. R. P. Singh, Dr. V. K. Gupta, and Mr. Amit Nagar.

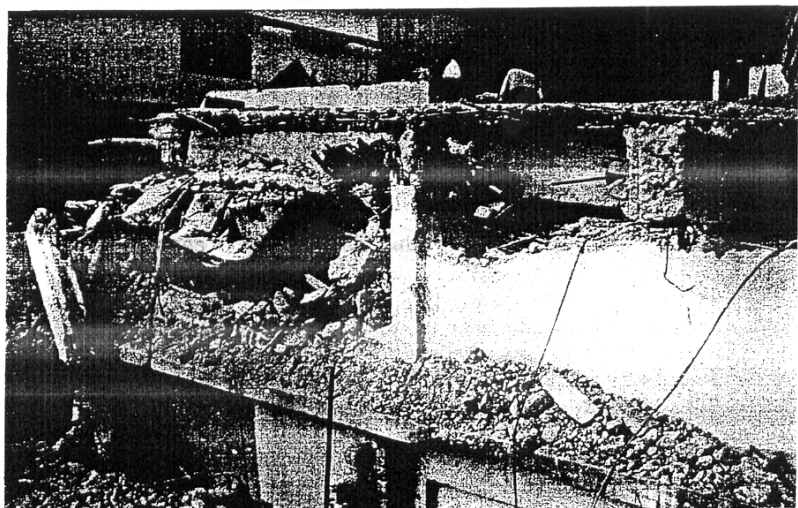
Figure 2 shows the State Bank Building in Uttarkashi. During the earthquake, the upper two stories collapsed on the first story. Information from local residents revealed that the building was first constructed as one story only; the upper two stories were added subsequently. The beams had only two nominal rebars on the top face near the column joint and those were incorrectly placed.

FIGURE 2 - State Bank Building at Uttarkashi

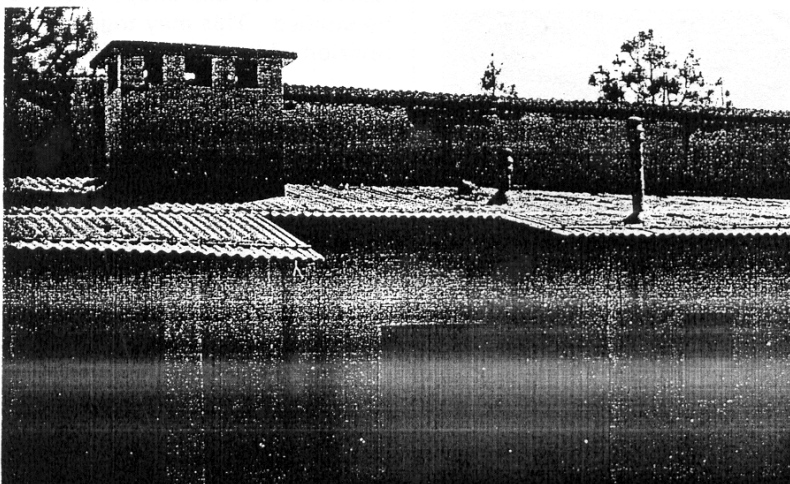
The ITBP Paramilitary Campus at Mahidanda consists of a large number of two story residential buildings with load bearing walls of concrete block masonry. All have RC lintel bands, but no roof bands or gable bands. The construction is about 10 years old. The damage to buildings consisted of (i) diagonal cracks

below window sills, (ii) damage at the connection between masonry walls and RC roof slabs, (iii) in buildings with corrugated iron sheet roofs, damage at the seat of purlins on the gable end walls, and (iv) damage to walls supporting roofs of different height at either end (Fig. 3). Roof and gable bands would have prevented damage of types (ii), (iii), and (iv) above.

FIGURE 3 - Damage to Wall Supporting Split Level Roof - ITBP Campus, Mahidanda

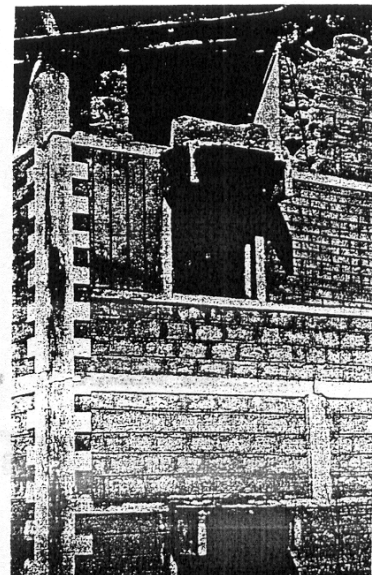
The Maneri Hydel power project colony campus has two-story buildings with concrete block masonry bearing walls, of poorer quality construction than that seen on the ITBP campus. Many buildings were damaged beyond repair. Damage consisted of (i) severe damage to gable walls (Fig. 4), and (ii) diagonal cracks in ground story walls.

FIGURE 4 - Damage to Gable Wall - Maneri Hydel Project Colony

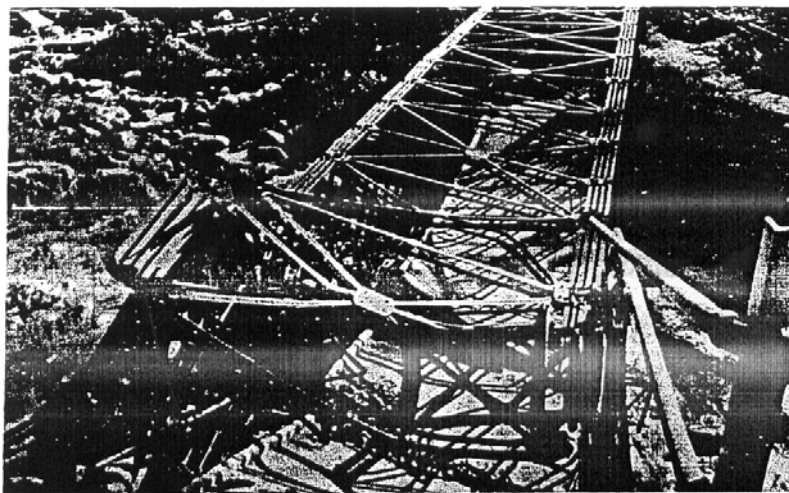
The Gawana Bridge is a 56.0 m span steel truss bridge built in 1974. It is located at 6 km from Uttarkashi towards Maneri. The entire bridge came off the abutments and fell into the river (Fig. 5), causing the entire area beyond Uttarkashi to be cut off from the rest of the country. Inadequate design of bearings and anchor bolts as well as absence of any suitable means of preventing the span from falling

off the supports were responsible for the damage.

FIGURE 5 - Collapsed Gwana Bridge
