Learning from Earthquakes

Some Observations on Engineering Aspects of the Jabalpur Earthquake of 22 May 1997

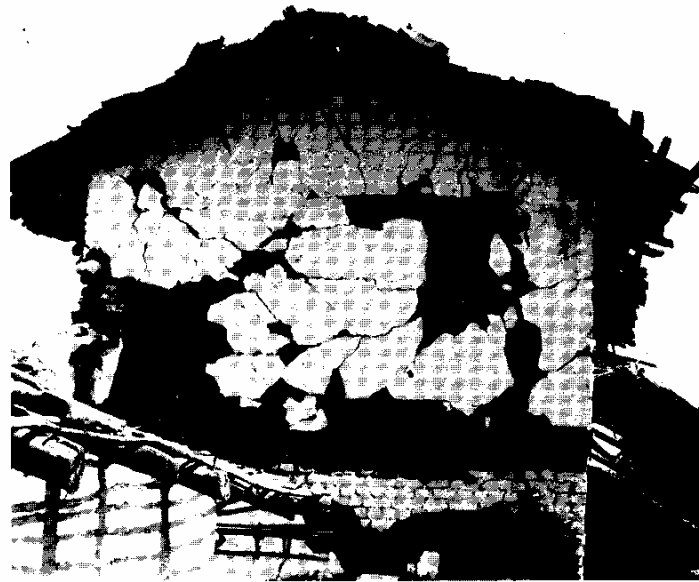
Some houses in rural as well as urban areas are built with burnt brick masonry in mud mortar. Unlike the traditional construction practice, the mud mortar is not reinforced with straw in this type of construction. Most structures of this type are one or two-story buildings whose walls are a single brick thick (230 mm). These structures sustained significant cracking (*Figure 3*).

Figure 3 - In rural and urban areas, houses are built using a single wythe of burnt brick with mud mortar. Buildings of this type suffered significant cracking.

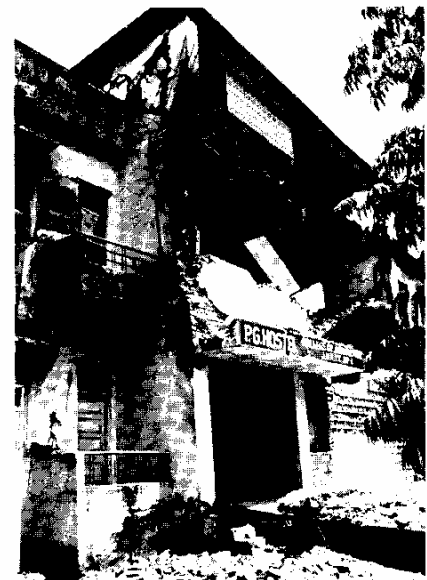
walls to partial collapse of buildings. The failures are attributed to the weak cement masonry walls and poor connection between the walls. The severe damage to the post-graduate students' hostel building is shown in *Figure 4*.

Figure 4 - Load-bearing brick masonry structures on the campus of Jawaharlal Nehru Agricultural University in Jabalpur were badly damaged.

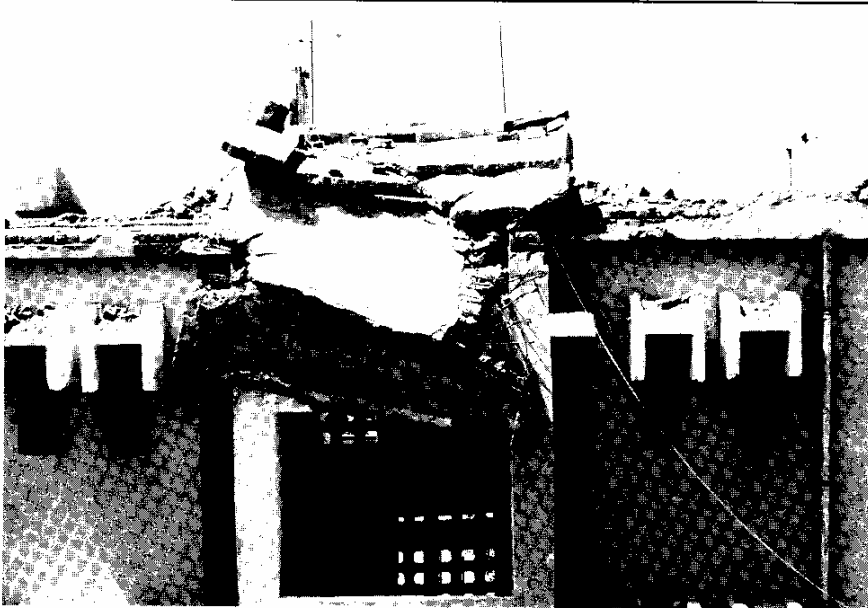
nected to each other only through the slab above it. Vertical projections in houses (for example, chimneys) are known to be particularly prone to damage during earthquakes, and extensive damage to *mumty* is a clear indication of this behavior.

Figure 5 - Many staircase towers, called "mumty," which project about 2 m above the surrounding construction in masonry houses, collapsed.

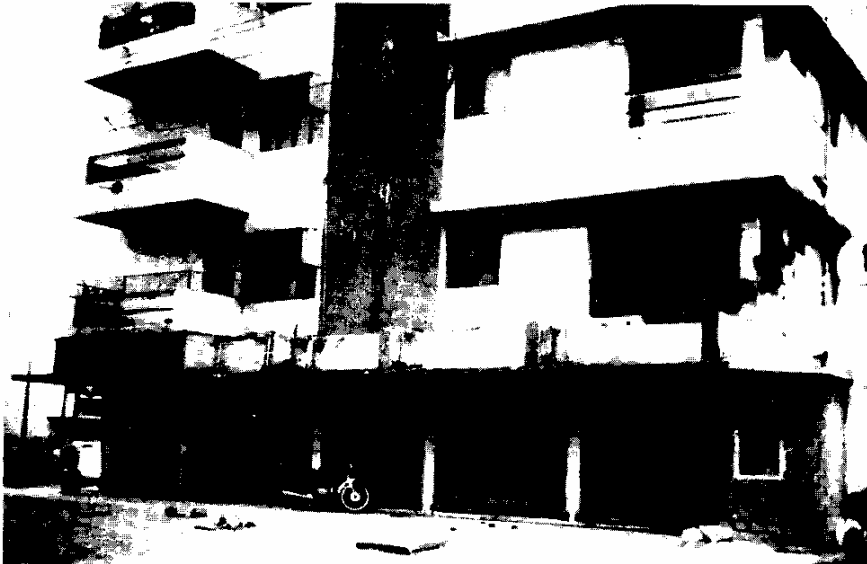
Figure 6 - The columns in the ground story parking area of the Himgiri Apartment Buildings, a five-story reinforced concrete building with brick infill, suffered shear failure.

1. Himgiri Apartment in Jabalpur. This is a five-story RC frame building with brick infill located in the "Wright Town" area of Jabalpur. There are shops on two adjacent faces of the building at the ground story with brick masonry partition walls (*Figure 6*). The remaining corner of the building on the ground story is meant for parking and hence is "open," i.e., with no walls. The columns in the ground story in the parking area were badly damaged; shear failure of columns, opening of transverse ties, and buckling of longitudinal

There was only nominal damage in the upper stories consisting of cracks in the filler walls. This is a clear case where the columns were damaged as a result of the "soft first-story" effect. Moreover, loading on these columns may have increased through the torsion effect caused by higher lateral stiffness on the other side due to filler walls in the shops.

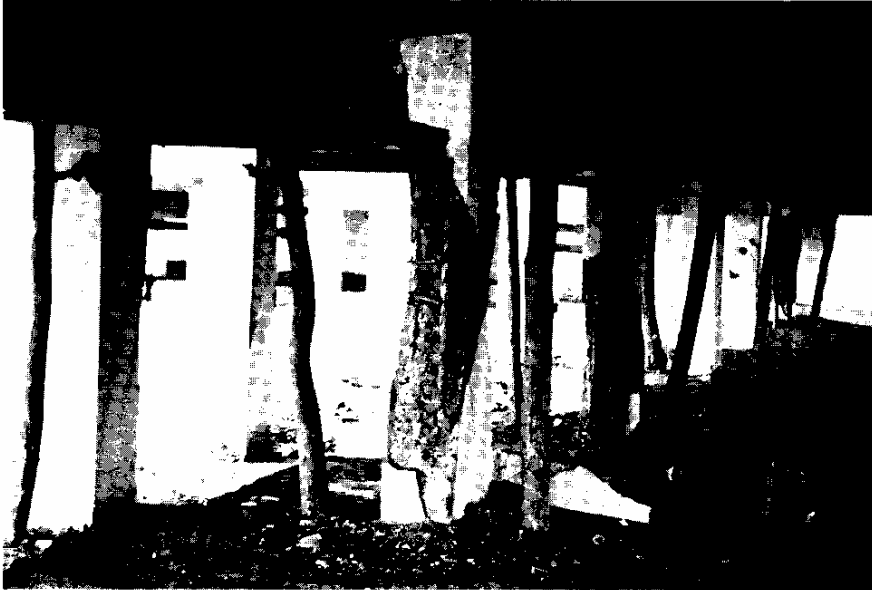
Figure 7 - Built on piles and stilt columns on the site of a previous pond, the new, still unoccupied Youth Hostel in Jabalpur suffered serious damage to its stilt columns.

3. *Youth Hostel Building in Jabalpur.* This is a C-shaped RC frame building built by the Central Public Works Department but not then occupied. It is located in the Ranital area of Jabalpur. The building is located where there originally was a pond. It is supported on piles, pile caps, and stilt columns. Above the stilt columns are two stories with brick masonry infill. The damage is concentrated only in the stilt columns; severe cyclic shear cracking in many columns was observed (*Figure 7*). The soft story at the stilt level is clearly the primary reason for such severe damage.

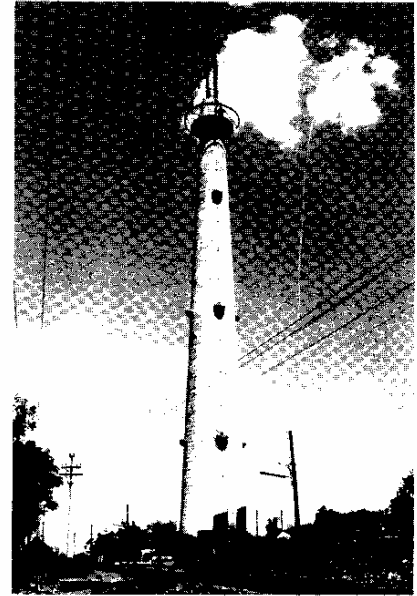
A 225m high TV tower (lower 175m RC shaft; upper 50m steel truss) located in the Katanga area of Jabalpur was built during 1989-1992 (Figure 8). Careful observation did not reveal any earthquake-induced distress. Minor cracks were seen at the junction of the concrete balcony and the concrete shaft, which may have been construction-related and therefore existed prior to the earthquake.

Figure 8 - No damage was observed to the 225 m high RC and steel TV tower in Katanga.

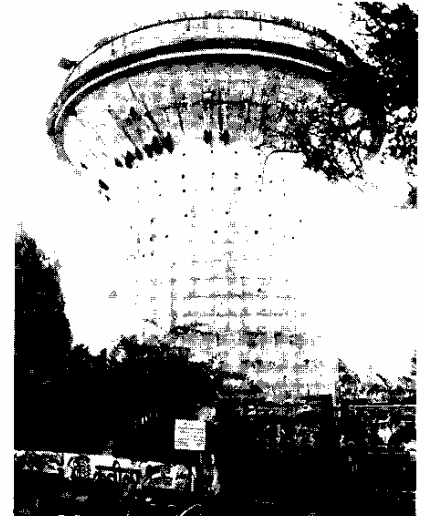
There are a number of elevated water tanks in the area for storage and distribution of drinking water. The majority of the elevated water tank structures are supported on reinforced concrete frame stagings, which did not suffer any damage. However, a 500,000 gallon-capacity shaft-supported tank (Figure 9), located in the Gadha area of Jabalpur, sustained horizontal cracking at the ground level and diagonal cracking in two directions at about every 15° angle subtended at the center. The horizontal cracking was restricted to two circumferentially equal segments. The tank is supported on piles in black cotton soil.

Figure 9 - Horizontal and diagonal cracking occurred at the base of the 500,000 gallon shaft-supported water tank.

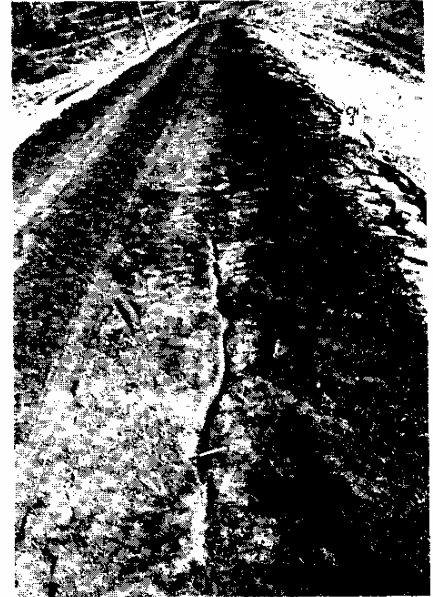
developed longitudinal cracks. The team visited two such dams: the 16.9-m-high earth dam at Mahgaon (30 km east from Jabalpur), and the 29-m-high Matiyari dam (95 km southeast of Jabalpur). Both suffered longitudinal cracks along the crest and the downstream face (Figure 10). These dams are made of the locally available black cotton soil, which is known for its high shrinkage characteristics in dry conditions. The intensity of shaking at village Mahgaon was about VII on the MSK scale, while that at Matiyari dam was about VI.

Figure 10 - Longitudinal cracks appeared along the crest and downstream face of several earthen dams.
