Learning from Earthquakes

Preliminary Observations on the Origin and Effects of the January 26, 2001 Bhuj (Gujarat, India) Earthquake

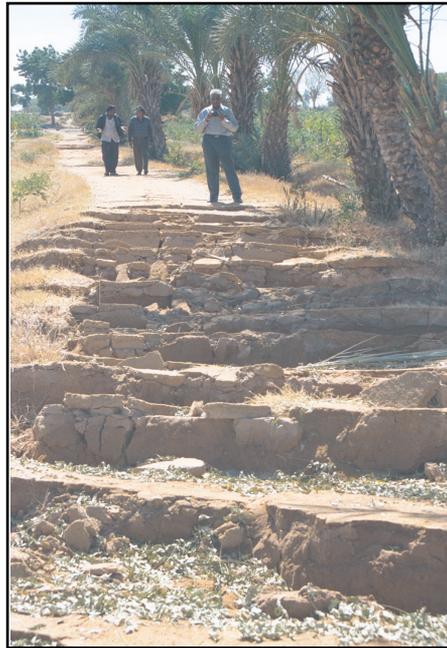
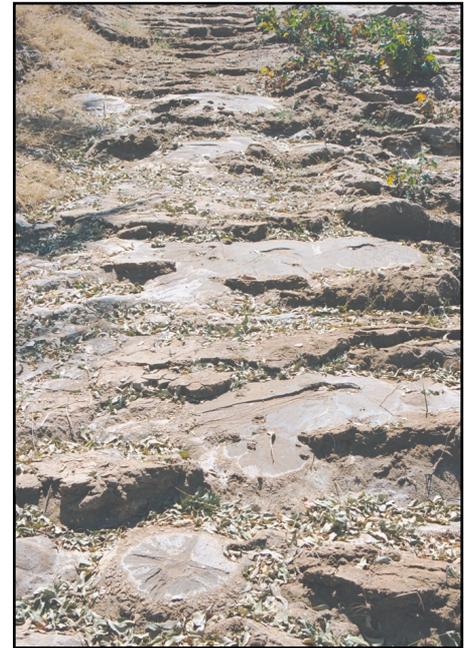
A zone of ground deformation occurred within alluvial/sabka deposits near the northern margin of an anticline along the Mainland fault. The ground deformations include extensional ground cracking (Figure 4) and compressional bulging in a zone over 16 km long and 0.5 km wide near the epicenter. The features trend east-northeast, and are associated with extensive sand boils (Figure 4). The authors interpret

Figure 4 Extension failures at top of lateral spread in epicentral area. Figure on right shows sand boils in extensional cracks. (Photos by James Hengesh)

these ground failures to be related to liquefaction and lateral spreading and not primary fault rupture.

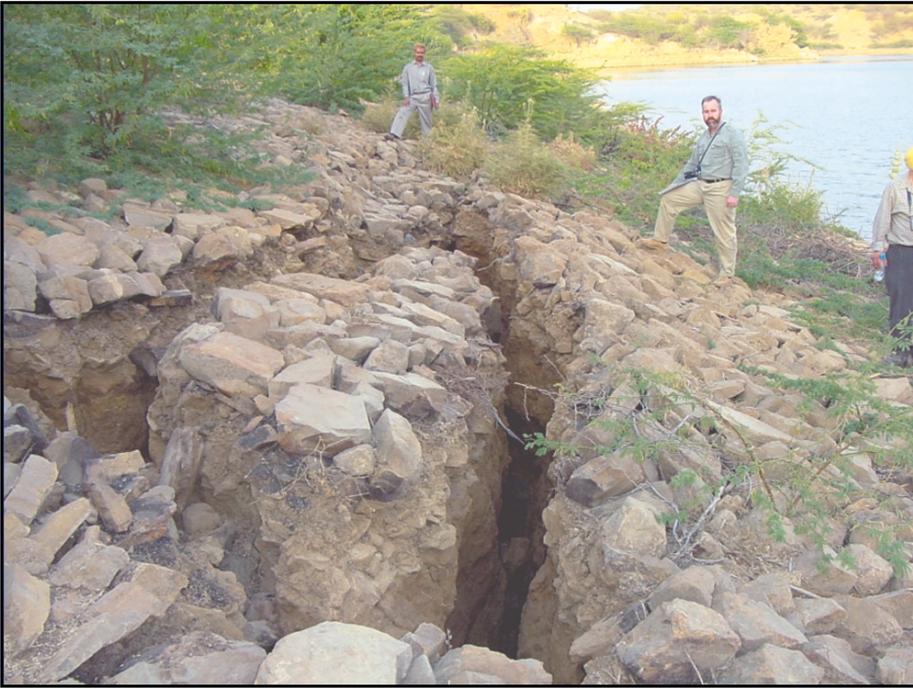
Figure 6 Failure on upstream face of Fatehghadh Dam

Seven medium-size earth dams (Shivlakha, Rudramata, Fategad, Suvi, Kaswati, Tapar, and Chang) and 14 smaller earth dams were damaged during the earthquake, providing a wealth of new information on the response of zoned embankment dams to strong ground shaking. Liquefaction of the foundation soils beneath these dams produced moderate to severe failure of the upstream, and, locally, the downstream faces of the dams (Figure 6).

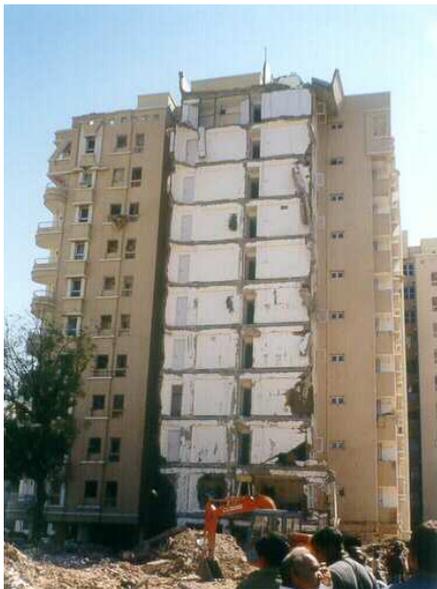
Figure 7 The building adjacent to this open first story building at Ahmedabad collapsed (Photo by Sudhir K. Jain)

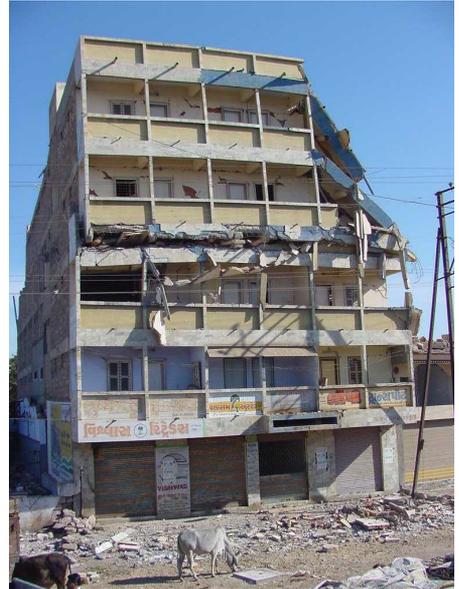
The earthquake also provided examples of collapses of upper or intermediate stories in RC buildings (Figure 8). In keeping with gravity load design concepts, the column reinforcement is often lapped just above the beam-column joint. Inadequate lap of column reinforcement at the joint, or abrupt reduction in column dimensions may have resulted in these collapses.

Figure 8 Intermediate story collapse of 6-story RC building at Bhuj. (Photo by C.V.R. Murty)

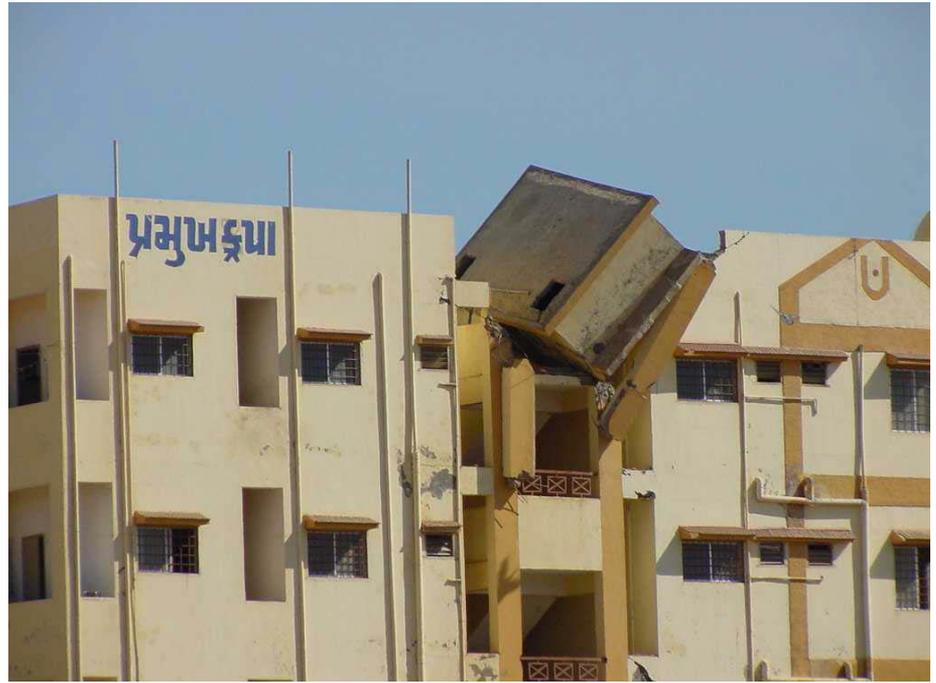
Another interesting feature of the earthquake was damage to numerous water tanks on top of multi-story buildings built integrally with the RC frame (Figure 9). The capacity of these tanks is relatively small and these acted as cantilever appendages above the building.

Figure 9 Water tanks atop multistory buildings sustained severe damage. This five-story building was located in Bhuj. (Photo by Jaswant N. Arlekar)

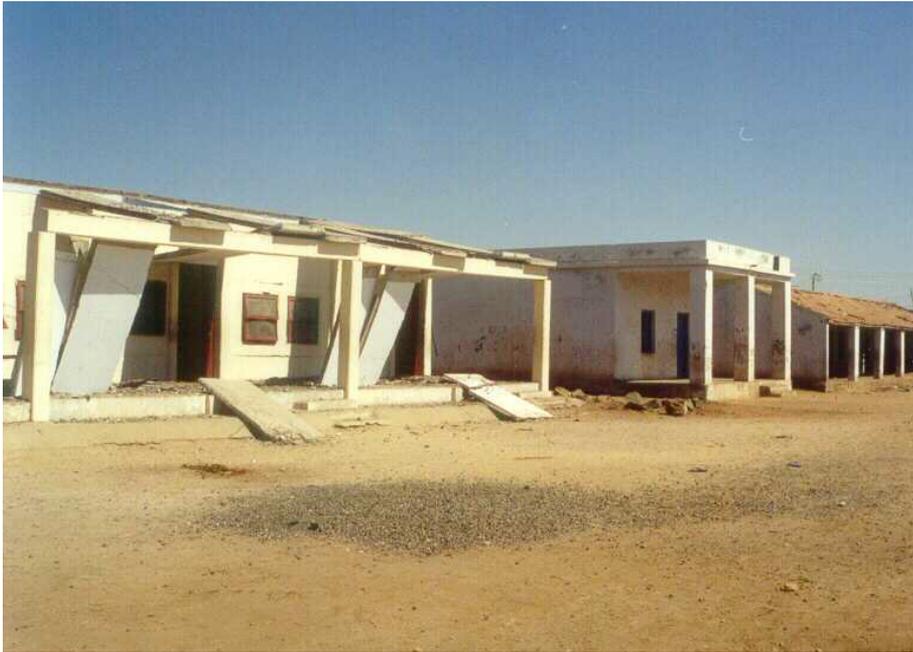
Precast Construction: Some single-story school buildings in the Kachchh region are made of large panel precast RC components for the slab and walls, and precast RC columns. A typical design using this construction has been recently replicated all over Gujarat, including in the affected region. Approximately one-third of 318 such schools in the Kachchh region had roof collapses (Figure 10). Inadequate connection between the roof panels led to lack of floor-diaphragm action, and insufficient seating and anchorage of the roof panels over the walls and beams led to dislodgement of the precast roof panels from atop the

Figure 10 A school at Gandhidham with precast components has collapsed roof panels. Traditional buildings at the same school did not collapse. (Photo by Sudhir K. Jain)

walls. This has been observed in many past earthquakes across the world. Most of the failures of precast building systems resulted from these problems. Precast technologies are not popular in India and their suitability in high seismic areas has not yet been experimentally established. There is a serious need to determine the suitability of such construction before any more precast buildings are erected in seismic areas.

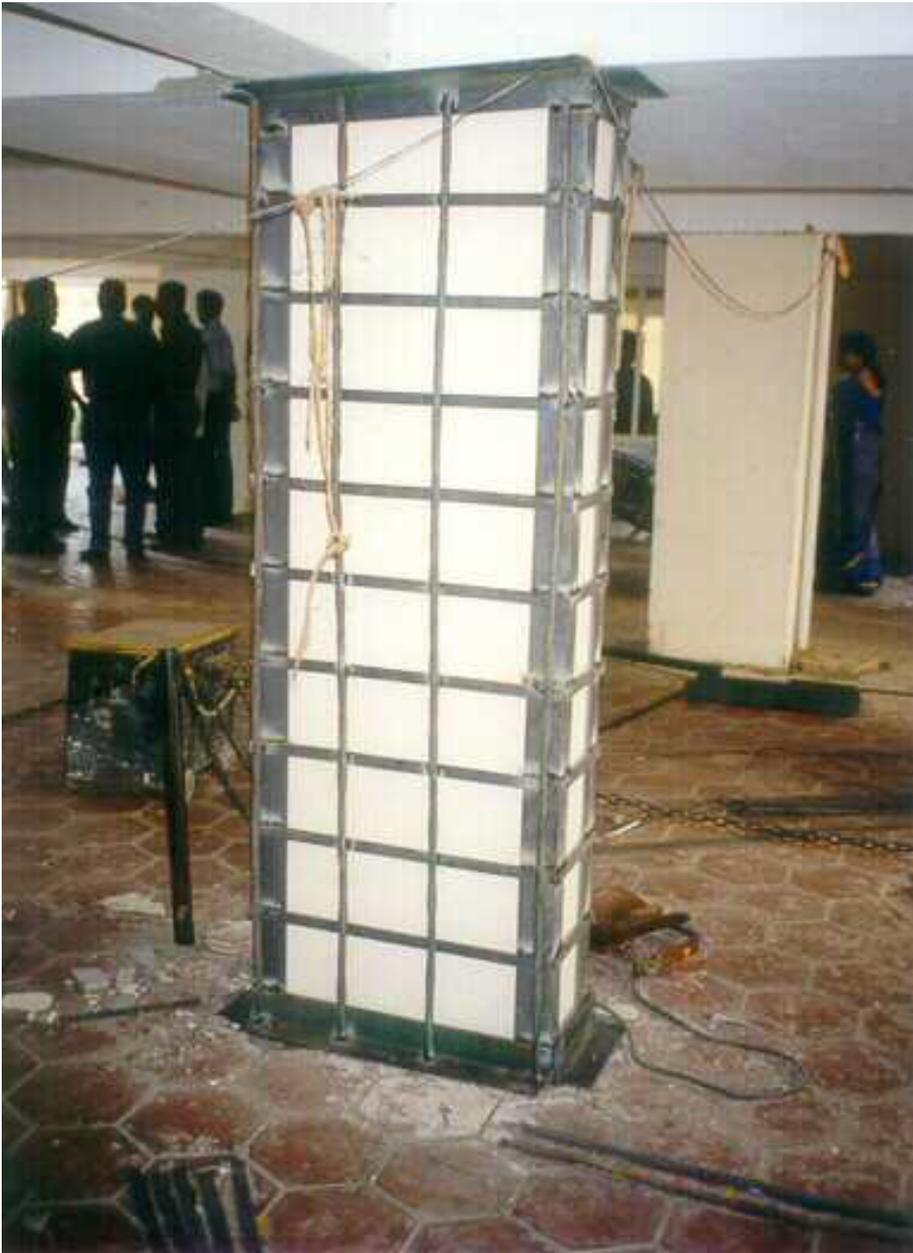
With collapse of numerous RC buildings in Ahmedabad and severe damage to the columns of others, efforts to repair and strengthen buildings were begun by local builders and contractors immediately after the earthquake. In many cases, the damaged first floor columns were jacketed with new concrete, usually in an improper way. For instance, new steel frames that were installed around existing columns to encase the concrete rested on the finished ground floor and were not carried to the foundation (Figure 11). Similarly, the

new frame was not adequately connected to the beams above. In some cases, the plaster of beams and columns was not removed. In others, a structural steel member was placed adjoining the damaged RC column, and both column and the adjoining steel member were jacketed together with concrete. In this instance, the steel column was taken below the floor level but still not extended to the foundation. An urgent need was strongly felt in the affected area for structural engineers with expertise in earthquake-resistant construction, but there were not many such engineers available.

Figure 11 *Improper concrete jacketing of the columns was widely practiced in Ahmedabad immediately after the earthquake. Note that the new reinforcement simply rested on the floor, and was not anchored to the slab/beam at top (Photo by Sudhir K. Jain)*

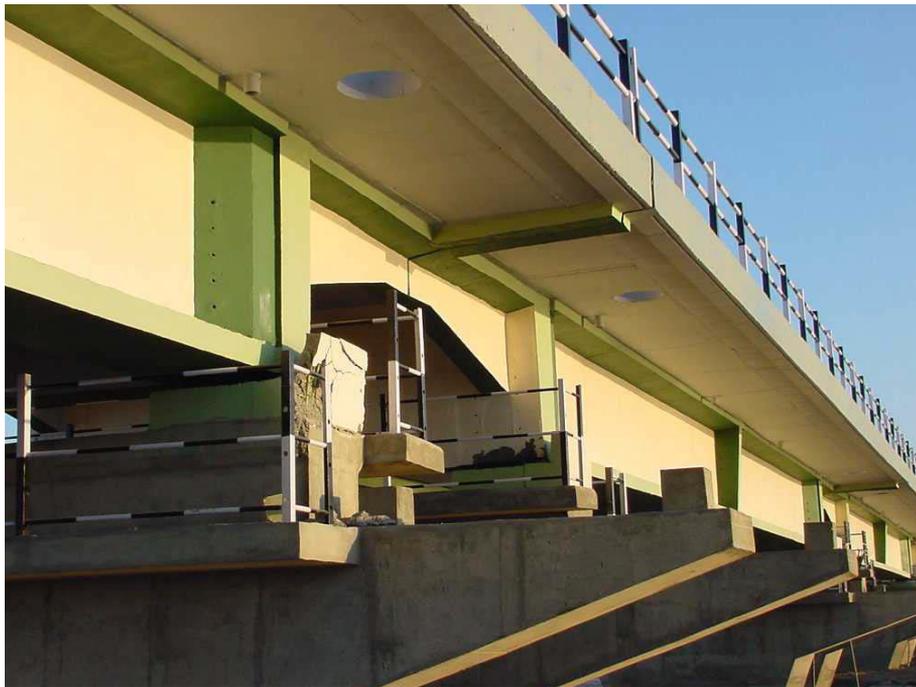
well foundation supports two piers, one each on two adjacent spans. The bridge was provided with RC up-stands at the ends of the pier caps to act as restrainers to limit transverse displacement of the superstructure. Neither the piers nor the well foundations sustained any damage during the earthquake, but the pounding of the superstructure girders damaged almost all of the RC up stands (Figure 12). Indeed,

these lateral restrainers were called on during the earthquake. Damage to the deck joints due to pounding of two adjacent spans was also observed.

Figure 12 The new bridge across Little Rann of Kachchh at Surajbadi was provided with concrete upstands to act as seismic stoppers in the transverse direction. All the stoppers were damaged by pounding of the superstructure, indicating their successful use (Photo by C. V. R. Murty).

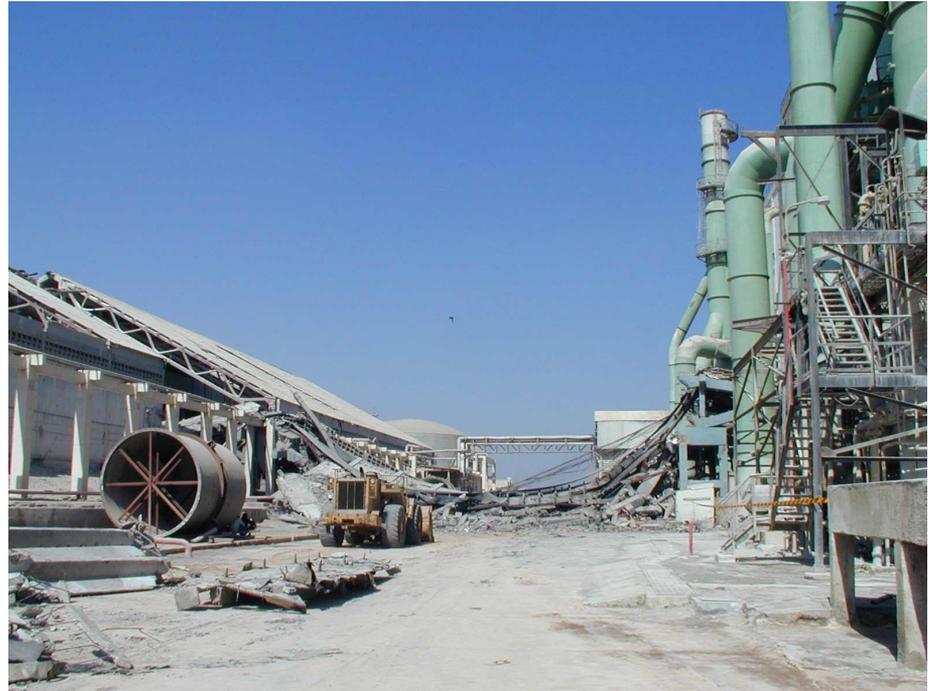
Figure 13 Collapsed product conveyor from manufacturing unit to storage at the IFFCO plant at Kandla (Photo by Praveen K. Malhotra)

poration Limited (IFFCO) plant at Kandla is about 20 years old and sustained serious structural damage. Widespread liquefaction occurred at the site. Serious damage at the plant included collapse of the Conveyor Belt Facility (Figure 13) due to the failure of the underlying concrete truss system, out-of-plane collapse of concrete block infills from within the RC MRF at the Manufacturing Unit Building, collapse of prestressed concrete roof trusses at the Potash Storage Facility, collapse of steel truss roofing at the Bag Loading Unit, and large settlement of the Ammonia Storage tanks.

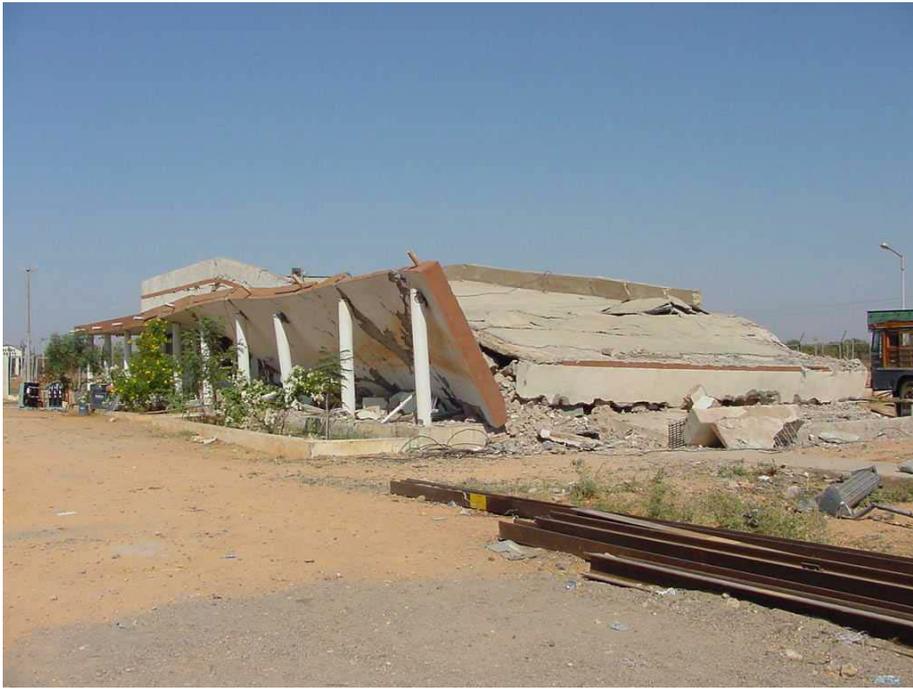
Figure 14 Collapse of the electric sub-station at Anjar was a major setback for electricity supply to the region (Photo by C. V. R. Murty).

One of the major bottlenecks in power transmission was the collapse of the 220 kV substation building at Anjar (Figure 14). The communications system and power protection system failed due to collapse of the battery rack. Workers could not immediately enter the control building to repair the battery rack because of collapse or the threat of collapse of the roof. The unanchored control panels inside did not topple. In the yard, all transformers derailed, but no bushings broke. The fluid seals of three-line breaker poles failed, and one of the circuit breakers fractured. This failure led to the complete blackout of Anjar and five villages

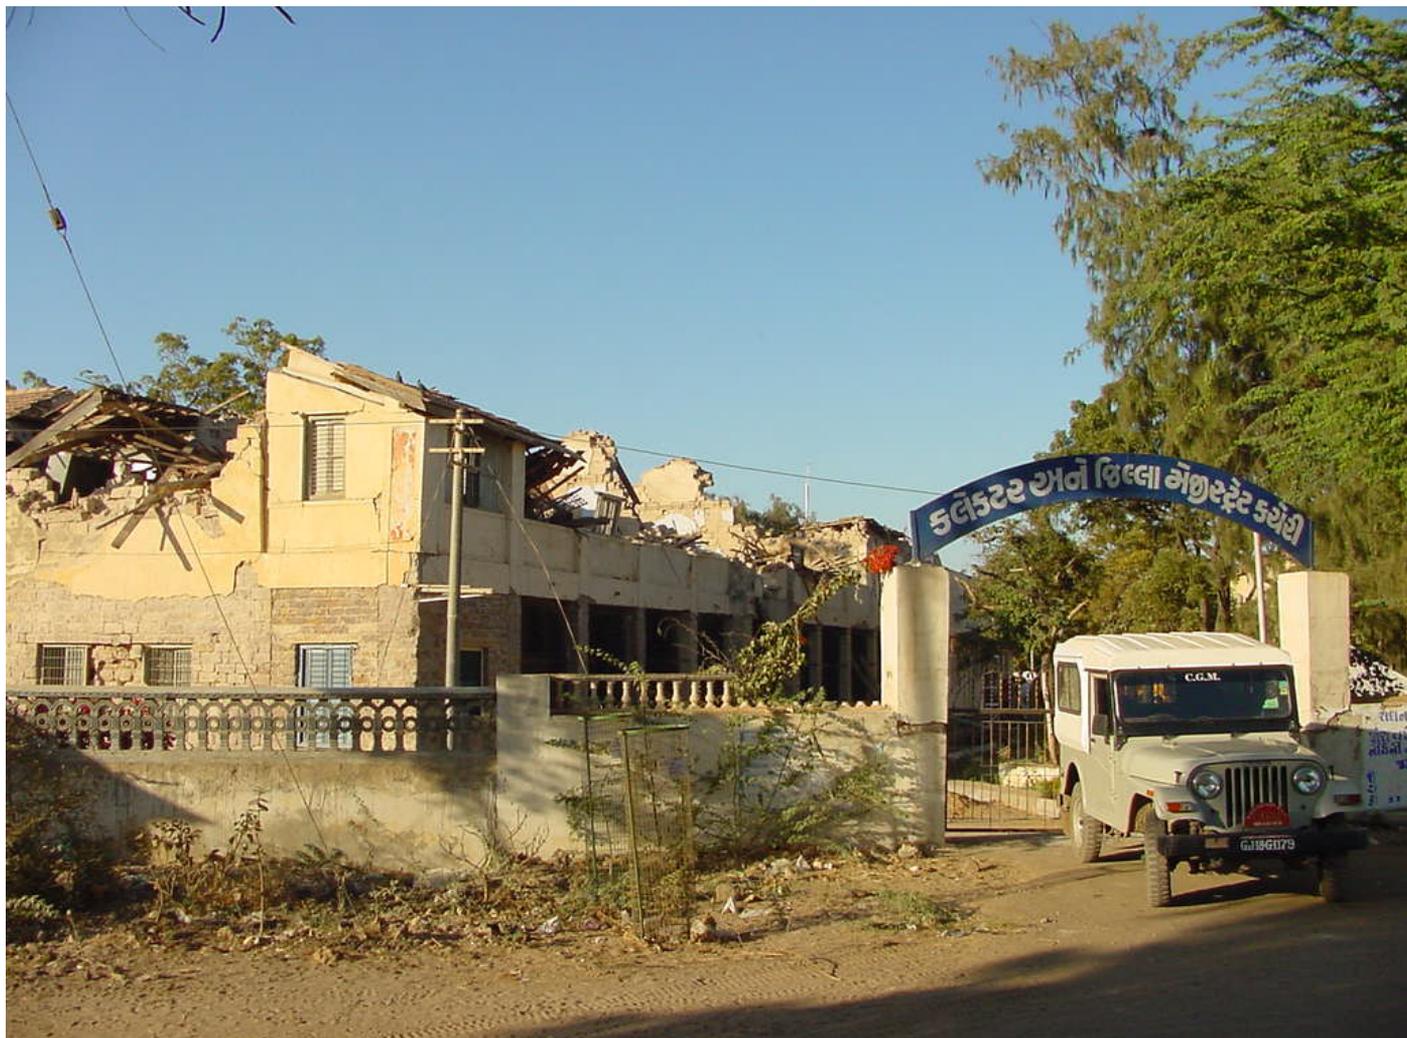
Figure 15 Upper story of the District Collector's office at Bhuj collapsed. The District Collector is the most important official for handling emergencies in the District (Photo by C. V. R. Murty).
