STRUCTURAL DEFICIENCIES OF ENGINEERED BUILDINGS EXPOSED DURING 2001 BHUJ EARTHQUAKE

Prabuddha Dasgupta, Jaswant N. Arlekar, C.V.R. Murty and Sudhir K. Jain

Department of Civil Engineering
Indian Institute of Technology Kanpur

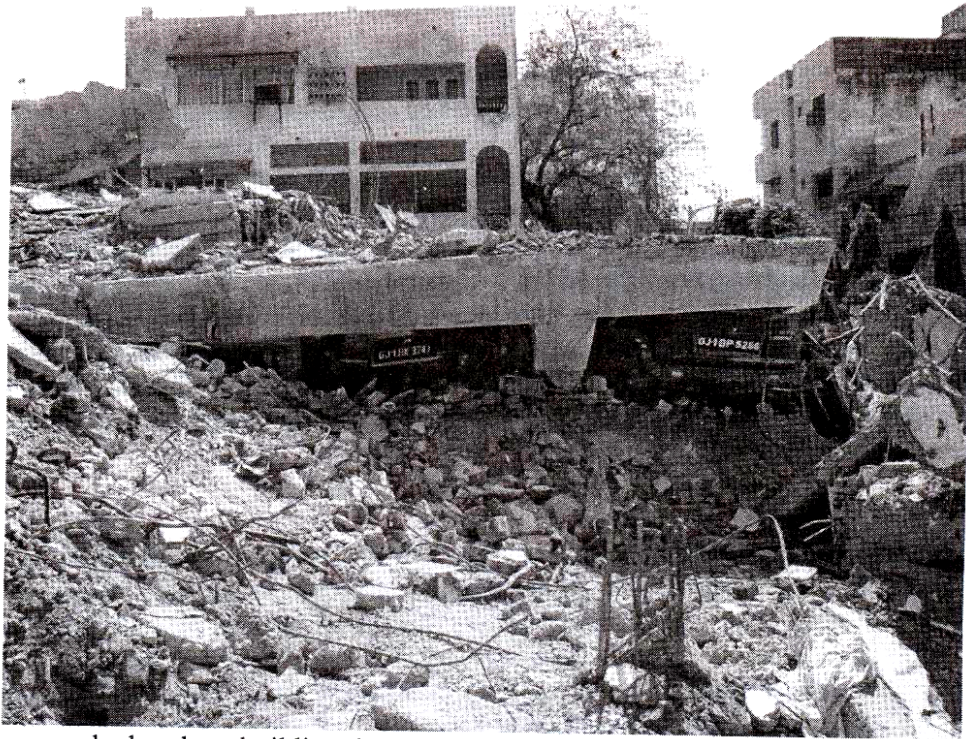
Fig. 1 Cars crushed under a building due to the collapse of open ground storey in Ahmedabad.

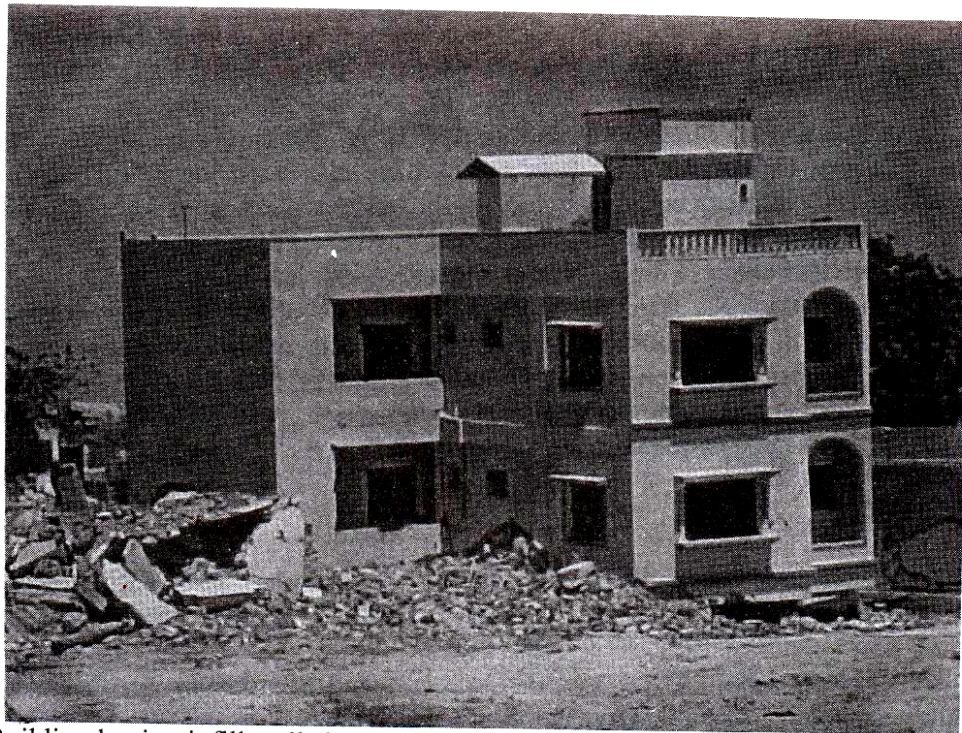
The large drift demands on the ground storey columns due to strong earthquake shaking, results in their heavy damage that distresses the whole building and may even cause collapse. In Bhuj, all this theory turned into a harsh reality. Buildings were reduced by one storey at the ground floor level (Fig. 2). At least one case with intermediate soft storey collapsed was also observed, even though the drift and force demand on the columns of intermediate floors are much lesser than those on ground floor columns (Fig. 3). The reason for such poor performance can be attributed to lack of adequate transverse reinforcements provided in the columns. It is well established now that providing confinement to concrete with the help of hoops and stirrups can enhance the strength and ductility of the concrete to a large extent [Pauley and Priestley, 1992]. The confinement also helps the RC columns to undergo large deflections without failure. But, unfortunately, building in India are generally designed and constructed by considering the transverse reinforcements as carriers of member shear and something that helps holding the longitudinal bars in place. As a result of this the amount of transverse reinforcement in columns is often too low to enable the columns to undergo the large deformations without being severely damaged.

Fig. 2 Building having infill walls in the upper storeys with the open ground storey collapsed.

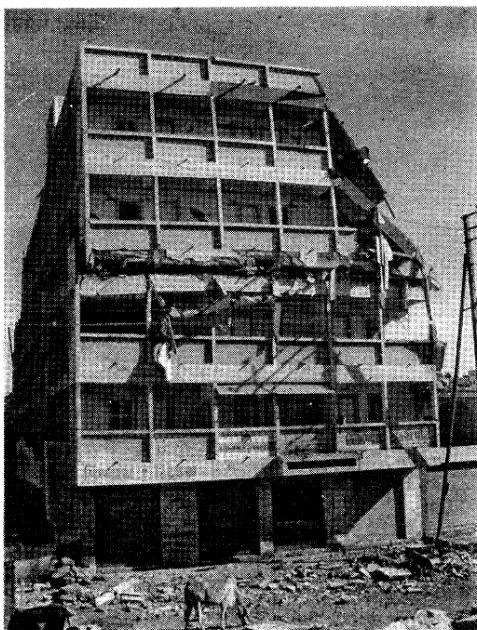
Fig. 3 Intermediate storey collapse of a 6-storey building in Bhuj.

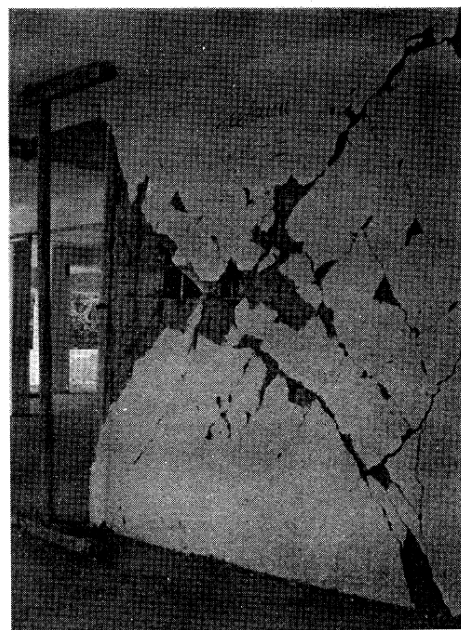
Fig. 4 Severely damaged RC elevator core of a 5-storey building in Ahmedabad

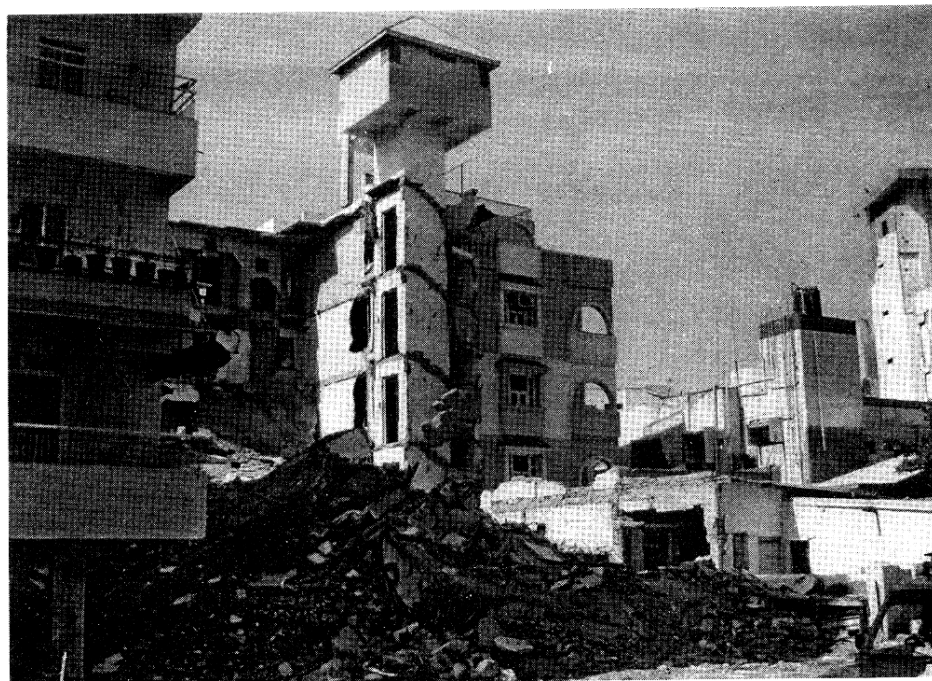
Some buildings with open ground storeys and RC elevator cores withstood the shaking without collapse. Due to their large size, the RC elevator cores offer much larger stiffness compared to other columns and as a result draw larger seismic. They are also very effective in limiting the drift of the ground storey. In many buildings, the RC elevator cores were severely damaged. Interestingly, these RC cores were not designed as lateral load resisting elements. It has been shown in the earlier study [Arlekar, 1997] that the RC cores can be effectively used as lateral load resisting element in the ground storey in the absence of the infill walls. Due to their large lateral dimension, they were rendered very stiff in the lateral direction as compared to the other lateral load resisting elements (columns) in the ground storey. Further, these were not designed to resist the forces and deformations resulting from the earthquake shaking; they were designed for the loads due to the operation of the elevator. Thus, the RC core walls, being very stiff without adequate deformation and strength capacity, were heavily damaged. However, the columns were not severely damaged as the deformations in the ground storey were limited by the presence of the RC core walls. The columns were primarily designed as gravity columns and all the lateral load resulting from the earthquake was absorbed by the RC core walls, leaving the columns in a state that they could still function as gravity columns and save the buildings from collapse. The connection between the RC elevator core and the rest of the building plays an important role in the effective use of the RC elevator cores. Building with a good connection between the slabs and the walls of the RC elevator core transfer the seismic loads to the RC core and utilize its strength and stiffness. However, there are instances, where lack of good connection between the building and the RC elevator core resulted in the core not sharing the lateral load with the building; the building collapsed while the core stood strong (Fig. 5).

Fig. 5 Collapse of a 4-storey RC building in Ahmedabad due to inadequate connection between the RC elevator core and the building.

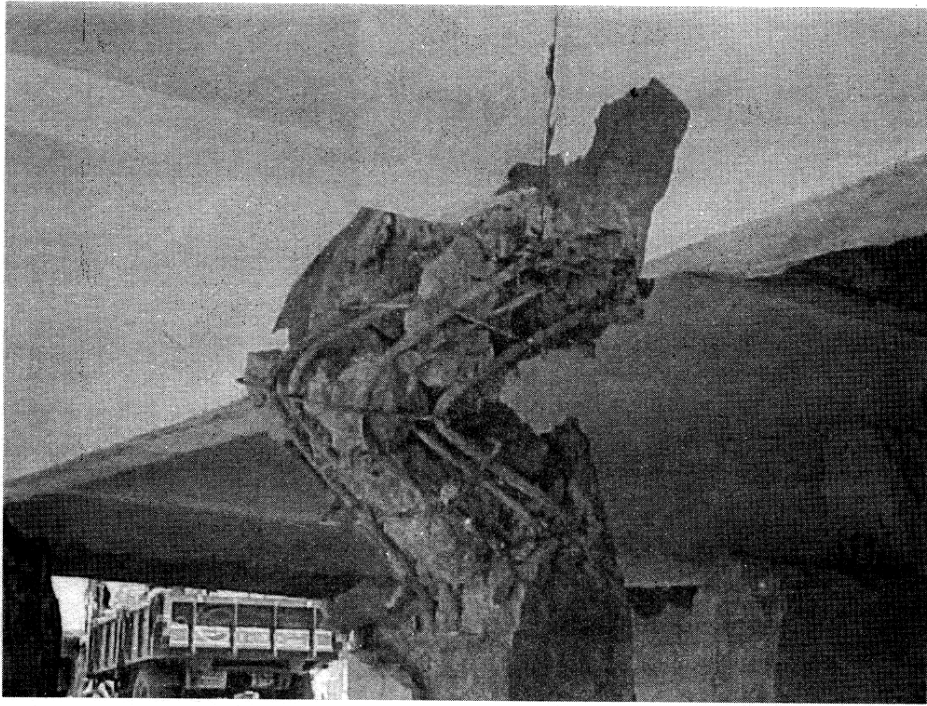
Inadequate detailing of column reinforcement also took its toll. Spacing of stirrups along the member was often too large to effectively confine the column core concrete (Fig. 6 and 7). Indian code for ductile design of RC buildings recommends the use of 135° hooks for effective embedment of hooks into the core concrete [IS:13920-1993]. However, 90° hooks were used in columns (Fig. 8). In some cases, failed

Fig. 6 Crushing of core concrete due to inadequate confinement.

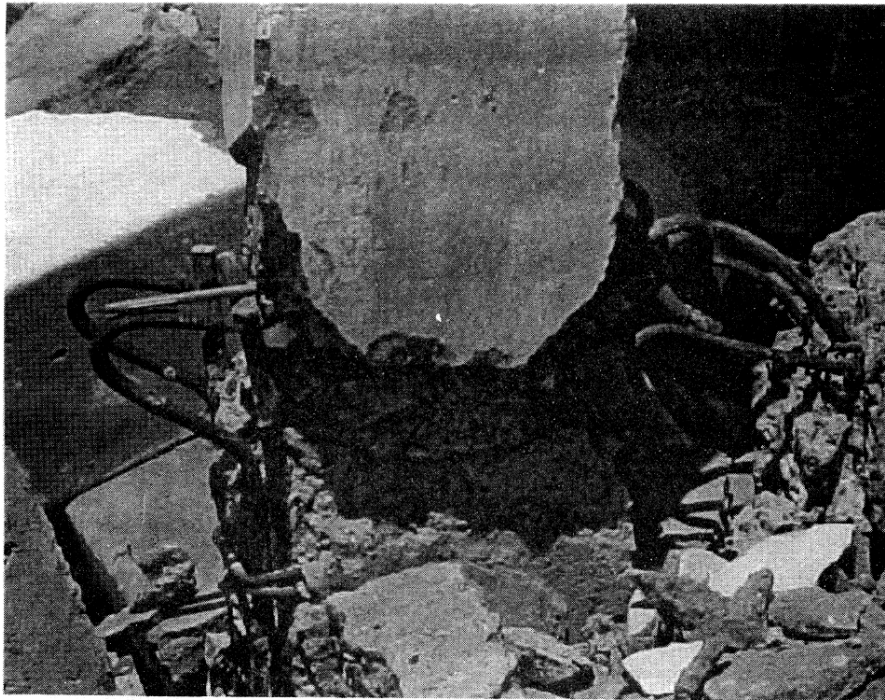
Fig. 7 Buckling of longitudinal reinforcement due to large spacing of lateral ties.

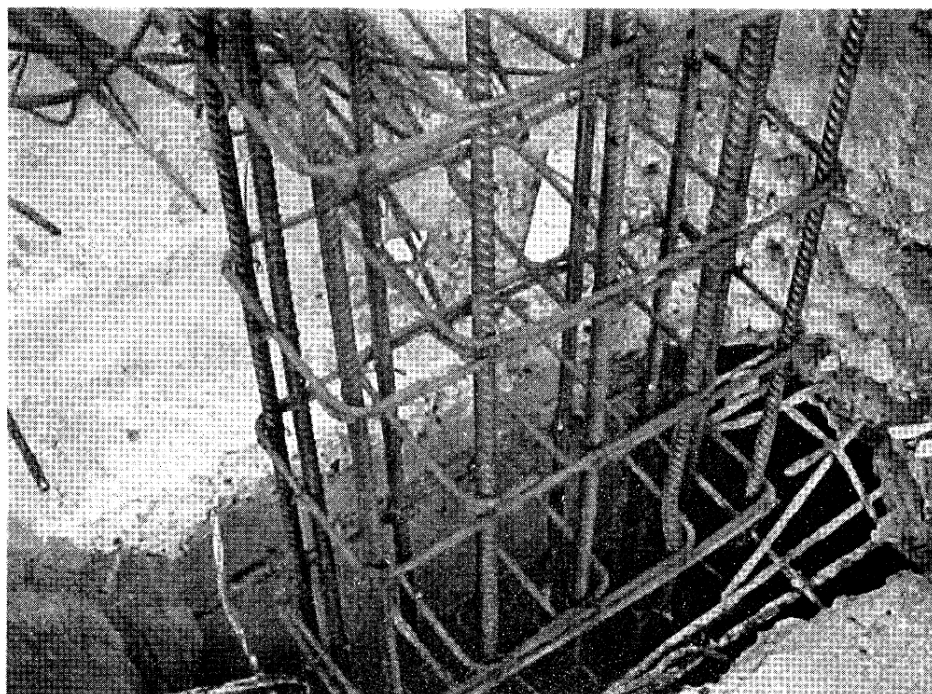
Fig. 8 Use of 90° hooks for the transverse reinforcement.

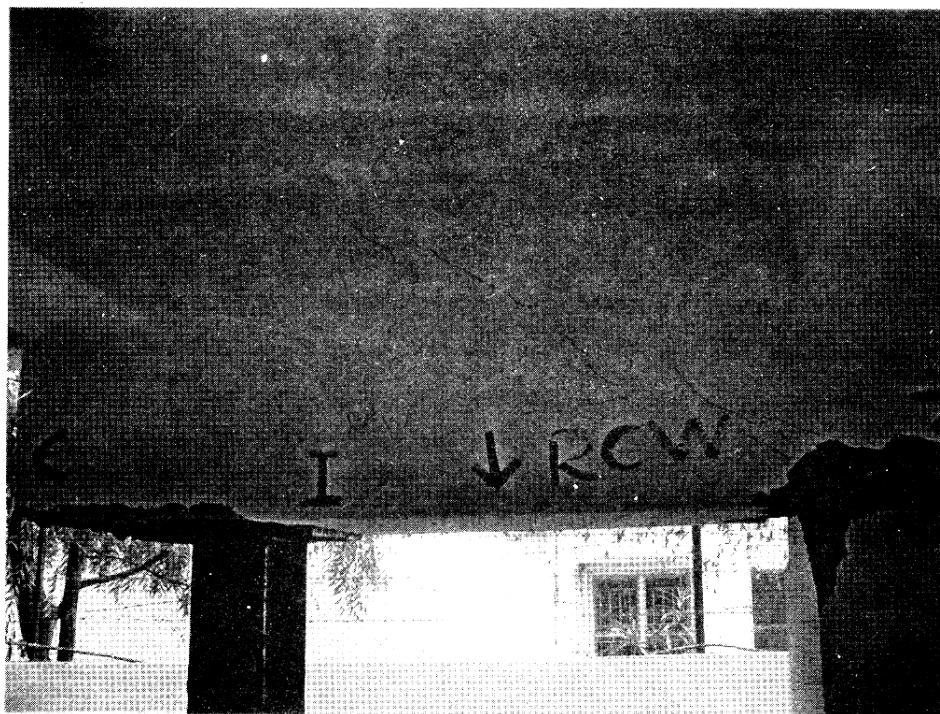
The building bylaws in Ahmedabad and Gandhidham (and rest of the country) require spaces to be left open on all sides of the building. The pre-specified offsets are measured from the edge of the building footprint in the ground storey. Designers often take advantage of this aspect of measuring the offset from the building footprint in the ground storey and have covered balconies on cantilever overhangs in the upper storeys. This configuration invariably results in floating columns located at the end of the overhangs. This is a popular practice in order to have larger floor area in the upper storeys while compiling with the requirement of the offset in the ground storey. This results in cantilever beams that are projected out from the columns at the floor levels, giving the buildings a mushroom like spread on top of the ground floor columns. The exterior columns in the upper storeys are terminated at the first floor level, which results in a sudden change in the flow-path of the seismic forces. Although, no collapse or large scale damage was observed due to this feature, most of the buildings having this feature sustained minor shear cracks in the cantilever (Fig. 9).

Fig. 9 Shear cracks in the cantilever that supports the floating column of the upper storeys.

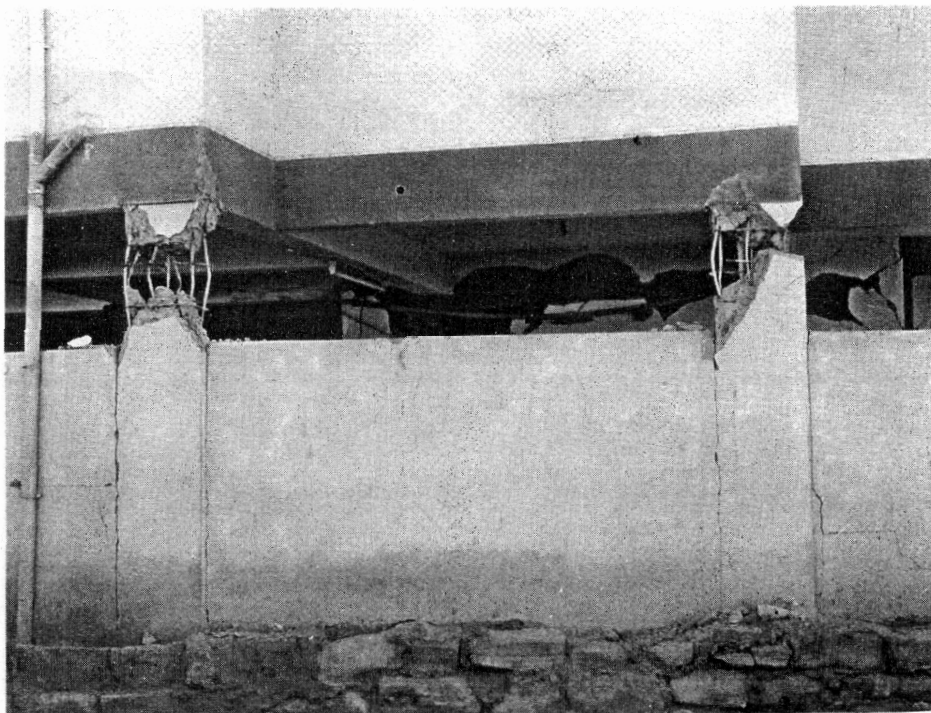
At some locations it was observed that brick walls of partial storey height were constructed along the perimeter of the building frame to serve as an enclosure. The partial heights of these walls allow adequate lighting and ventilation while maintaining privacy. Such configuration reduces the effective length of the columns giving rise to short columns, which are very stiff as compared to the other columns that are not embedded in the walls. During lateral shaking, these columns attract large forces for which they are not designed. Due to their short height, the shear behavior is dominant, which brings about a shear failure in these short columns (Fig. 10). Failure of such short columns can result in the collapse of the building if alternate path for the transfer of gravity loads is not available.

Fig. 10 Severe shear damage to short columns.
