# Recent tsunami and earthquake devastation

## General observations

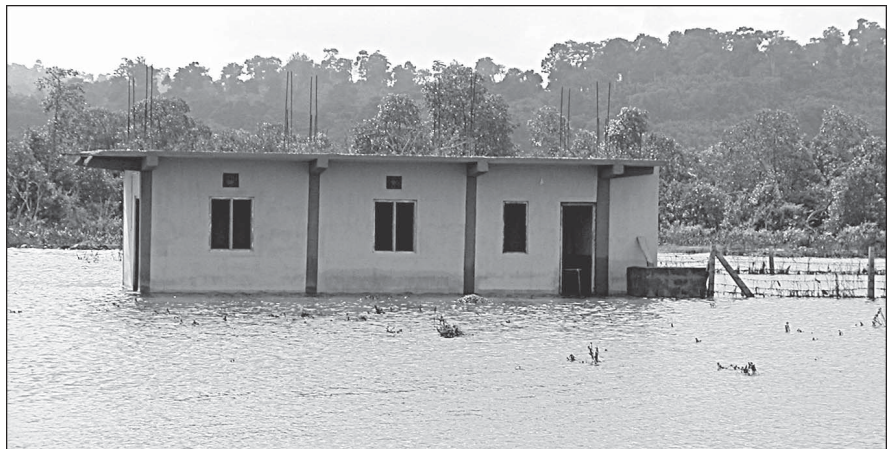
**Fig 1** Sea water level at Port Blair with respect to land has gone up by about 1 m. Hence many areas are now flooded during high tide (Photo: Sudhir K Jain)

plate, the Andaman and Nicobar Islands experienced uplift on the western coast and subsidence on the eastern coast as seen from the field evidence. At Port Blair, located on the east coast, water level has risen by about 1 m, *Fig 1*. Western coast of the middle Andaman islands showed emergence of new shallow coral beaches suggesting an uplift.

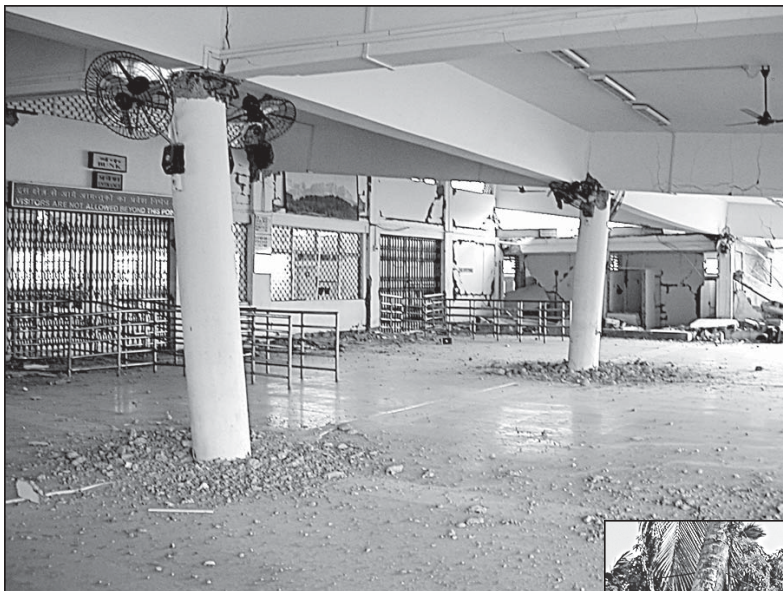
**Fig 2 Severe damage to Passenger Terminal Building at Port Blair** (Photo: Sudhir K Jain)

Due to the ground shaking, the wooden buildings have performed very well as compared to the more modern RC frame and concrete block masonry buildings. The latter sustained large damages wherever the seismic codes were not complied with. For instance, the passenger terminal building at the Phoenix Bay in Port Blair was recently constructed but did not comply with the seismic codes. This rather expensive building has been irreparably damaged, *Fig 2*. At least two houses built by local people using reinforced concrete but without proper engineering supervision and seismic detailing collapsed, *Figs 3 to 5*. A three-storey apartment building in Port Blair

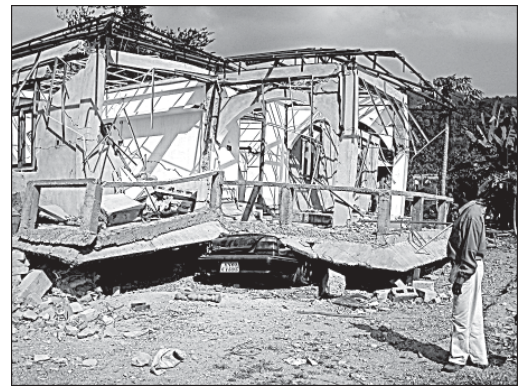
**Fig 3 Collapse of a stilt plus one-storey house in reinforced concrete near Port Blair** (Photo: Sudhir K. Jain)

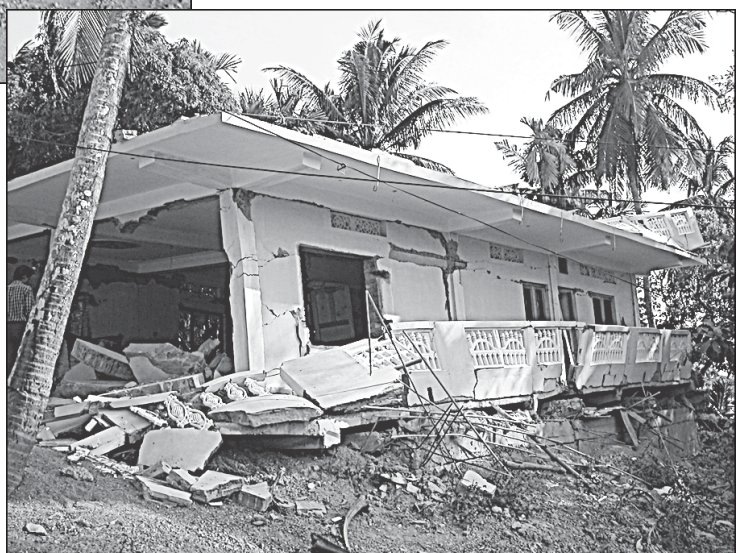
**Fig 4 Collapse of a stilt plus one-storey house in reinforced concrete near Port Blair** (Photo: Hemant Kaushik)

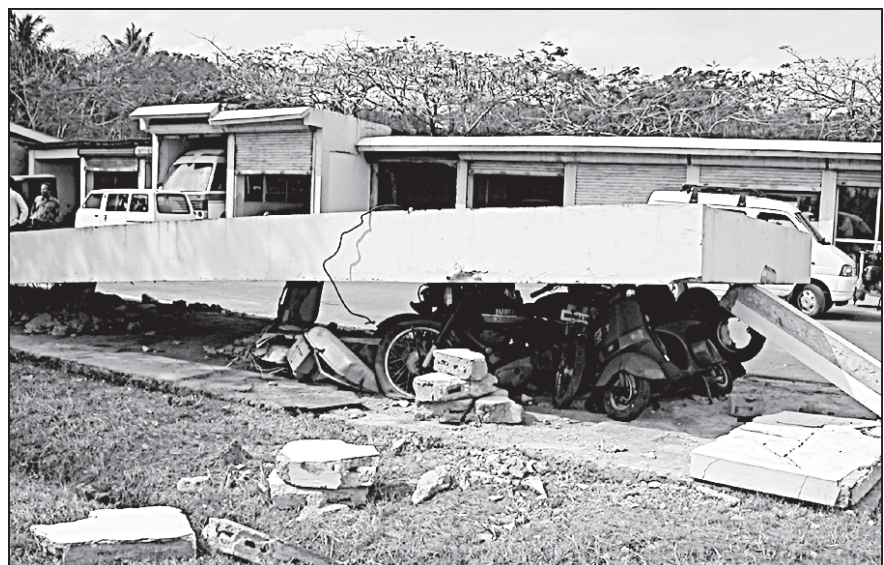
**Fig 5 Collapse of a reinforced concrete scooter stand at Port Management Board office in Port Blair** (Photo: Hemant Kaushik)

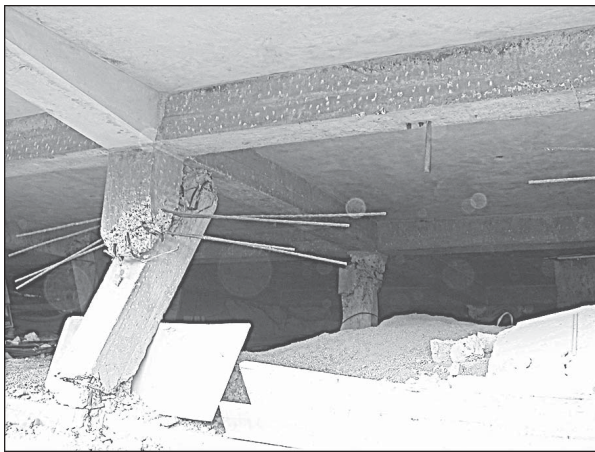
**Fig 6 Collapse of three-storey reinforced concrete frame building at Port Blair** (Photo: Sudhir K Jain)

on stilt columns, not complying with the codal requirements, collapsed, *Fig 6*.

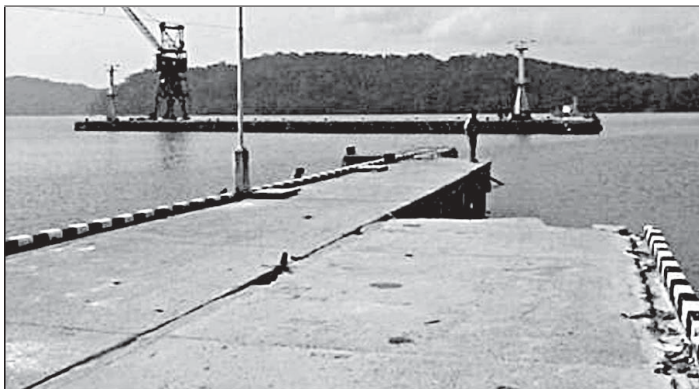
A number of jetties collapsed or were severely damaged in a number of islands, *Fig 7*. This has severely affected the sea traffic and hence the relief operations.

**Fig 7 Collapse of the 80-m segment of the approach to Great Nicobar island jetty at Cambell Bay. This has adversely affected the relief work** (Photo: CVR Murty )

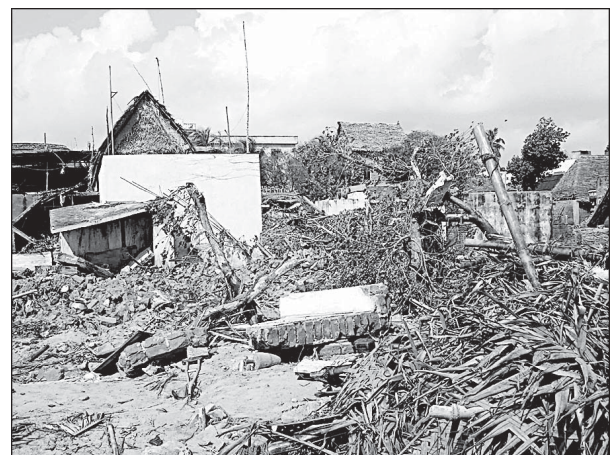
**Fig 8 Ravaged houses at Nagapattinam due to poor construction** (Photo: Alpa Sheth)

The fishing community living along the shore suffered the maximum damage: to its housing, to its boats and fishing equipment, and in terms of loss of life,

Fig 8. Most houses along the coast had been non-engineered. In general, quality of construction had a major influence on the level of damage sustained by the buildings. Buildings with low foundation depth, those with poorer building materials, poor integrity and poor workmanship were worst sufferers, Fig 9.

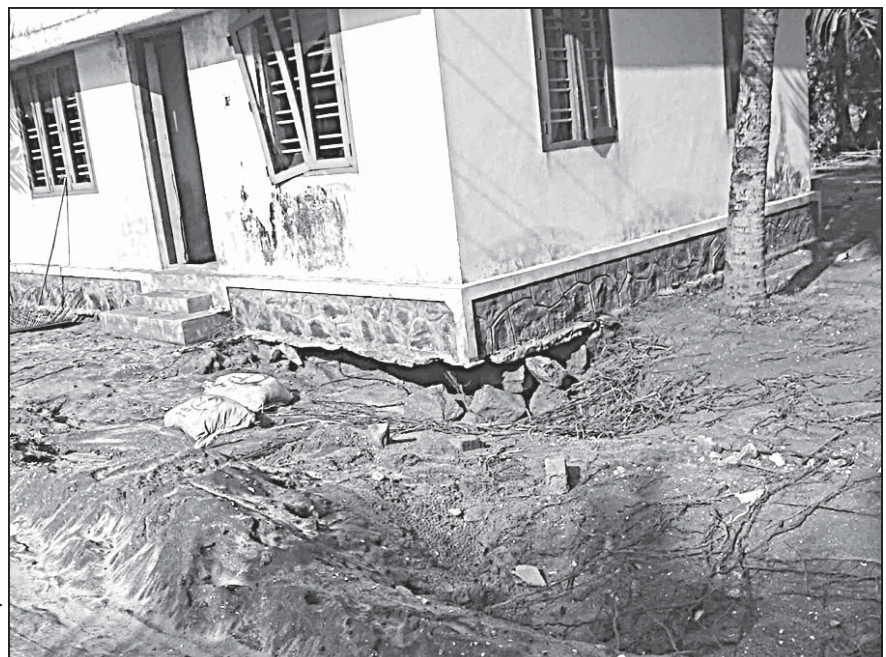
**Fig 9 Foundation failure in Kerala due to scouring of rather shallow foundation** (Photo: Alpa Sheth )

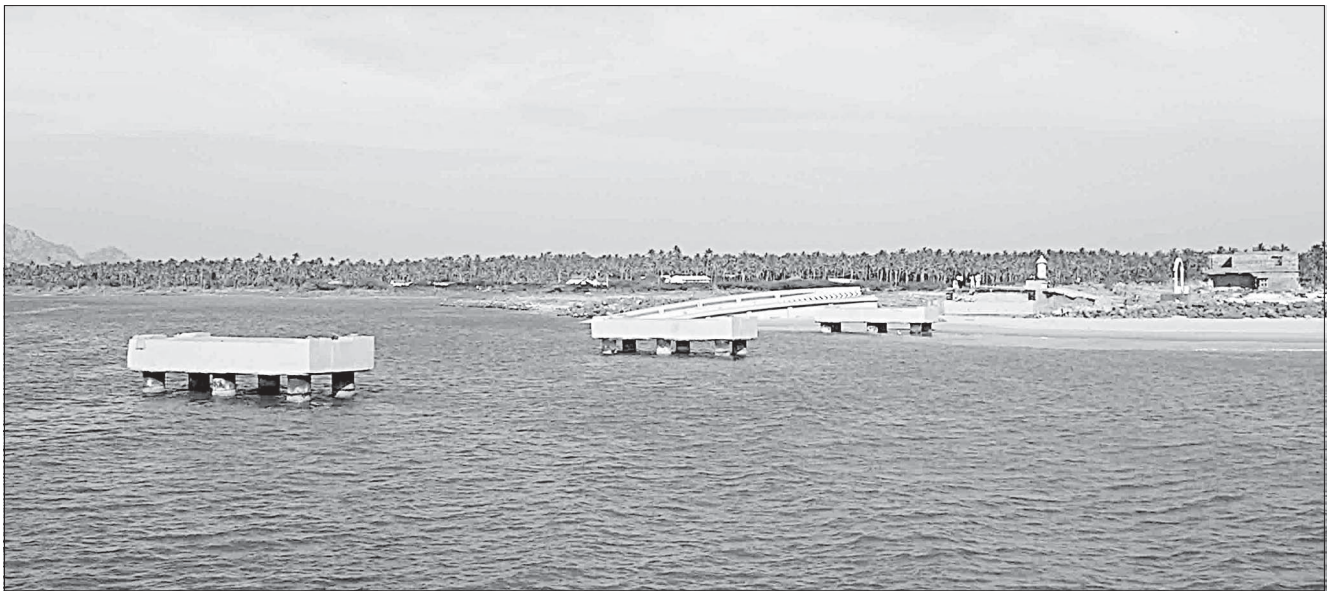
**Fig 10 Complete loss of the four span of a RC bridge at Melmannakudi** (Photo: Alpa Sheth)

Several bridges suffered serious damages. The superstructure of all four spans of a bridge at Melmanakuddi came off the sub structure and two of the spans washed away to large distances, Fig 10. A good connection between the superstructure and the substructure and the additional

provision of restraining upstands — recommended features for seismic design — would have helped these bridges. Infrastructure in Nagapattinam district was significantly affected: a railway line on the shore, telecommunication tower and control panel room were irreparably damaged. Compound walls upto 300 m inside the shoreline were very extensively damaged.

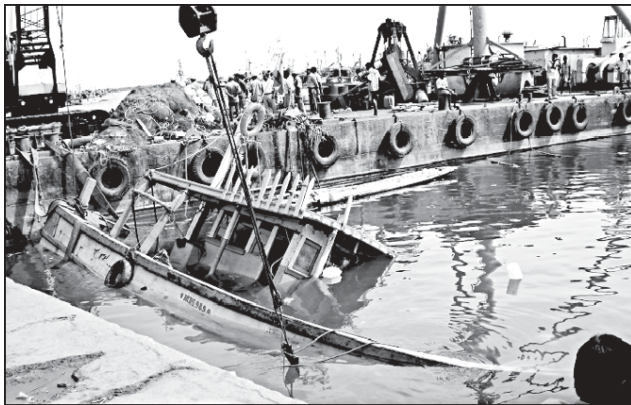
**Fig 11 Small mechanised boat sunk into harbour basin being pulled out of water at Fishermen's Wharf, Chennai** (Photo: Arvind Jaswal)

In ports and harbours, major disturbance was caused by vessels parting their ropes and becoming loose and hitting other vessels and causing damage. Small boats and ships were tossed astray onto the land by the incoming wave and thereby damaging them. Some boats were sunk to the basin due to the returning giant waves, Fig 11.
