# **On Better Engineering Preparedness: Lessons from the 1988 Bihar Earthquake**

Sudhir K. Jain, M.EERI

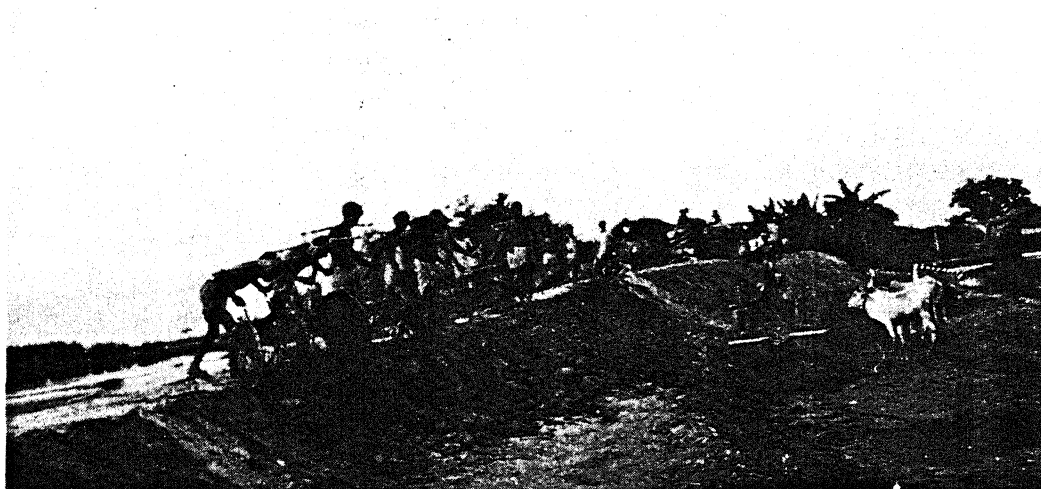
Figure 2. Restoration of a subsided embankment without any compaction.
