16

Postearthquake Handling of Buildings

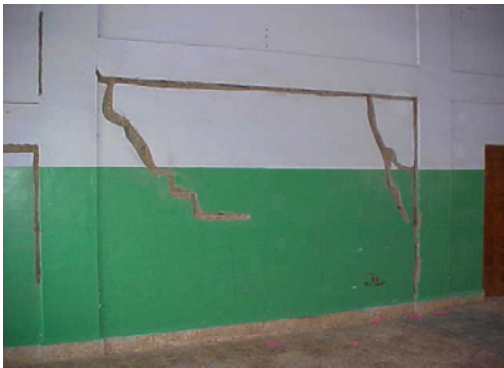
Figure 16-2. Numerous buildings in the affected area sustained only frame-infill separation. In most of these cases, the separations were cleaned and filled with rich cement mortar. The above picture shows the repair done at a school building in Gandhidham.

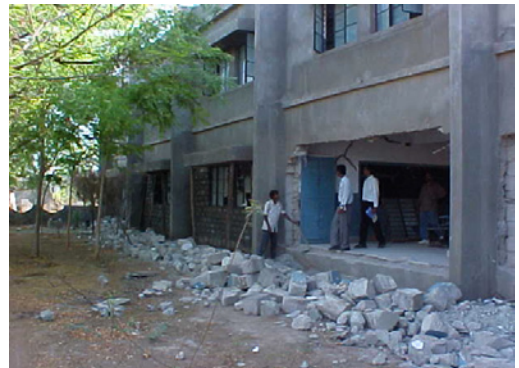
Figure 16-3. Large block sandstone masonry infills in cement mortar at a two-story school building in Ahmedabad were completely replaced with burnt-clay brick masonry infills in cement mortar.

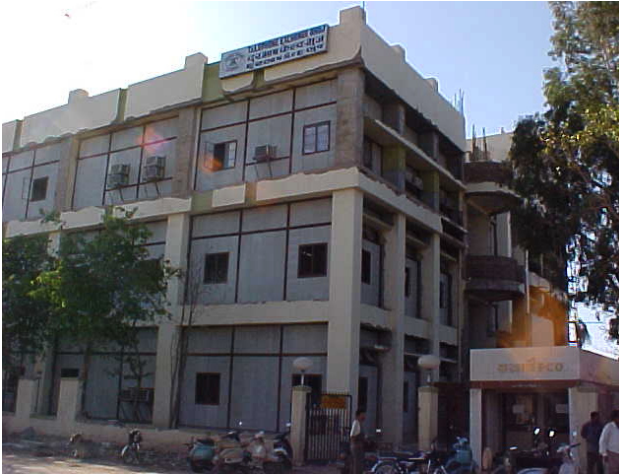
Figure 16-4. The large panel burnt-clay brick masonry infills in cement mortar, sustained partial collapse at the upper story of the three-story telephone exchange building in Bhuj. The infills of the entire building, including those at the lower stories, were replaced with lightweight foam concrete panels sandwiched between asbestos sheets. These panels were secured to the frame with thin steel straps.

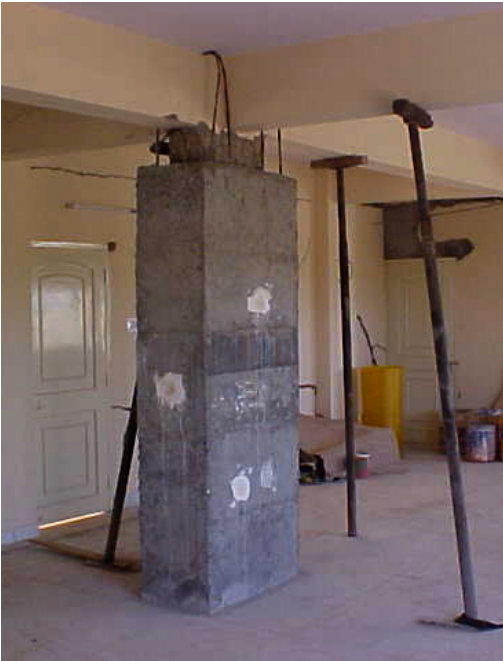
Figure 16-5. Jacketing of a rectangular column of the ground story of a seven-story old age home in Gandhidham, was performed from the floor level to a level well below the beams at the top of that column. The column bars are seen curtailed by the side of the beam.

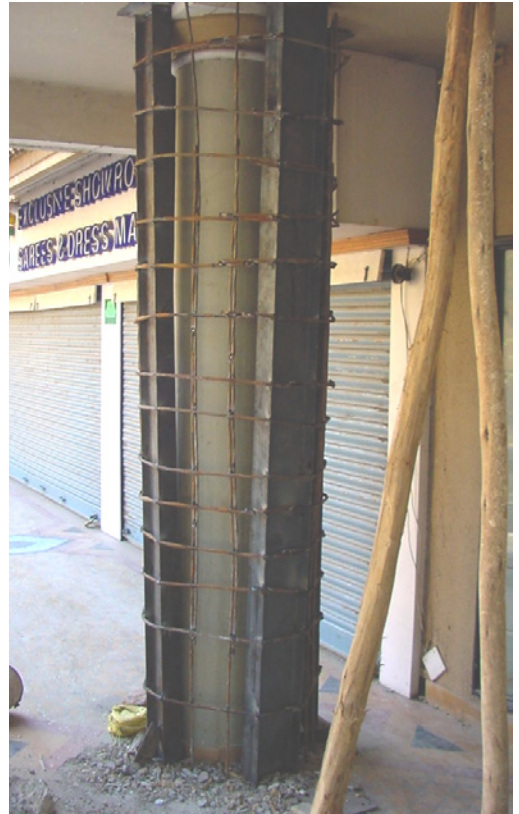
Figure 16-6. The circular RC column in the ground story of an 11-story (including a basement story) commercial building in Ahmedabad is jacketed with hot-rolled I-sections with ties to hold it adjoining the concrete column. There are no connections between the RC column and the steel I-section.

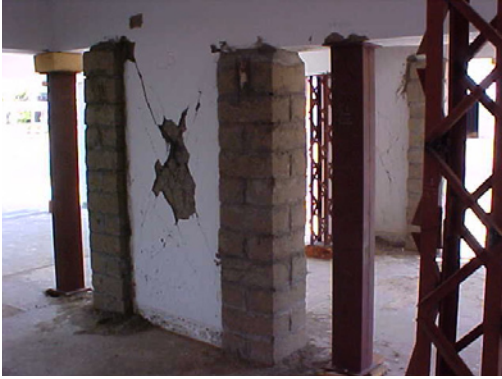
Figure 16-7. RC columns of the three-story residential RC frame building in Gandhidham are adjoined with brick masonry columns from the floor level to the beam soffit. The beam is propped at intermediate locations with hot-rolled steel I-sections.

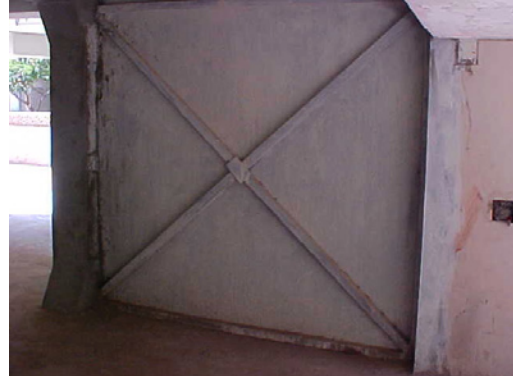
Figure 16-8. Steel braces are employed in limited cases to strengthen the open ground story panels. This picture shows bracing employed in addition to the infilling with burnt-clay brick masonry infills and jamming of steel sections at the outer faces, in a residential building. The bracing member used is a steel hollow box-section of 100 size with 8 mm plate thickness.

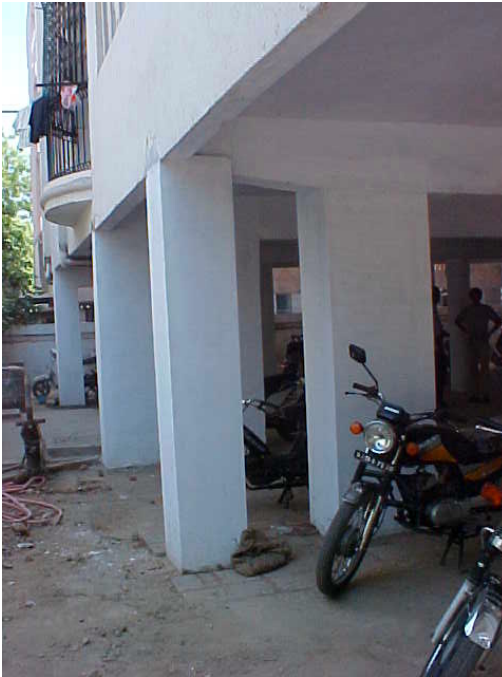
Figure 16-9. RC frame buildings with open ground stories usually have overhanging beams along the perimeter in the ground storey. Many of these cantilevers sustained shear cracks during the earthquake. In this building, masonry columns were constructed under the tips of these beams as a retrofit measure.

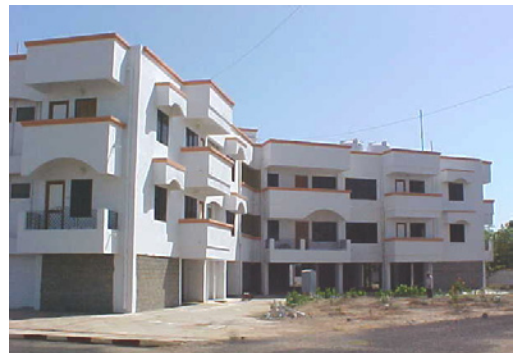
Figure 16-10. In this RC frame building with open ground story masonry infills were provided in select panels of the ground story without hampering parking in the open ground story.

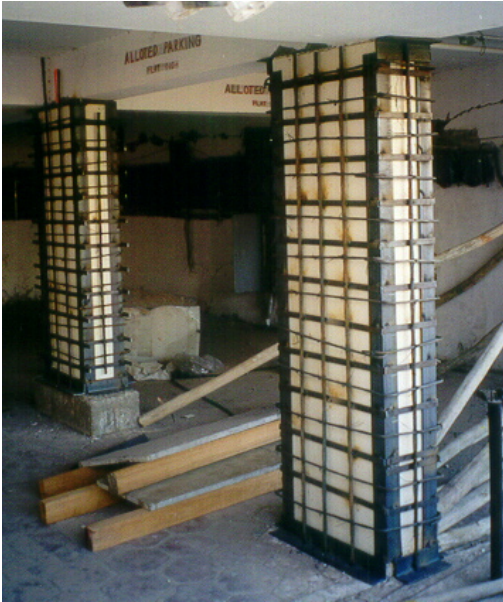
Figure 16-11. Mild steel angles of 75 mm size at four corners and 25 mm steel flats as battens were employed as the primary reinforcement for damaged RC columns of this open ground story building before jacketing them.

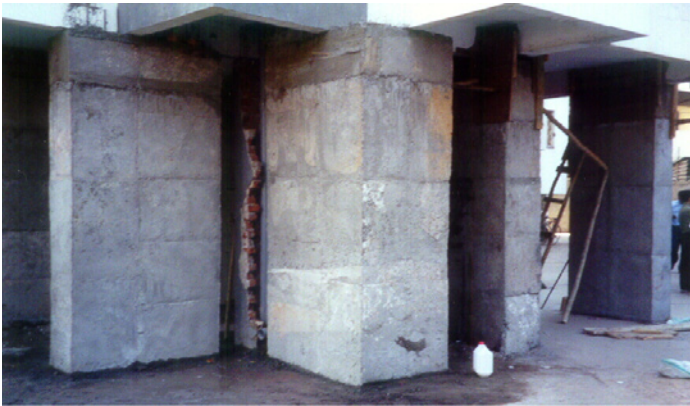
Figure 16-12. The open ground stories in RC frame buildings were intended to provide parking in the ground story. In some cases, this function was hampered after jacketing, because the size of the jacketed columns did not leave much space for movement, particularly for cars.

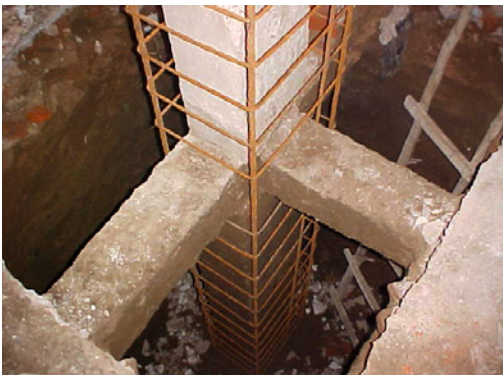
Figure 16-13. Instances where column jacketing was started at the footing level were few. Even in these cases, the column reinforcement may not have been anchored into the footing and even the footing may not have been enhanced.
