Learning from Earthquakes

The Great Sumatra Earthquake and Indian Ocean Tsunami of December 26, 2004

Report #3

The Effects in Mainland India and in the Andaman-Nicobar Islands

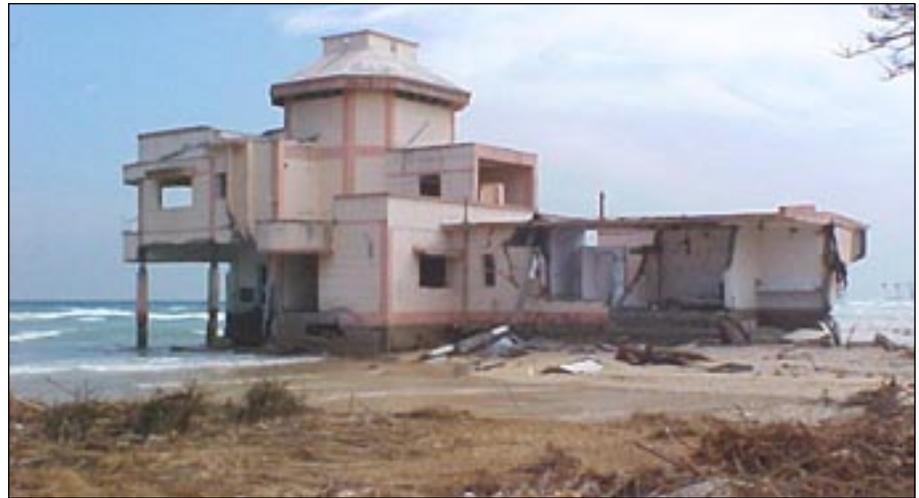
Figure 3. RC frame building (MES Inspection Bungalow) now stands in water on the eastern coast of Car Nicobar Island (photo: C.V.R. Murty).

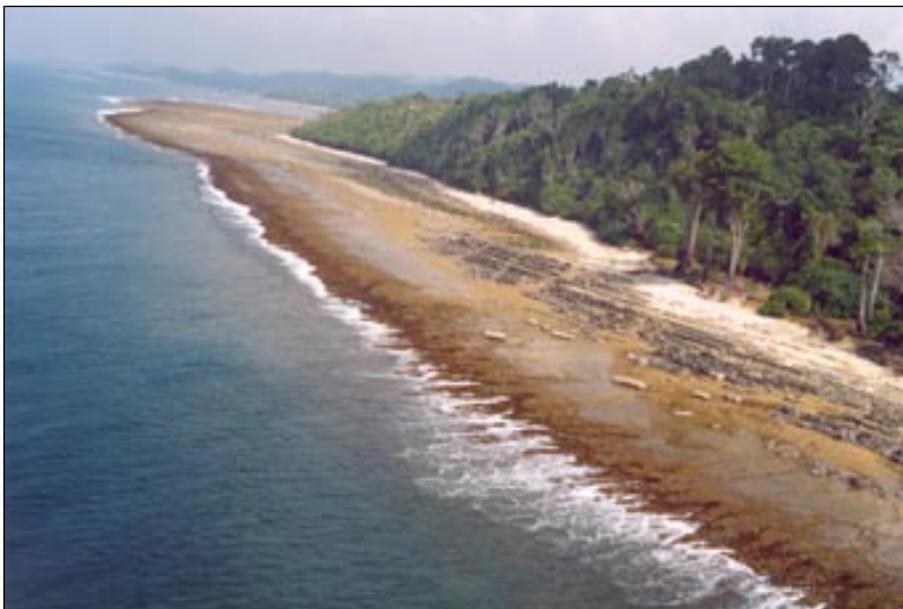
Island, suggesting an uplift of up to 0.3 m (Figure 4). The increased exposure of the RC piles at the jetty structure at Diglipur Harbor at the northern region of North Andaman Island (the northernmost of the A&N Islands) indicates an uplift of about 1.2 m.

Figure 4. Up-throw of coral beds and rock strata due to uplift on the western coast of Middle Andaman Island near Flat Island (photo: Javed N. Malik).

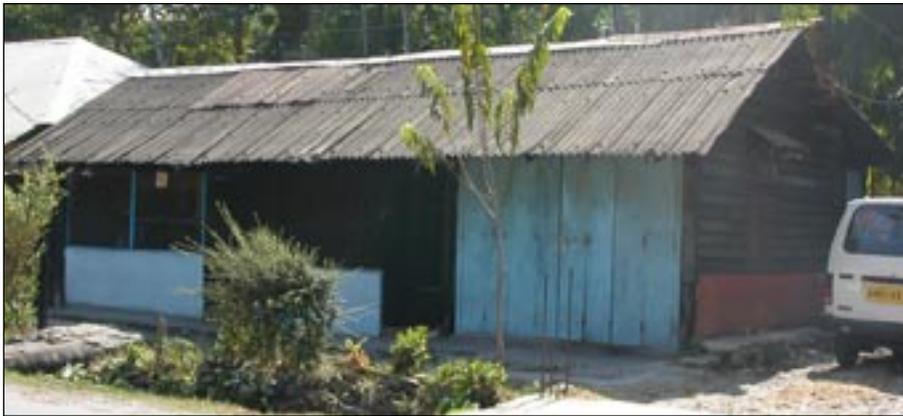
Figure 5a.
Single-story wood house in Port Blair with light roof had no damage (photo: C.V.R. Murty).

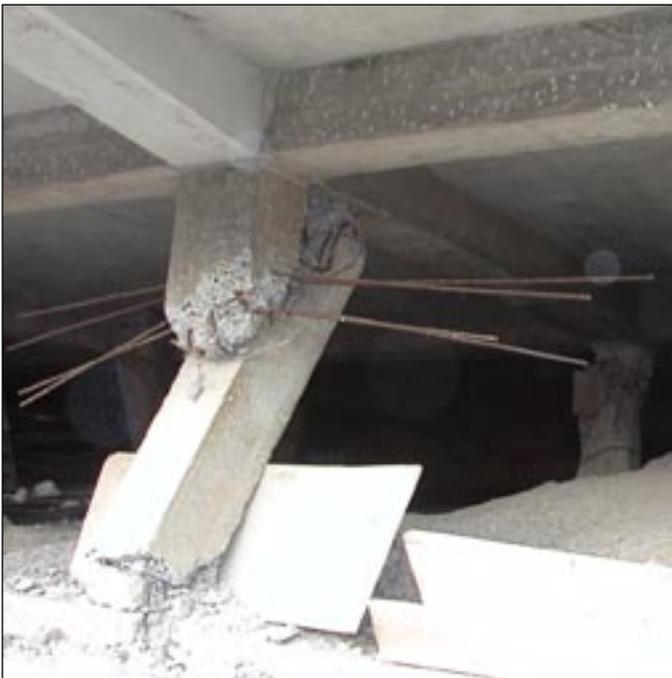
Building Damage: While damage in Little Andaman Island and all Nicobar Islands was predominantly tsunami-related, that in the islands north of Little Andaman was primarily due to earthquake shaking, though tsunami waves and high tides were also an issue. In general, the building stock consists of a large number of traditional and nonengineered structures. Many traditional structures are made of wood, and they performed well in the earthquake shaking (Figure 5a). However, a number of new, poorly constructed reinforced concrete (RC) structures suffered severe damage or even collapse due to shaking (Figure 5b).

Figure 5b.
A three-story RC frame building in the same town collapsed in a brittle manner (photo: Sudhir Jain).

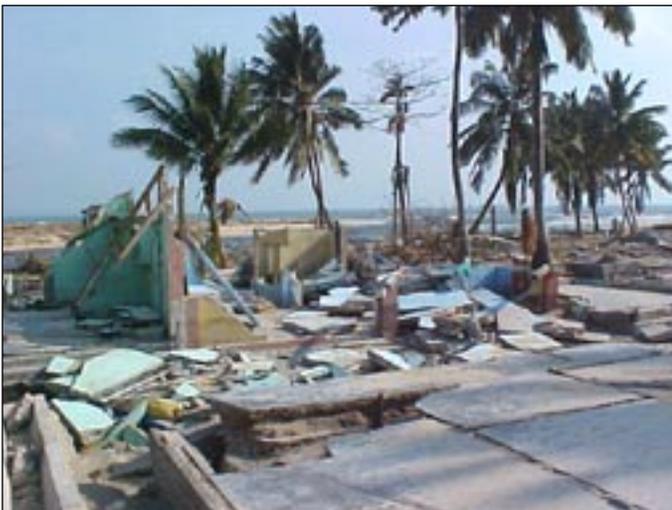
The tsunami waves caused severe destruction in the coastal areas of the southern islands (Figure 6). Structures near the water were subjected to (1) a positive water pressure when the waves arrived, and (2) a suction pressure when the waves receded. A large number of buildings right on the water in Little Andaman and Car Nicobar islands were washed away, regardless of how they were constructed.

Figure 6. *General destruction of built environment at Hut Bay in Little Andaman Island (photo: C.V.R. Murty).*

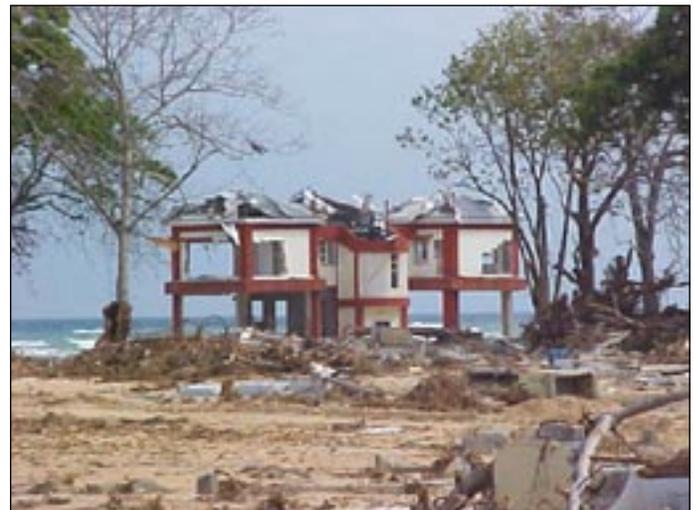
Figure 7. *Shore-front building on Car Nicobar Island was inundated by the waves, but the frame resisted the wave effects (photo: C.V.R. Murty).*

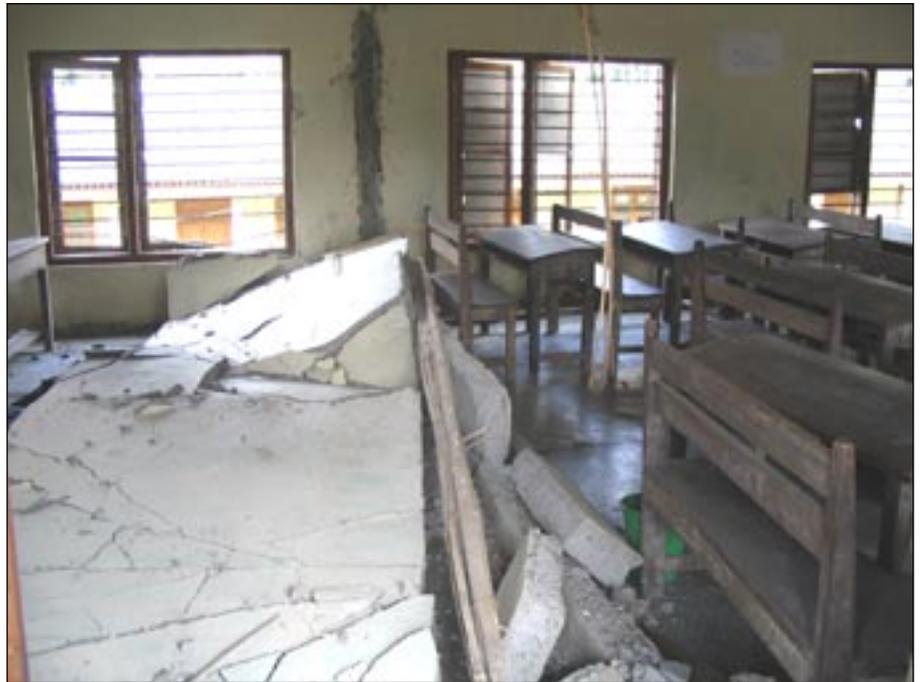
movement of the flexible roofs from earthquake forces caused out-of-plane masonry wall collapse. Similar damage was observed at a much larger scale in many school buildings, where the long partition walls separating two classrooms were either badly damaged or had fallen due to out-of-plane instability (Figure 8).

Figure 8. Slender masonry walls dislodged due to out-of-plane instability and poor or no connection to the surrounding structural elements (photo: Durgesh C. Rai).

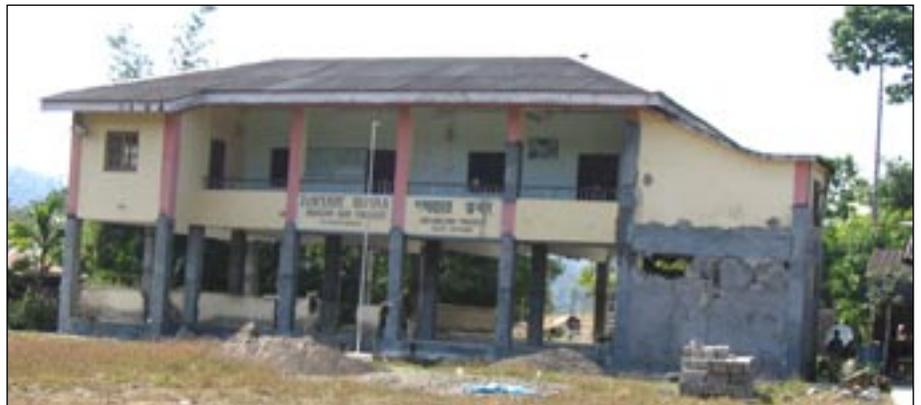
Generic RC structures are built in the A&N Islands for community facilities and for government office buildings. These structures were severely damaged during the shaking intensity of VII manifested in the islands. For instance, the Panchayat Bhavan Building in North Andaman Island sustained severe cracking to its infill walls and its brittle RC columns in the open ground story (see Figure 9). This building had experienced column damage due to inadequate lateral reinforcing ties in the 2002 M_w 6.5 Diglipur earthquake. Though the building was apparently retrofitted, this retrofit did not ensure safer building behavior, and similar damage patterns recurred.

Figure 9a. The Panchayat Bhavan building showed severe cracking and damage to the soft first-story columns and infill walls (photo: Durgesh C. Rai).

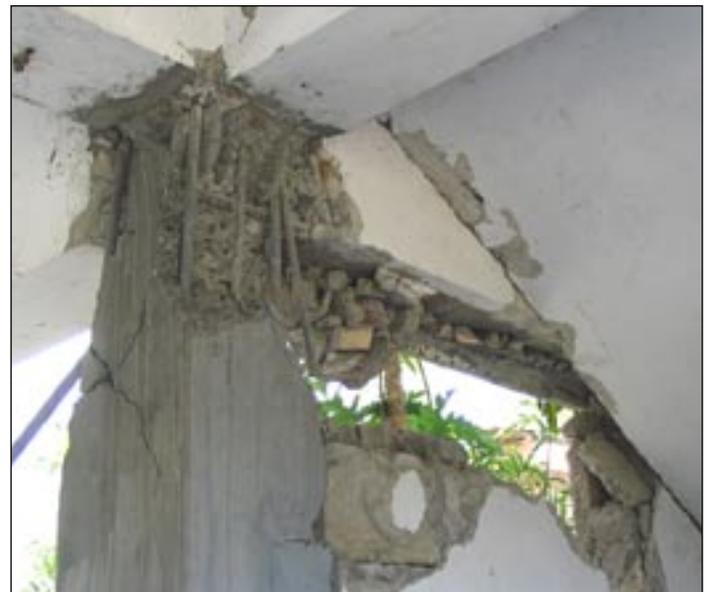
Figure 9b. Detail of column failure in the ground story (photo: Durgesh C. Rai).

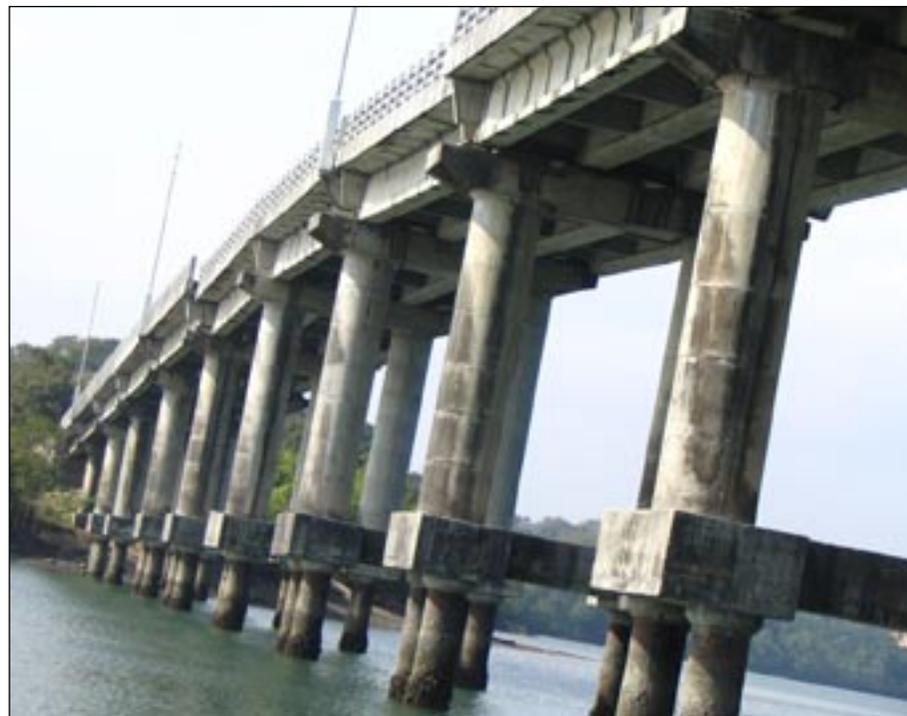
Damage to Infrastructure: A newly constructed 268 m-long RC bridge over the Austen Strait, connecting the North and Middle Andaman Islands on the Andaman Trunk Road, had to be closed to even light vehicles. Three middle spans of the superstructure were displaced laterally by about 70 cm and vertically by about 22 cm and fell off the bearing (Figure 10). Some other spans were also

moved laterally by about 2 cm to 15 cm. Two of the authors of this report visited this region two years ago after the moderate 2002 Diglipur earthquake. Their published reconnaissance report (Rai and Murty 2003) expressed the following concerns about this bridge:

“Inadequate seating of bridge deck over piers and abutments is a serious concern for its safety during a stronger earthquake in the future. The bearings are simple neoprene pads which are far from satisfactory for a bridge located in seismic

zone V. Bridge deck restrainers are the minimum that need to be provided to ensure that the spans are not dislodged from the piers in future earthquakes.”

Figure 10a. Chengappa Bridge over Austen Strait was rendered dysfunctional by displacement of the middle spans (photo: Durgesh C. Rai).

- d) Bridges in the coastal areas need to have lateral restraints to prevent the loss of spans during the buoyant conditions developed under high-tide levels.

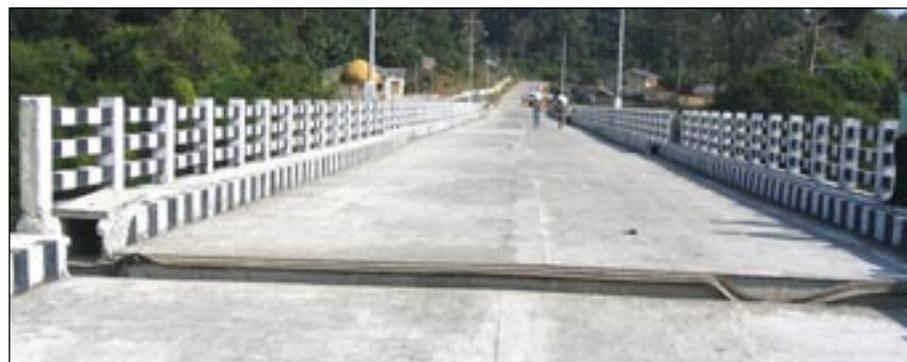
Figure 10b. Detail of the bridge deck showing lateral and vertical displacement due to shifting of the decks on their neoprene bearings (photo: Durgesh C. Rai).

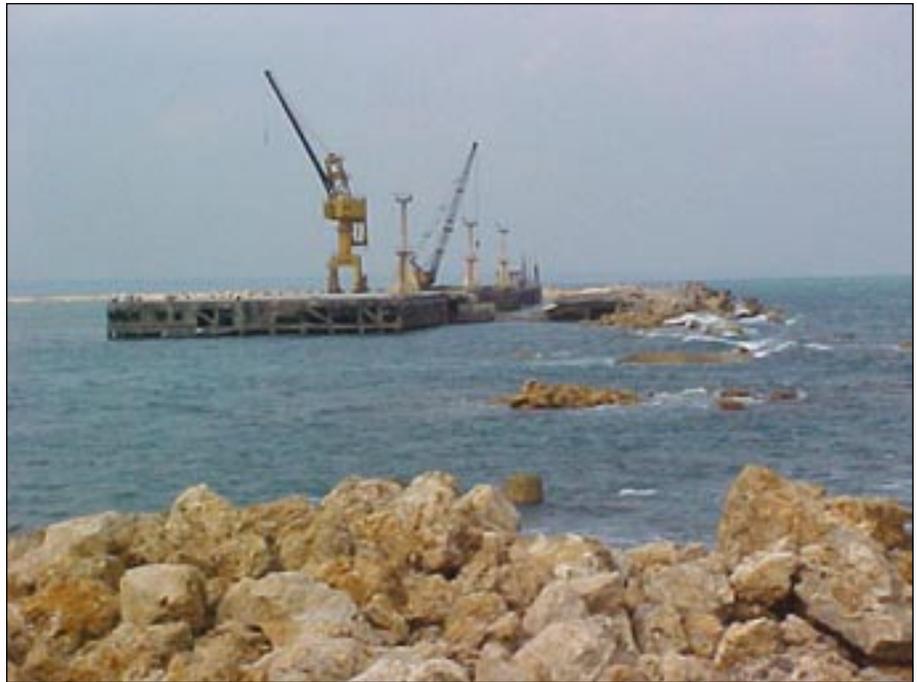
Figure 11. Shortage of appropriate construction material forced the use of porous coral stones from local quarries for building the breakwaters. The stones were easily uplifted during the tsunami and breached a large segment of the approach to the RC jetty at Hut Bay (photo: C.V.R Murty).

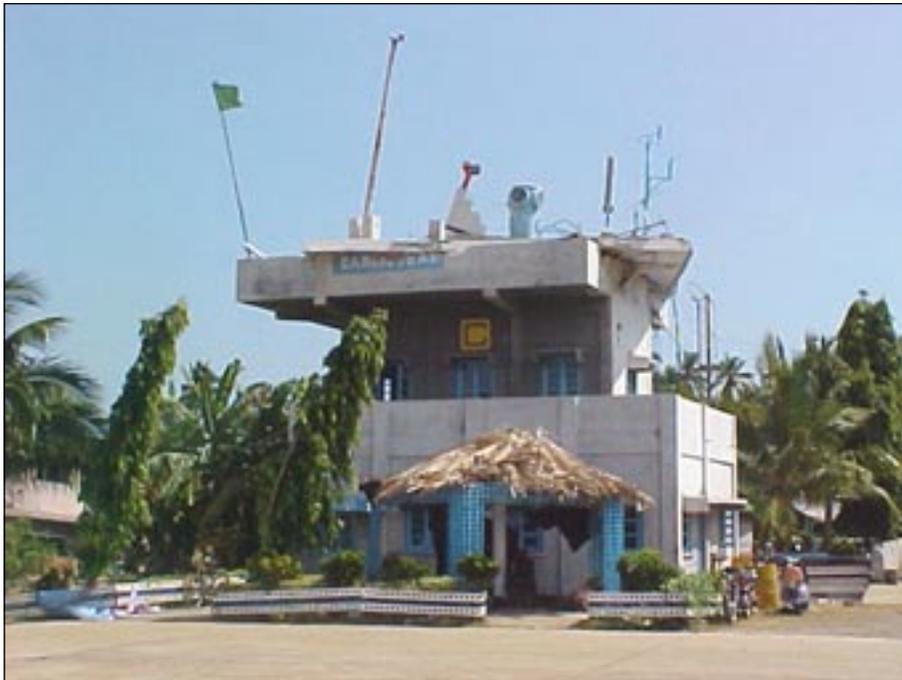
Other facilities like hospitals and seaport/airport control towers collapsed due to shaking and/or wave pressure. The airport control tower at Car Nicobar is a three-story RC frame with masonry infills, and its upper story collapsed in the shaking (Figure 12a). The seaport control tower at Hut Bay on the east coast of Little Andaman Island also collapsed due to the tsunami waves (Figure 12b). This square-plan three-story RC frame building with masonry infills had only four-corner columns and, hence, limited redundancy. The large positive pressure created by the tsunami waves toppled the building. Similar tower designs are being used elsewhere in the country, particularly in the seismic zones, so there is an urgent need for corrective action to strengthen them.

Figure 12a. Partial-collapse of the upper storey of the air traffic control tower at airport on Car Nicobar Island (photo: C.V.R. Murty).

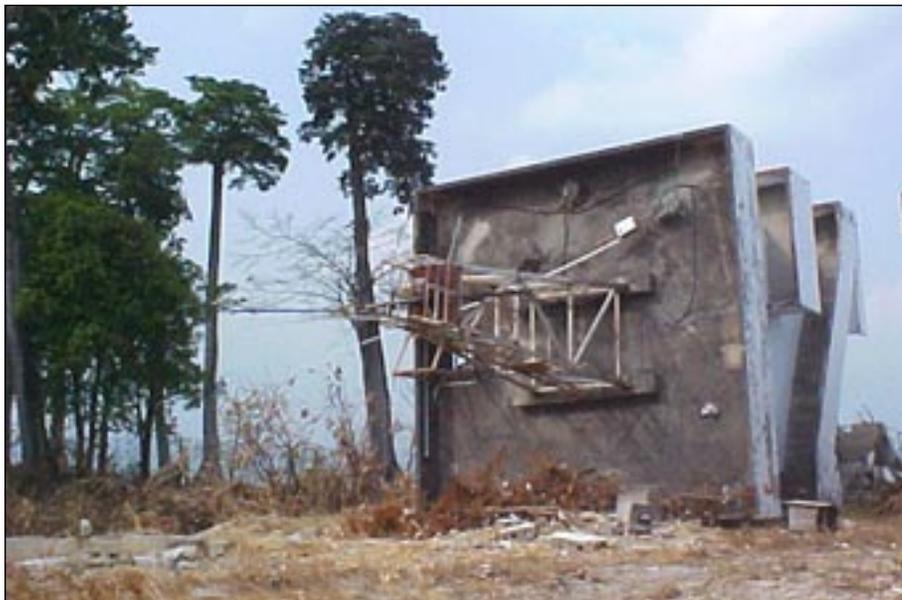
Figure 12b. Laterally toppled three-storey seaport traffic control tower at Hut Bay in Little Andaman Island (photo: Suresh R. Dash).

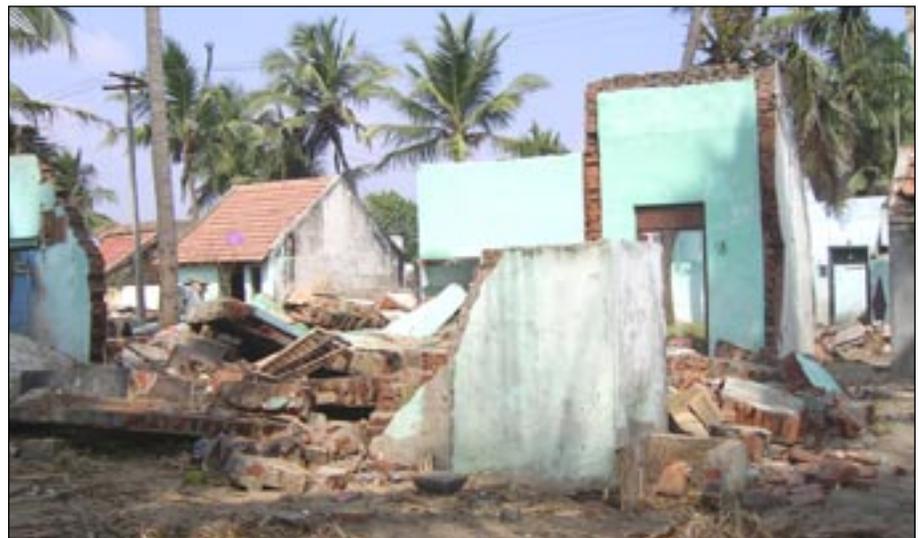
Figure 14. Houses destroyed by the waves at Nagapattinam in Tamil Nadu (photo: Alpa R. Sheth).

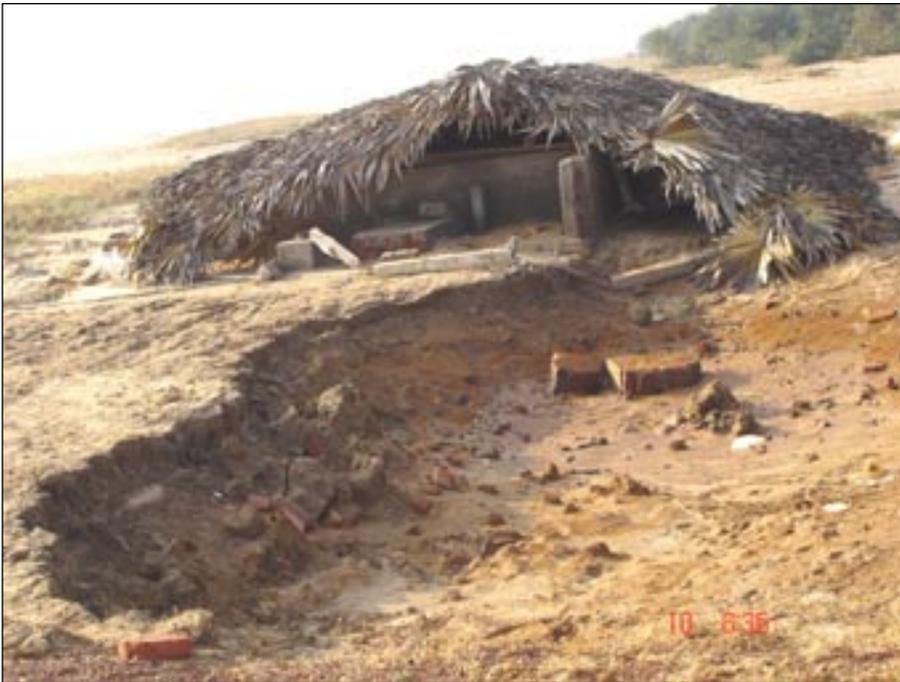
Figure 15. Mud house with thatch roof built within 100 meters of the sea at Pakala Beach in Andhra Pradesh (photo: Arvind Jaiswal).

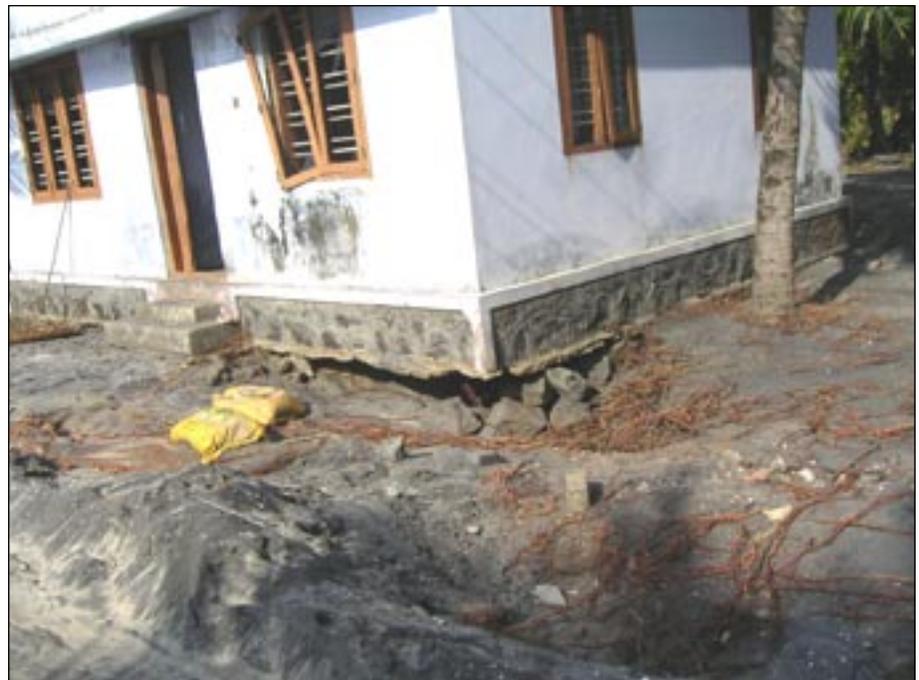
Figure 16. Scouring action at the base of houses due to returning wave of the tsunami in Kollam district in Kerala (photo: Alpa R. Sheth).

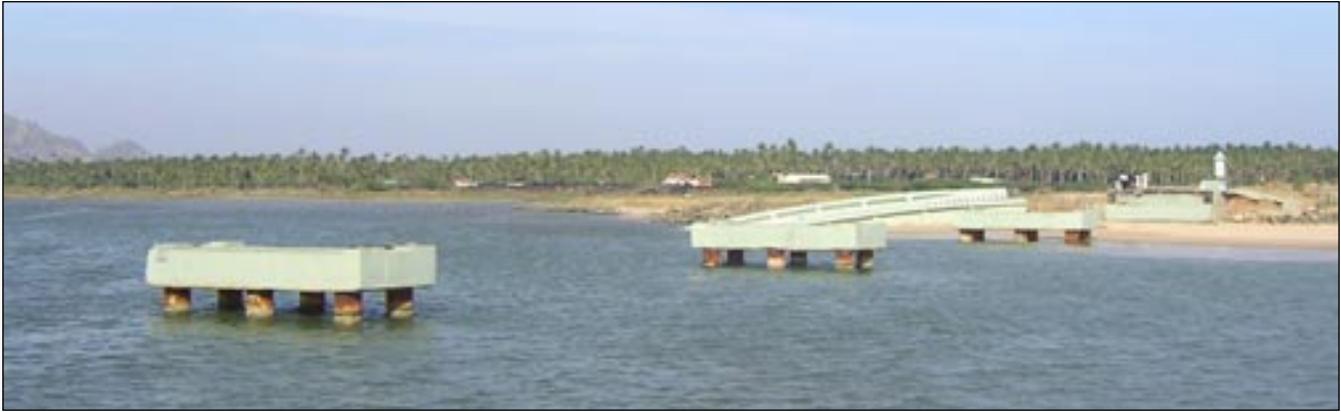
Bridges and culverts were affected. At least three bridges were damaged, with one of them losing all four spans (Figure 17). Roads suffered significant scouring at numerous places along the coast, as did railway lines. Road embankments were eroded. Compound walls

Figure 17. Complete loss of spans of the four span RC bridge at Melmannakudi in Tamil Nadu (photo: Alpa R. Sheth).
