LESSONS LEARNT ON ENGINEERING PREPAREDNESS FROM THE 1988 BIHAR EARTHQUAKE

Sudhir K. Jain
Assistant Professor
Department of Civil Engineering
Indian Institute of Technology
Kanpur - 208 016 INDIA

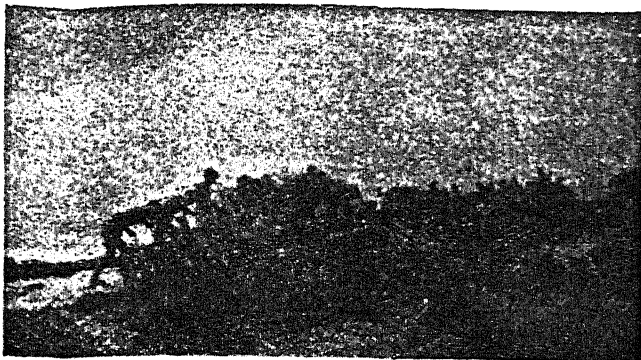
in aseismic construction. For instance, in Bihar during the recent earthquake long stretches of flood control embankments developed longitudinal cracks while at a few places the embankments subsided by a very significant amount (e.g., Jain, et al, 1988). In the author's opinion, total lack of compaction in construction of these embankments was largely responsible for this. Fig. (1) shows the repair of a subsided embankment with obviously no compaction even after the earthquake. On the other hand the author found much better awareness in Siliguri for earthquake resistant design among government as well as private builders. This went to the extent that even in the multistorey R.C. frame buildings "lintel band" is commonly provided; except that it does not act as a band because it is not connected to the columns and hence is not continuous around the building. Fig. (2) shows one such building. Obviously in the latter case a very encouraging climate exists for earthquake resistant construction but the builders lack proper training and hence misunderstand the code provision of lintel band in masonry load bearing construction to also apply to partition masonry in frame buildings.

FIG. (1) RESTORATION OF A SUBSIDED EMBANKMENT WITHOUT ANY COMPACTION

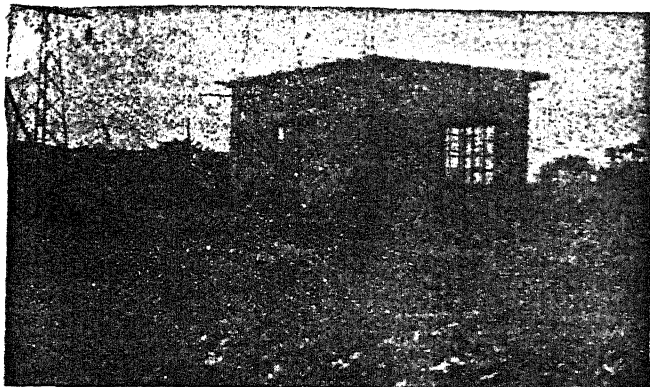
FIG. (2) A R.C. FRAME BUILDING IN SILIGURI WITH "LINTEL BAND"
