A National Technological Crisis

Structural and Geotechnical Damages Sustained During M7.9 Bhuj Earthquake Force

C. V. R. Murty, Umesh Dayal, Jaswant N. Arlekar, Sailender K. Chaubey, and Sudhir K. Jain
Department of Civil Engineering, Indian Institute of Technology, Kanpur.

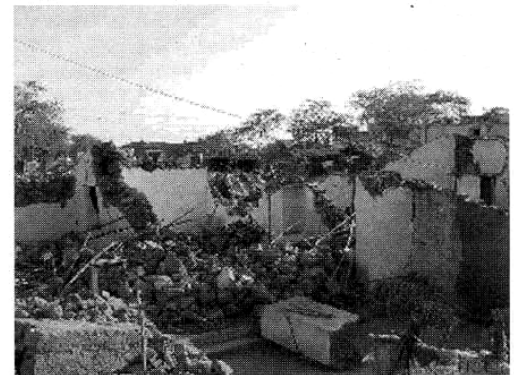
Several towns and large villages, like Bhuj, Anjaar, Vondh and Bhachau, sustained widespread destruction (Figure 1). The other prominent failures in the Kutch region include extensive liquefaction, failure of several earth dams of up to about 20m height, damage to masonry arch and RC bridges, and failure of railroad and highway embankments. Numerous recently-built multi-storey RC frame buildings collapsed in Gandhidham and Bhuj in the Kutch region, and in the more distant towns of Ahmedabad (300km east) and Surat (375km southeast) killing a large number of people (Figure 2).

Figure 1: Total collapse of traditional houses in random rubble stone masonry with mud mortar at Maliya village.

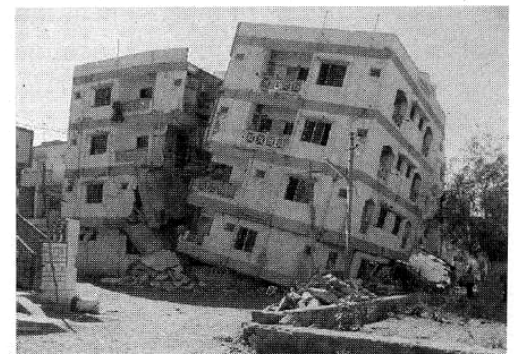
Figure 2: Collapse of the ground storey and vertical splitting of a typical four-storey RC frame building.

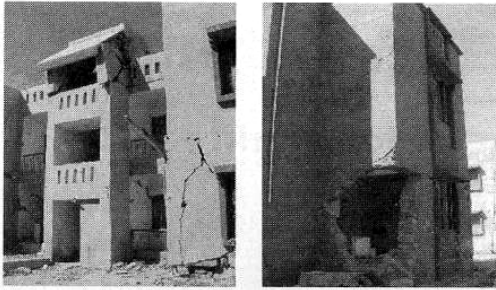
Figure 3: Imminent collapse of staircase tower and collapse of the corner of two-storey large block stone masonry houses without lintel bands in Bhuj.

problems of walls not being adequately connected to each other and to the roof, separation of the 40-60cm thick masonry walls into two distinct wythes, and failure of the rather heavy mass "Mangalore" clay tile roofing system with thick wooden logs as purlins and rafters, are among the notable deficiencies of such dwellings. The Kutch area has additional characteristic constructional issues associated with the non-engineered constructions. For instance, the use of very large block (25cm'40cm'60cm) masonry with mud mortar or low strength cement mortar is very common (Figure 3). These too have shown very poor performance.

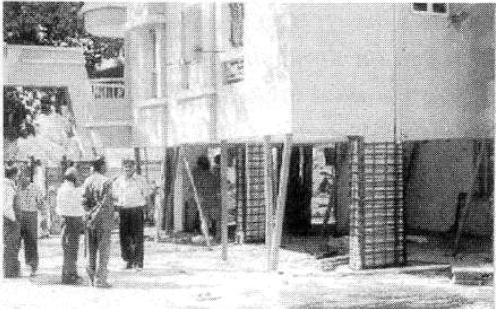
Figure 4: Precariously balanced severely damaged RC frame building with open ground storey in Ahmedabad.

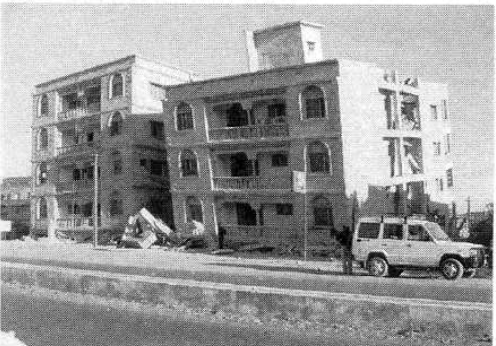
Figure 5: Ground storey collapse of a 4-storey building with open ground storey at Bhuj.

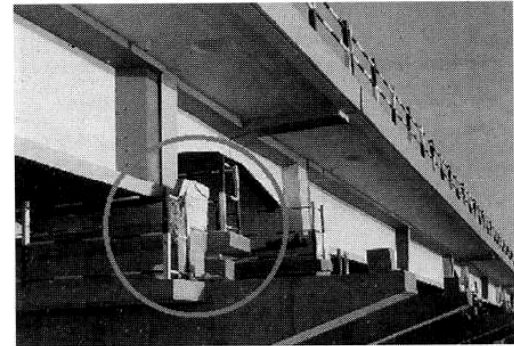
Figure 7: The bridge was provided with RC lateral restrainers to prevent dislodging of spans in the transverse direction. Most of these devices sustained damage due to lateral pounding by the spans.

cating their successful use (Figure 8). The large movement of the girders of this bridge along the longitudinal and transverse directions imposed severe strains on the neoprene bearings. The possible uplift of the girders may have also been responsible for the spalling of cover concrete at the bottom of the girders.

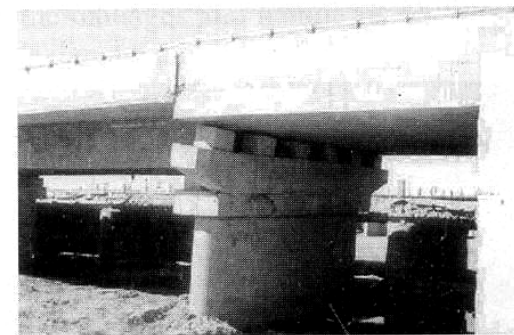
cent spans with unequal-height bed blocks owing to the two spans having girder/slab with different depths, was very obvious from the severe damage sustained by one such bridge in the epicentral area (Figure 7). This is a very good lesson for future to avoid such designs.

Figure 8: Damage to the unequal-height bed blocks at the RC bridge near Vondh. The pier supports two spans with different girder/slab depths.

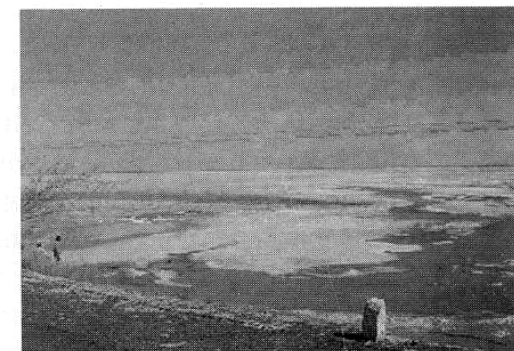
Figure 9: Extensive liquefaction near India Bridge at Khawda (The Great Runn of Kutch).

(Figure 9). Classic sand boils (6-8m in diameter and 20cm in height) are captured from the liquefied area that had an impervious overlying layer (Figure 10). But, at many other locations, liquefaction was widespread. The extensive liquefaction under a 3-storey RC frame office building at Kandla port caused only minor cracks in the walls. However, the building settled down by about 7cm. The extensive liquefaction in the Runn of Kutch did not affect the performance of the numerous

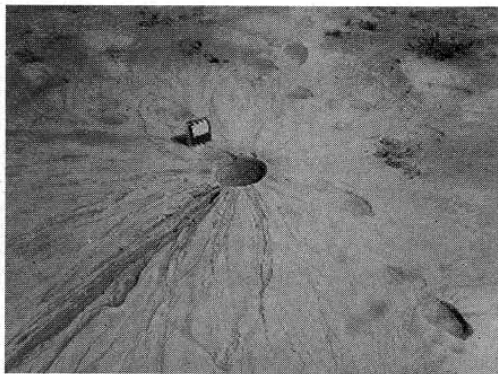
Figure 10: One typical sand boil (6-8m in diameter and 20cm in height) from the liquefied area in the Great Runn of Kutch.

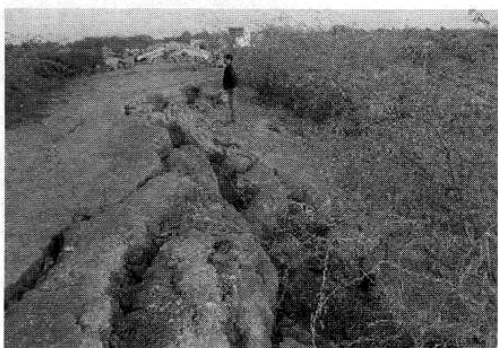
Figure 11: Failure of the upstream slope of the Fatehgad dam.

At least five earth dams (Tappar, Kaswati, Fatehgad, Rudramata and Suvi) have failed during this earthquake (e.g., Figure 11). The damage included slope failures of the upstream/downstream side, longitudinal cracks along the crest of the dam, vertical settlement of the embankment in general, and toe failures on the upstream side. This is a very serious matter particularly with the impending rainy season. Also, the failure of a large number of dams during one single earthquake has generated tremendous interest in the international scientific community to benchmark their analytical models using these failures; some at-site tests/investigations may be required to assess the soil parameters at these sites. Failure of sea wall at Navlakhi port, wherein over 50 meters stretch of the wall was washed away into the sea, provided yet another example of the catastrophic soil slope failures.

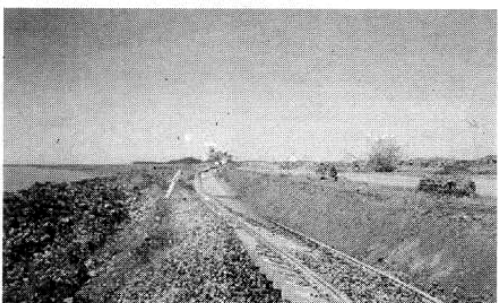
Figure 12: Massive slope failure of the rail-road embankment near Navlakhi port resulting in fracture of rails, and damage to prestressed concrete sleepers and panroll clips.

The earthen embankments of the railroad and highways also suffered widespread damage. The massive slope failure of the rail-road embankment near Navlakhi port resulting in fracture of rails, and damage to prestressed concrete sleepers and panroll clips, should stand as the main source deterrent to looking away from the concerns related to geotechnical problems (Figure 12). In some instances, ground liquefaction at the base of the embankment was responsible for extensive damages to the railway embankments. Damage to highway pavement and kerbs due to lateral

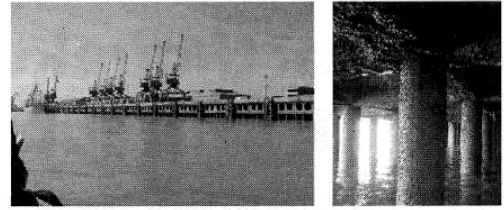
Figure 13: Six of the twelve jetties at the Wharf at Kandla port were damaged; flexural cracking of the piles at the jetty.

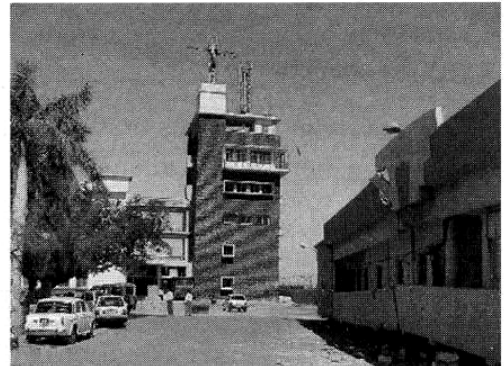
The wharf, the industrial warehouses and the control tower buildings at the port of Kandla suffered major damages owing to both structural inadequacies as well as liquefaction of the ground. The lateral spreading of the liquefied soil at the jetty, led to a lateral translation of the 50cm diameter piles of the old jetty, resulting in flexural cracking in them (Figure 13). However, the 100cm diameter piles under the newer jetty performed well. The flexural and shear cracks at the beam-column joint at the knee-bent frame supporting craft jetty; severe damage (cyclic shear cracks) to the exterior short columns at the ventilators of the warehouse in the form of opening of ties and buckling of longitudinal steel; undulations of floor tiles of the container terminal due to extensive liquefaction; and a 15° tilt in the six-storey control tower structure on the shores due to liquefaction of the underlying soil and consequent lateral spreading towards the bay, are some of the notable damages at the Kandla port (Figure 14).

Figure 14: A 15° tilt in the 6-storey control tower at Kandla port due to liquefaction and consequent lateral spreading towards the bay.
