IMPLICATIONS OF THE 2004 GREAT SUMATRA EARTHQUAKE AND TSUNAMI FOR RISK REDUCTION IN INDIA

Sudhir K Jain¹

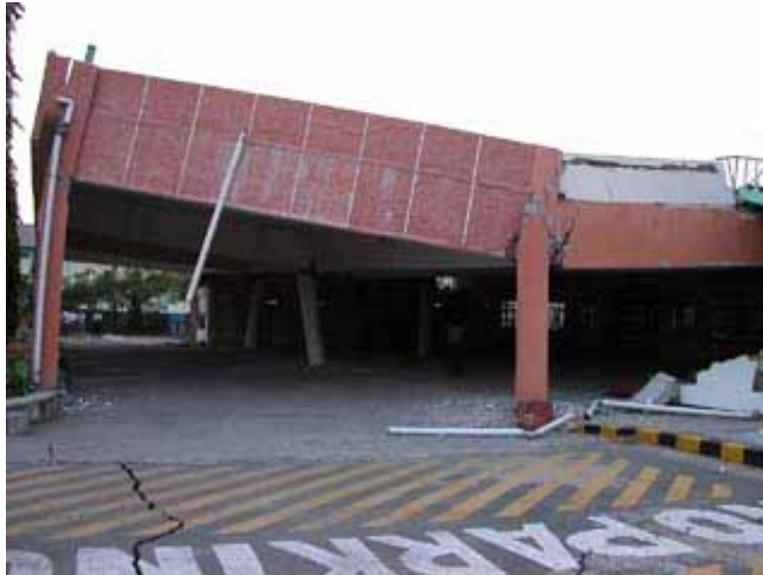
In general, it is believed in India that the constructions by the government agencies by and large comply with the seismic codes. However, in the case of A&N Islands, at least some construction projects in recent years in the government sector did not follow the codes. For instance, the reinforced concrete Passenger Terminal Building in Port Blair was built about five years back. A part of the building was supported on piles while the other part was situated on spread footings on relatively soft soil. The building did not comply with the requirements of IS13920, mandatory for seismic zone V, on ductile detailing, and underwent partial collapse (Fig.1).

Figure 1. Partially collapsed Passenger Terminal Building at Haddo Wharf, Port Blair.

As a consequence of recent earthquakes and a number of capacity building activities in the country (Jain and Murty, 2003), many more structural engineers now know about the concepts of earthquake engineering than was the case a decade back. However, the above example clearly illustrates that a lot more work remains to be done to train and sensitize the government engineers and structural consultants on earthquake resistant design.

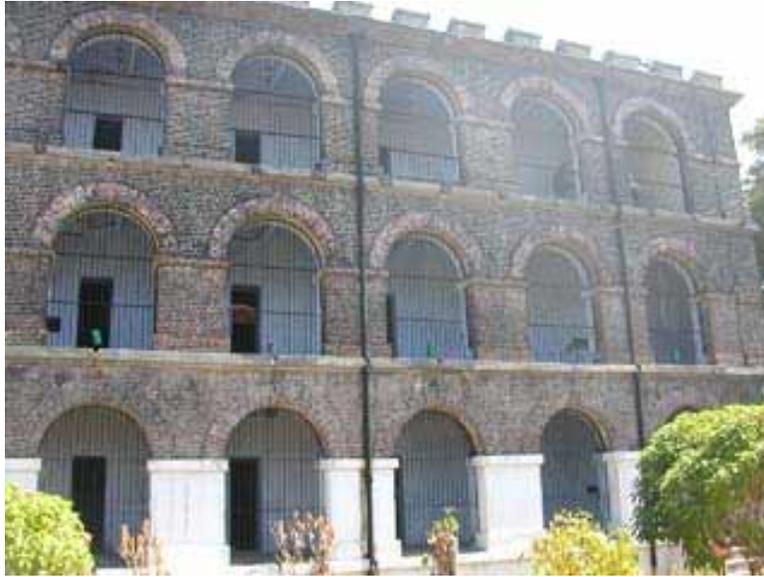
The A&N Islands were colonized by the British only after 1857 and originally the preferred mode of construction was brick masonry (Fig. 2). As a consequence of the M7.7 earthquake on June 26, 1941, the wood became the preferred construction material. Such traditional wood houses in the A&N Islands performed well during the seismic shaking (Fig. 3). However, in recent years, new constructions are either in reinforced concrete or masonry. Many recently built masonry and RC constructions suffered damages due to ground shaking, some even collapsed (Fig. 4). This is due to lack of expertise by the public to use such materials in earthquake regions. Thus, vulnerability of the islands to earthquakes has been increasing dramatically in recent years.

Figure 2. Cellular Jain in Port Blair; historical construction practice in brick masonry.

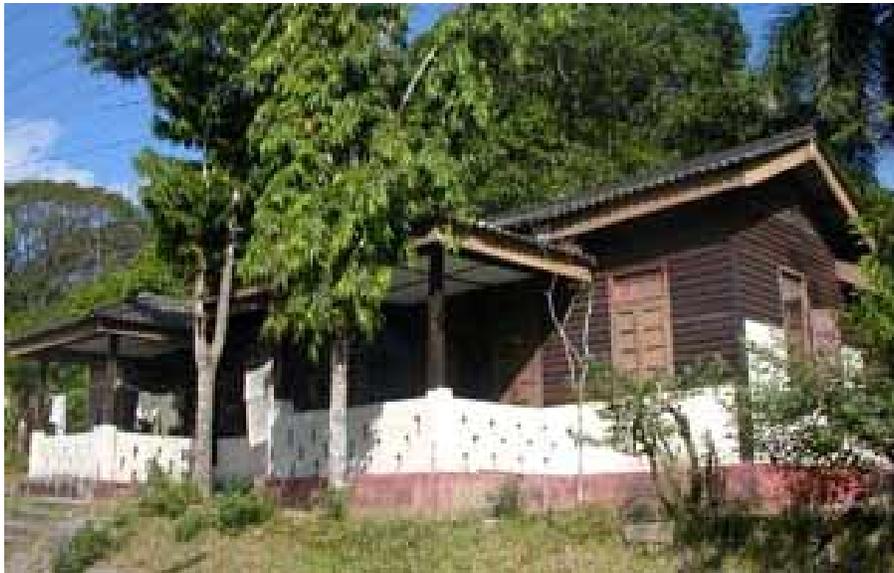
Figure 3. Undamaged traditional wood house at Port Blair.

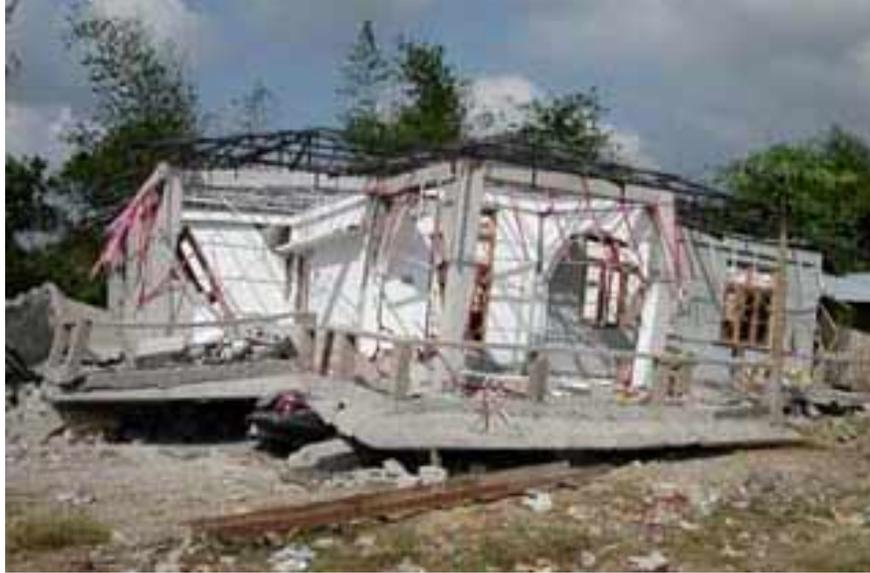
Figure 4. Collapsed 2-storey RC building on stilts at Bamboo Flat near Port Blair.

The above state of affairs clearly illustrates that (a) it is hard enough to ensure quality in modern RC frame buildings by government departments having trained engineers and with systematic checks and balances, and (b) it is virtually impossible to expect the public to bring in enough engineering expertise for construction of one- or two-storey dwellings in reinforced concrete. As has been seen in numerous earthquakes around the world, if not designed and constructed correctly, RC frame buildings can be major killers. And yet, in most towns and cities in the country, numerous RC frame buildings continue to be built by the public without any engineering support and expertise. It is unrealistic to expect that this situation will change substantially in the short term. Hence, a paradigm shift is needed in our construction practices: we must develop and propagate construction types that are more resilient against earthquakes and yet do not require major engineering inputs. For instance, even in a developed country such as the US, an ordinary house is not expected to be designed following the calculations specified in codes meant for major buildings. Instead, empirical provisions of a small building code (ICC 2003) govern such constructions. In case of India, confined masonry may be a very good option for one- or two-storey buildings and should be encouraged in place of ordinary masonry. Similarly, reinforced concrete shear walls should be systematically encouraged in place of RC moment resisting frames, both in formal and informal constructions.

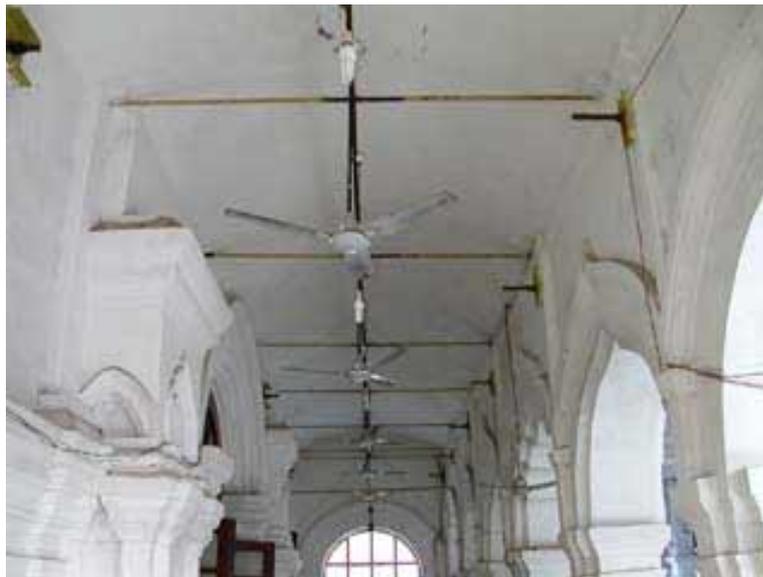
Many buildings require repairs of varying level after an earthquake. That is also a time when concerns about seismic safety are at the peak. Hence, post-earthquake scenario provides a major opportunity for undertaking seismic retrofitting of buildings concurrently with the repairs. In fact, the Jama Masjid, Aberdeen in Port Blair provides a very fine example of the same. The mosque made of brick masonry with arches, domes and minarets was completed in 1913. In the 1941 earthquake in A&N Islands, the mosque underwent some damage and was repaired, and retrofitted by providing tie rods to develop an integrated box action of the walls (Fig. 5). About two years back, while undertaking major renovation of the mosque, the tie rods that had fallen due to corrosion over the years were replaced. As a result, the mosque was well prepared to face the ground shaking of the 2004 earthquake and underwent only minor damage wherein some of the small minarets fell down while the main structure remained intact and safe.

Figure 5. Retrofitting of an old Mosque using tie rods at Aberdeen, Port Blair.
