Roads and Bridges

INTRODUCTION

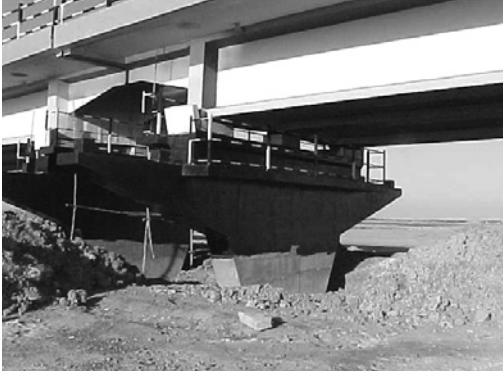
Figure 19-8. Girder-pier support system on the New Surajbadi Highway Bridge. Well foundation is not visible.

The New Surajbadi Highway Bridge consists of cast-in-place concrete tee-beam girders. It has 39 simply supported girder-slab superstructure spans, each of 32.2 m. There are three prestressed concrete girders under the deck. The girders were pretensioned and precast at the site in a shop on the south end of the bridge, and then brought to the span location by cranes for installation. The bridge girders are rested on the piers with elastomeric bearings in between. Reinforced concrete piers that flare out on top support the superstructure spans. The adjacent spans do not share the same pier; they are rested on different piers. These two piers are together supported on one foundation. Figure 19-8 shows two piers supported on the well foundation underneath (not visible). The bridge was designed for a static horizontal seismic coefficient of 0.09g.

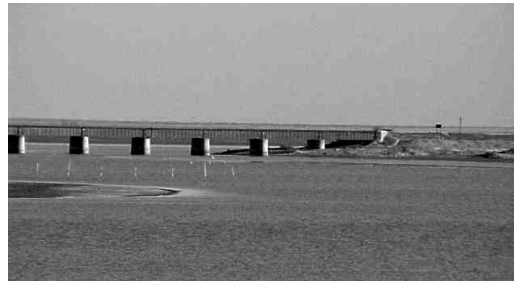
Figure 19-16. Near the south side abutment of the Surajbadi Railway Bridge.

The Surajbadi Railway Bridge and embankment near Surajbadi were completed in 1969-70.¹ The railway bridge consists of 62 spans of 18 m steel plate girders. The girders are simply supported on flat plate bearings on the piers. The railway track is directly supported on the railway ties that are placed on and anchored to the girders. There is no ballast under the rails on the bridge (Figure 19-16). The bridge performed well in the earthquake.

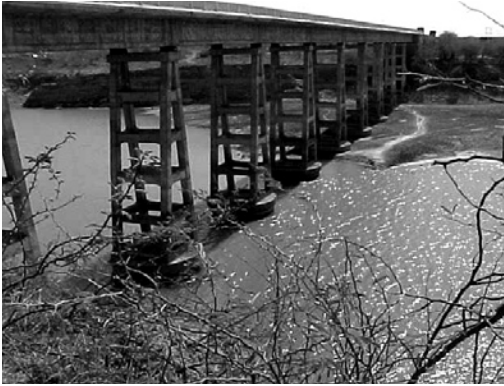
The Rudramata Bridge, built in 1966, is located on State Highway 45, 16 km north of Bhuj. The bridge is 7.3 m wide and is composed of 10 simple spans of 16.8 m each, with expansion joint at the piers. The superstructure consists of two precast/prestressed girders with cast-in-place concrete deck and diaphragms. Elastomeric bearings support the prestressed girders at both abutments and at intermediate piers. There were no longitudinal restrainers or transverse stops to control the superstructure movement on the piers. The substructures consist of reinforced concrete A-frame towers (Figure 19-17). These are each supported on a large diameter caisson. The main structure of the bridge performed relatively well during the earthquake, but the north end suffered approach damage, resulting in the closure of one lane of traffic.

Figure 19-17. The Rudramata Bridge, the tallest in the region, supported on open-type reinforced concrete A-frame piers.
