Geotechnical Damage Due to Bihar Earthquake of August 1988

SYNOPSIS: The Bihar-Nepal earthquake of August 21, 1988 (magnitude 6.6) caused significant loss of life and property. Besides the epicentral area, two distant places (Munger in India and Bhaktapur in Nepal) suffered significantly. This was also the case in the 1934 earthquake (magnitude 8.4) and is due to peculiar geology of the area. Geotechnical damage in the affected area includes liquefaction, cracking and subsidence of embankments, and cracks in bridge abutments and wing walls. Besides, in the hilly regions of Sikkim, landslides and rockfalls disrupted road network significantly. Extensive damage took place in the eastern Nepal also. This paper describes the geotechnical damage to the Indian areas only.

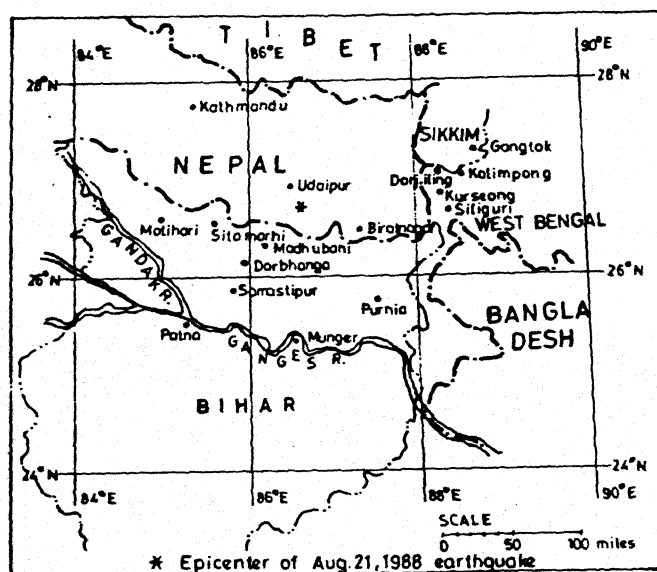
FIG. 1 Affected Areas, August 21, 1988 Earthquake.

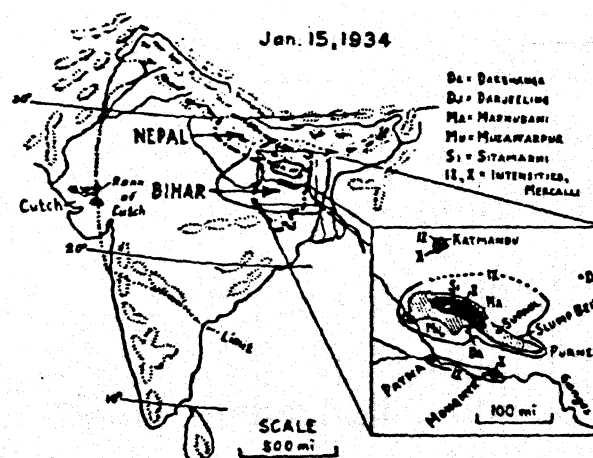
FIG. 2 Affected Areas, Bihar-Nepal Earthquake of 1934 (Richter, 1957).

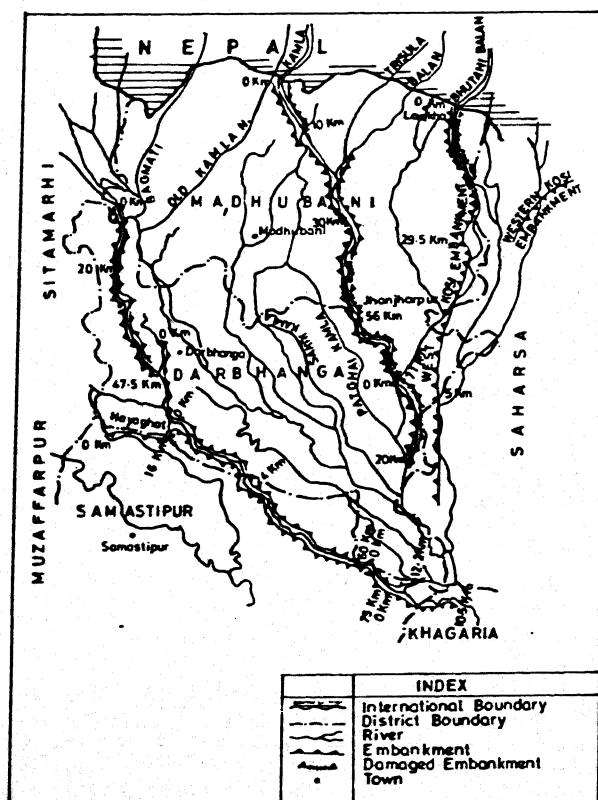
FIG. 5 The Damaged Embankments in Flood Control Circle, Darbhanga.

This embankment subsided very significantly at 67.0 km point (Fig. 5) near Jhanjharpur. The damaged site is about 22 miles from Darbhanga. This embankment is 18 feet wide at the top and approximately 18 feet high, having 1:2 slope on the river side and 1:3 slope on the other side with brick pitching on both the slopes. The embankment was reconstructed in August 1987 after a breach and washing away of the earlier embankment. The top of the newly constructed embankment subsided by about 8 feet (Fig. 7). The pitching on the river side slope bulged out, while on the other side it became wavy after subsidence. Longitudinal cracks on top of the embankment and sand boils brought by the liquefaction were also observed. Since construction practice in the area does not include compaction of the embankments, the embankment itself being loose and saturated underwent liquefaction resulting in large slumping.

Sormarat-Hayaghat embankments on the Kareh river at 16.5 km point (Fig. 5).
