Learning from Earthquakes

Preliminary Observations on the Origin and Effects of the January 26, 2001 Bhuj (Gujarat, India) Earthquake

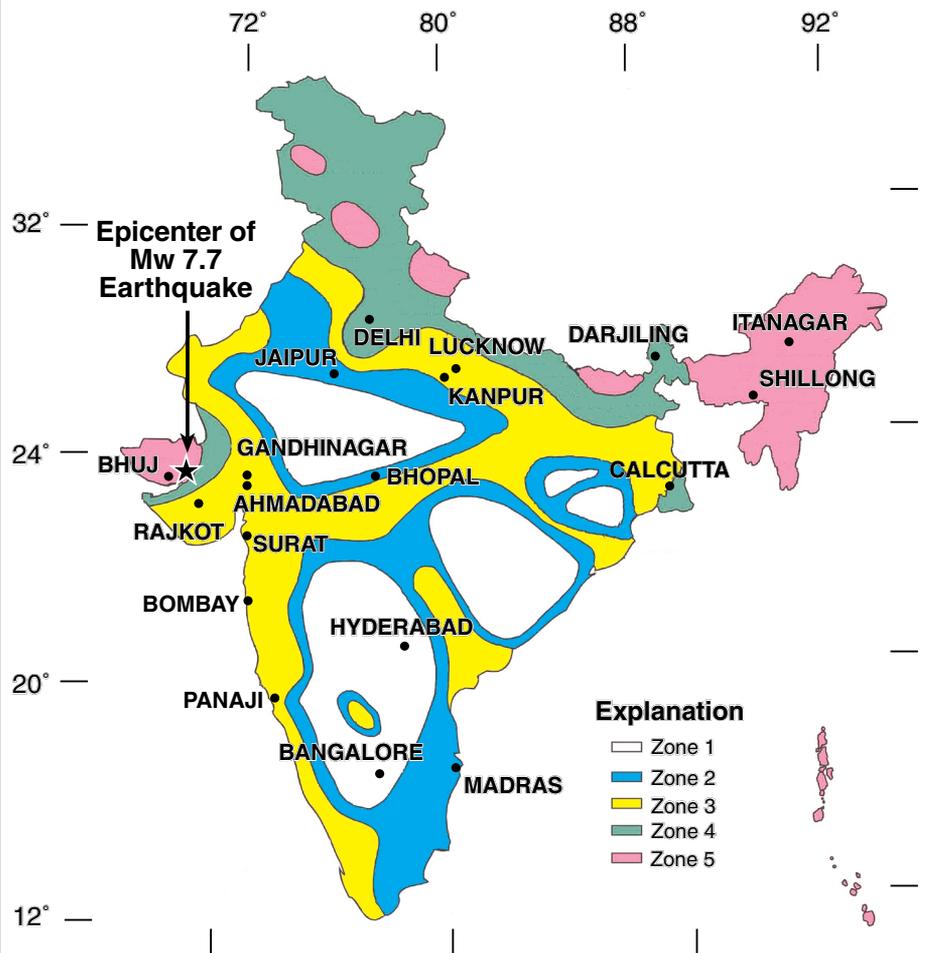
Figure 2 Seismic zonation map of India. The epicentral region of the January 26, 2001 Gujarat earthquake is in Zone V. Note that both Ahmedabad (238 km east of epicenter), and Surat (357 km southeast of epicenter) where damage was extensive, are located in Zone III. (Map prepared by the Geological Survey of India)

compared to peninsular India, is reflected in the higher seismic hazard assigned to the area on the seismic zonation map of India (Figure 2).

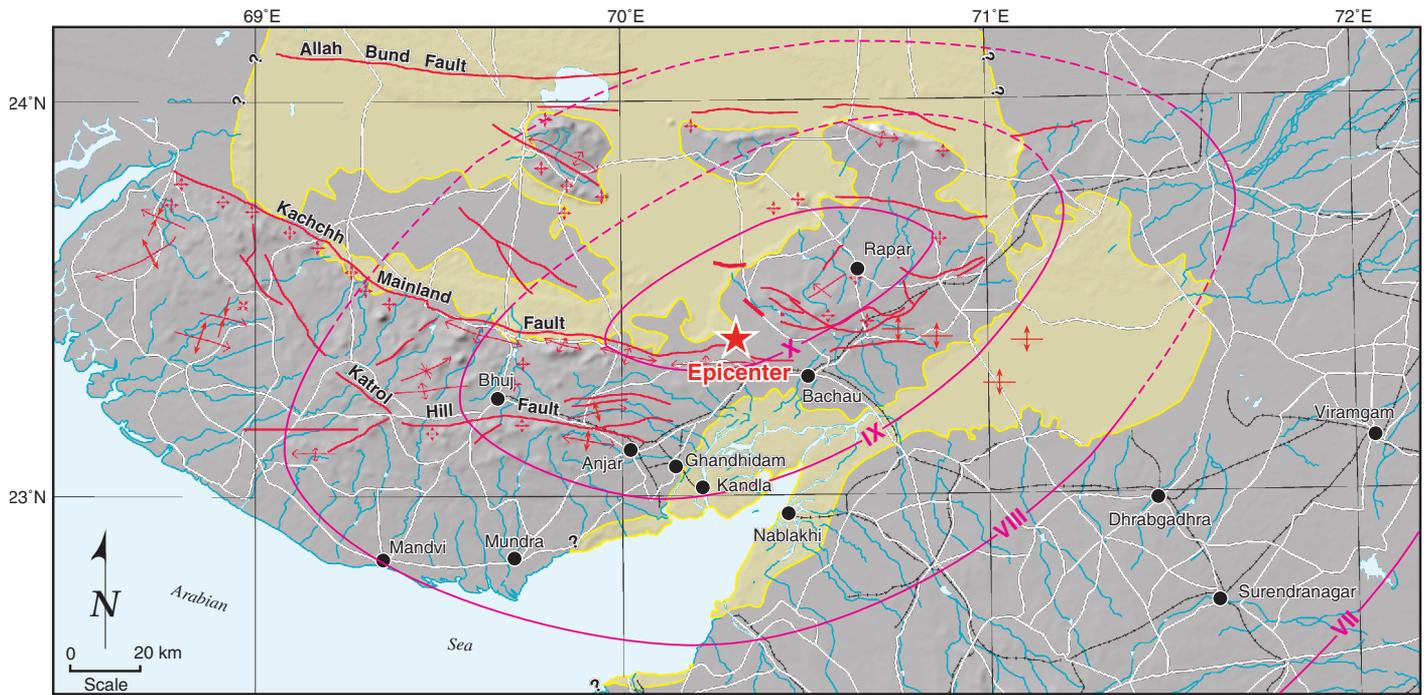
Figure 3 Topographic relief map showing MSK intensity levels (by P.L. Narula) and general distribution of liquefaction (by J. Hengesh) western Gujarat resulting from the January 26, 2001 Mw 7.7 earthquake. (Faults from Malik, et. al., 2000)

Liquefaction: The earthquake produced widespread liquefaction in the Great Rann, Little Rann, Banni Plains, Kandla River and Gulf of Kachchh (Figure 3). These areas contain low-lying salt flats, estuaries, intertidal zones, and young alluvial deposits, which typically have a high susceptibility to liquefaction. The extent of liquefaction shown in Figure 3 was inferred from local field and aerial observation and extrapolation to areas of similar susceptibility. Liquefaction was manifest at the surface as sand boils (Figure 4), lat-

Extensive liquefaction and lateral spread features occurred in the epicentral area (Figure 3). Some of these features have been reported by others as primary fault ruptures; however, their association with sand boils, arcuate shape, change in sense of deformation along the head, toe and lateral margins, and lack of noticeable vertical land-level changes favor a non-tectonic interpretation. The authors speculate that tectonic warping provided the driving force for the lateral movement of the liquefied soil on the previously very flat slope.

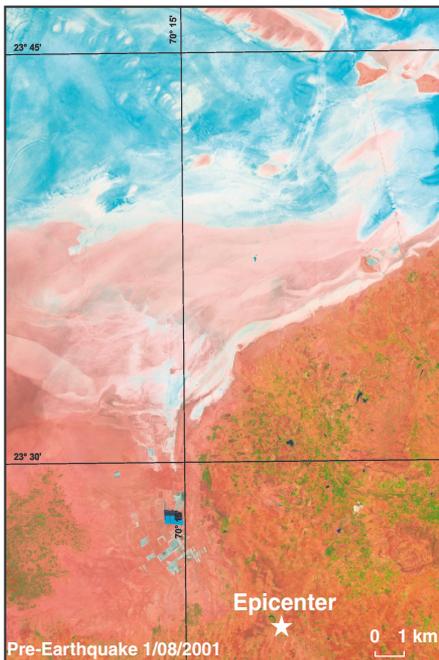
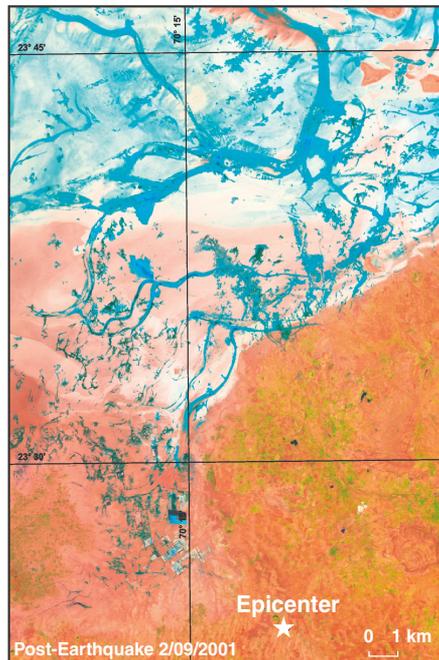
Figure 5 Landsat TM image of January 26, 2001 Mw 7.7 earthquake showing distribution of liquefaction. Image on left taken before earthquake. Image on the right shows accumulation of surface water produced during widespread liquefaction. Subsidence of the ground surface may also have occurred due to compaction and consolidation and tectonic down-warping. (Raw scene courtesy of Ken Hudnut and Zhong Lu, USGS. Image processing by Andrew Barron, William Lettis & Associates.)

eral spreads, and collapse features. Figure 5 shows satellite imagery of the epicentral area before and after the earthquake. The large amounts of water on the Banni plains after the event are a product of the liquefaction and possible consolidation of the ground surface. The authors estimate that approximately 10,000 km² of highly susceptible deposits liquefied during this earthquake.
